The Nautical Institute Mariners' Alerting and Reporting Scheme

MARS Report No 231 January 2012

MARS 201201

Soot from economiser caused fire

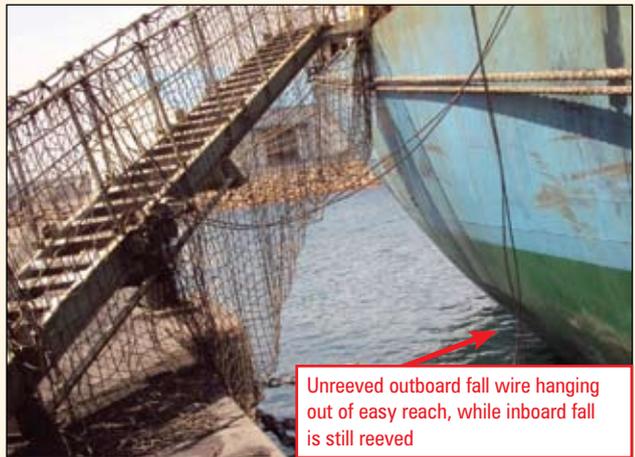
In most designs, the gangway fall wire leads from the winch to an outrigger from where it is reeved through sheaves on both inboard and outboard sides of the ladder. When the ladder is slewed outboard and its foot is landed on the shore, the fall wire on the outboard side tends to lead across the steps, obstructing free passage. On many vessels, the cheek plates of these side sheaves are hinged (similar to a snatch block) in order to allow the crew to temporarily unreeve the wire from the outboard sheave and move it clear of the access.

Unreeved outboard fall wire hanging out of easy reach, while inboard fall is still reeved

▲ Ship's accommodation ladder slewed outboard by a large angle and landed on the shore due to broad fendering on the berth and outboard fall wire temporarily unreeved from the side sheave

If the accommodation ladder has to be hoisted in an emergency, precious time may be lost in 're-reeving' the fall wire. This means that this practice must be carefully reviewed. One method of maintaining clear access would be to lash a tall vertical stanchion to the outboard side of the ladder and without unreeving the fall wires, loosely secure the slack wires to the top of this stanchion using short lengths of yarn that can either be released quickly or will part when the winch takes up minimal weight.

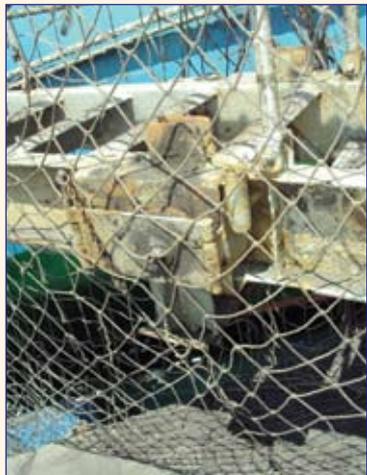
◀ A safety net rigged around the accommodation ladder would further hamper the quick re-reeving of the fall wire around the side sheave

Typical suspended accommodation ladder with extension gangway landed on shore. Recovery of or adjustments to ladders in this configuration can also be difficult.

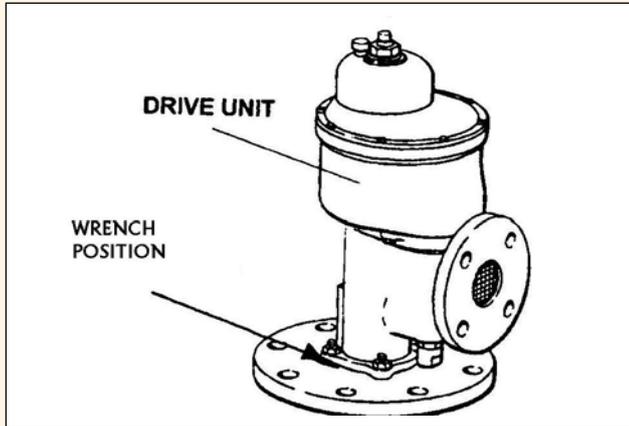
During routine maintenance of a fixed tank cleaning machine on a tanker, a crewmember removed all the nuts on the base studs, lifted the drive unit slightly and inserted the end of an open spanner (wrench) between the base flange and the drive unit to visually examine the working parts through the narrow gap. During this operation, he had inadvertently placed his left middle finger near the wrench, under the base mounting of the drive unit. Suddenly, the spanner slipped out and the drive unit dropped on his finger, badly crushing it. The injured person was given immediate first aid and was off work for the next three days and was given shore medical treatment at the next port.

1. Inappropriate tool used as temporary stopper device;
2. The task was not planned or assigned by the Chief Officer;
3. The crewmember decided to carry out this task on his own initiative and he did not conduct any risk assessment;
4. Crewmember did not follow the correct method of inspection as recommended in the maker's service manual;
5. Lack of skills and overconfidence on part of the worker in his ability to undertake the task.

▲ Diagram showing location of wrench (and crushed finger)

1. Incident report circulated to fleet reminding ships' staff to consistently follow safe working practices and follow maker's service instructions;
2. Ships' staff reminded to discuss work plan with immediate superior and/or Dept heads before starting work;
3. Responsible persons instructed to carry out and record risk assessment for every planned job. Assigned crewmember(s) instructed to always practice the concept of 'Take 5' before commencing work;

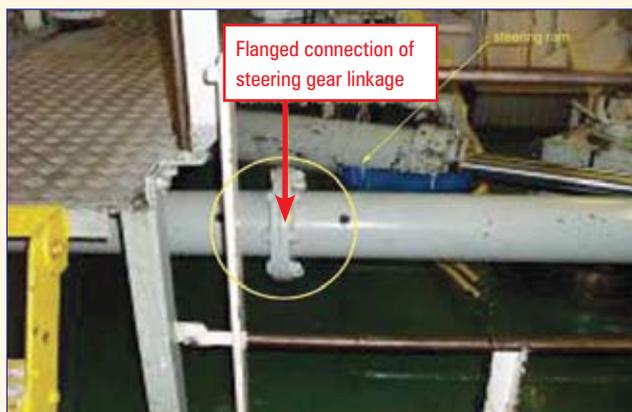
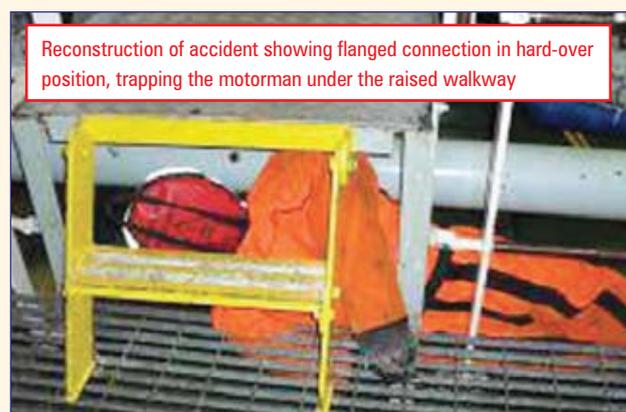
and mop up a small quantity of accumulated leaked hydraulic fluid. The steering gear machinery was enclosed by a perimeter railing and as the motorman entered this enclosure, his clothing snagged on the flange coupling of the linkage that connected the rams on opposite sides of the tiller. Simultaneously, a hard-over rudder movement was executed from the bridge, and the large axial movement of the linkage resulted in him being dragged into the narrow gap under the raised walkway frame, trapping and seriously injuring him. A short while later, the Chief Engineer went to the steering gear flat to check on the work and found the injured motorman lying motionless and unable to extricate himself. After he was evacuated from the steering gear space, the motorman was airlifted to the nearest hospital, where he received medical treatment for crush injuries to his vertebrae and pelvic region.

1. Areas around moving machinery should be securely guarded to prevent such accidents;
2. Personnel should never enter or remain alone in any unmanned machinery space unless they have advised a responsible person / control station / bridge of their intentions;
3. Warning notices directing the crew's attention to the likelihood of machinery suddenly starting up and moving were not displayed at the entrance of the space;
4. The Code of Safe Working Practices for Merchant Seamen (COSWP) recommends the use of a permit-to-work (PTW) for appropriate tasks. In this case, a PTW might have prevented this accident.
