Providing learning through confidential reports – an international cooperative scheme for improving safety

MARS 201208

Contact damage during double-banking manoeuvre

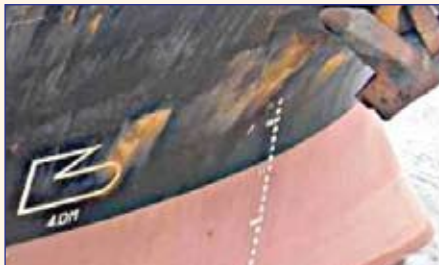
At a river port in West Africa, a bulk carrier under pilotage and with tugs assisting was to double-bank with a bulk cement storage vessel that was moored to a berth located on a sharp bend in the estuary. The cement vessel had several large pneumatic rubber fenders deployed on her offshore side. The bulk carrier had lowered both her bower anchors to just outside the hawsepipes for letting go. During the final approach, she encountered a strong cross-current which canted her bow sharply to starboard on to the cement vessel. The overhanging starboard anchor struck the cement vessel before the fenders on the waterline could cushion the impact and caused extensive damage to the cement vessel's side shell and internals. The accident was analysed and the underlying causes were identified as incorrect estimation of ebb current and lack of knowledge and skills on the part of the bridge team.

◀ Bulk carrier's bow with overhanging starboard anchor

1. Leadership training for key bridge team personnel;
2. Analysis of all critical operations and tasks;
3. Immediate investigation of all accidents/incidents and communication of findings and recommendations;
4. Improve emergency preparedness.

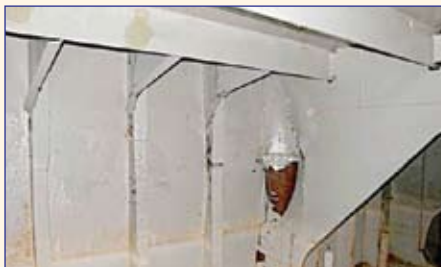
▶ Cement vessel's side shell holed and internals damaged by bulk carrier's anchor

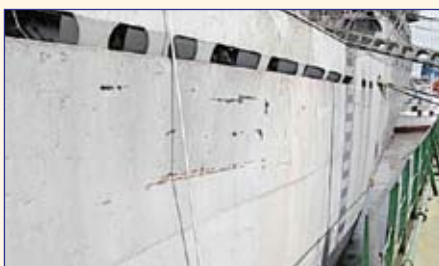
◀ Cement vessel's side shell dented and scratched

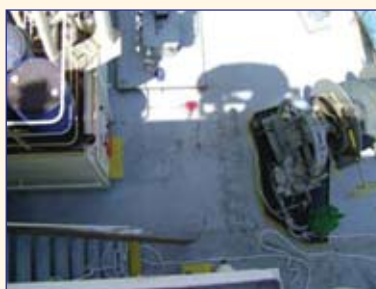
Plan view of location of accident ▶

A team of seamen was transporting a newly-supplied garbage compactor from the upper deck to a higher deck aft of the galley area. When changing the lifting arrangement from above the work area, they requested assistance from a passing crewmember, who was not part of the assigned work team. As he approached the work area, a shackle was accidentally dropped from above, hitting him on the head. Fortunately, there was no injury.

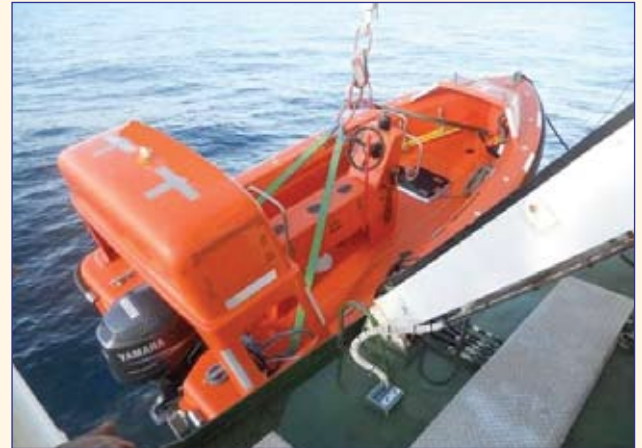
1. A photograph taken immediately before launching the rescue boat confirms that the painter release mechanism was apparently locked;
2. However, the spring-loaded activation lever of the painter release mechanism was not in the 'fully home' position, and a simulation at the manufacturer's workshop showed that, in this position and subjected to cyclical forces from different angles, the hook holding the painter would open under load; i.e. the painter release mechanism was practically in the open position when the boat was launched contrary to the photographic evidence;

▲ Rescue boat prior to launching showing forward painter secured

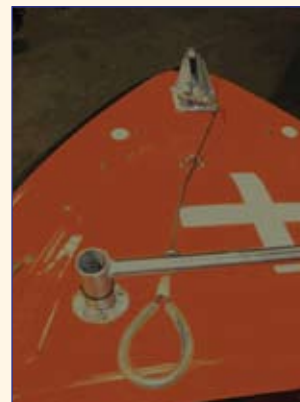
3. Further, as the boat was being swung out, the vessel's movement caused the rescue boat to swing appreciably, despite the light sea conditions. It is possible that when the deck cadet stationed in the bow held the grab rail fitted on the boat's bow cover to steady himself, he inadvertently also pulled the wire lanyard that was lying under the grab rail and unknowingly operated the painter release.

▲ Original design showing painter release lanyard situated under the forward grab rail

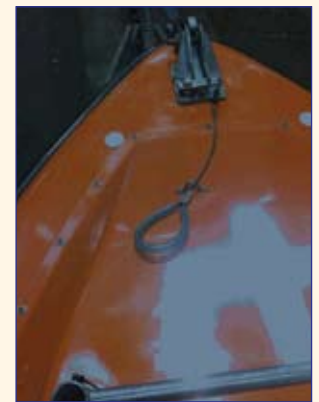
▲ Modified arrangement, showing shortened painter release lanyard now located well clear of forward grab rail

1. Damaged rescue boat repaired to original specifications, surveyed and passed by Class;
2. Painter release activation lanyard shortened to be positioned clear of the grab rail on the bow cover. This requires the boatman manning the painter release to reach across deliberately so as to release the painter once instructed by the coxswain;
3. Painter release mechanism overhauled and activating lever freed to reach proper locking ('fully home') position;
4. Company's procedures revised to specify following sequence for rescue boat operations.

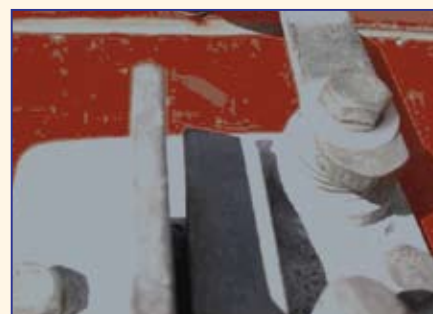
◀ Ineffective spring action of painter release activation lever due to lack of lubrication, preventing automatic return to 'fully locked' position

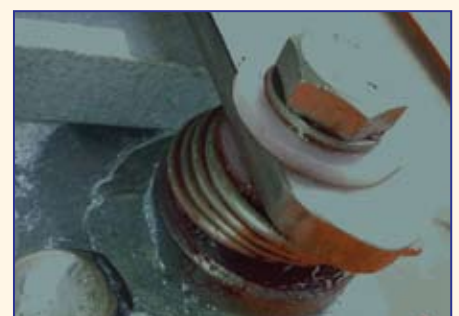
Painter release ▶ activating lever in 'fully locked' position after being overhauled
