SEAWAYS

March 2012

The International Journal of The Nautical Institute

Features

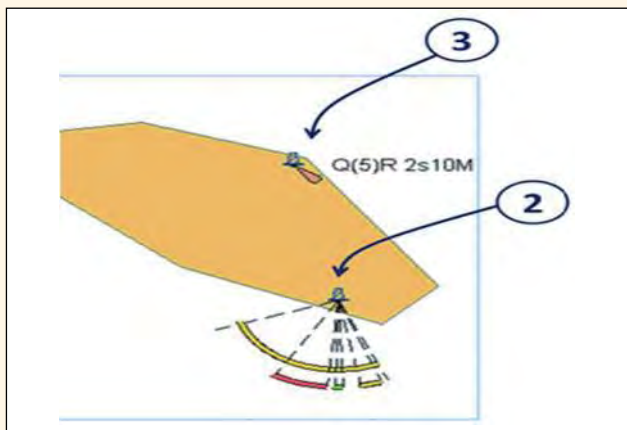
While the anomalies range in their potential seriousness for safety of navigation, there were concerns raised over the display of underwater features and isolated dangers; the display of complex lights as intended; the display of 'submerged wreck - dangerous' as intended by the standards; the display of 'underwater hazard with a defined depth' and the display of Archipelagic Sea Lanes (ASL), Environmentally Sensitive Sea Lanes (ESSA) and Particularly Sensitive Sea Areas (PSSA) properly.

▲ Q2 & 3 portrayal of complex lights. Is object 2 same as in the illustration?
Are light characteristics same as in the illustration

In order that all mariners using ECDIS are fully aware of any limitations in the use of their particular ECDIS, owners, managers, ship operators and ships' officers should ensure that they complete the IHO data checks on their ECDIS/ECS and also report the results back to IHO. If you have not yet received the check data it can be downloaded from the IHO website (<http://www.iho.int>) via the Newslink button on the homepage.

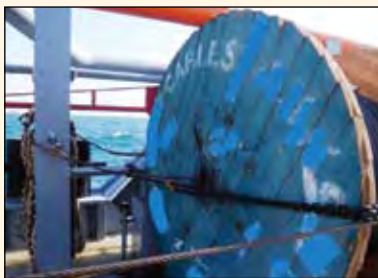
An offshore support vessel sailed from her shore base on a routine supply run to her designated oilfield. Her deck was loaded with a variety of tubing, casings, pallets, tool boxes, food containers and one large unpacked wooden cable reel, weighing about 11 tonnes. The reel was stowed with its axis fore-and-aft and was pre-slung with an extra-long 12 mm steel wire sling passed through the very narrow central hole, which precluded threading any other securing rope or chain through the coil. The sling was unsuitable for securing, so the ship's crew secured the reel by pushing wooden wedges under it and tightening a chain around its girth. Additionally, the vessel's tugger wire was tensioned at the reel's mid-height.

Soon after sailing, the ship rolled and pitched heavily in a gale, and the accelerations imposed large forces on the lashings. Suddenly, a link in the chain parted and the tugger wire instantly became slack. Subsequent movements displaced the wedges and the bridge watch observed the reel moving freely on the deck. The Master was called, speed reduced to minimum and heading altered into the sea and swell. With the ship now pitching gently, the crew managed to throw some square timber (4x4's) across the path of the runaway reel path and gradually regained control over the hazardous situation. A dunnage 'grid' was quickly nailed around the base and the reel remained safely inside this

▲ View of unpacked wooden cable reel – note very narrow central hole with lifting wire sling rove through, chain and tugger wire tightened at mid-height.

1. Unpacked wooden cable reels, especially those with a very narrow central hole, cannot be effectively secured and must be shipped only in containers or skids;
2. Cable reels made of steel with exposed cross-members or spokes may be shipped unpacked, but must be secured with sufficient number of lashings (chains or wires) and wooden wedges as determined from the vessel's approved Cargo Securing Manual (CSM) or as per the guidelines contained in the IMO publication Code of Safe Practice for Cargo Stowage and Securing (CSS Code);
3. Packing a cable reel inside a timber and plywood skid before shipping on a vessel offers an effective and economical method for safer carriage by sea.

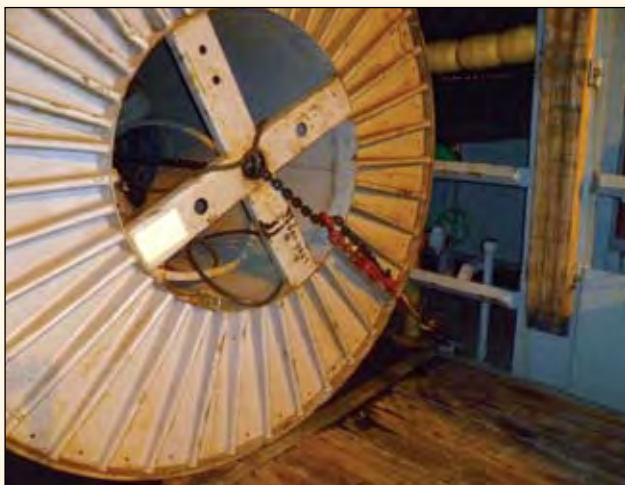
▲ Cable reels made of steel can be more effectively secured

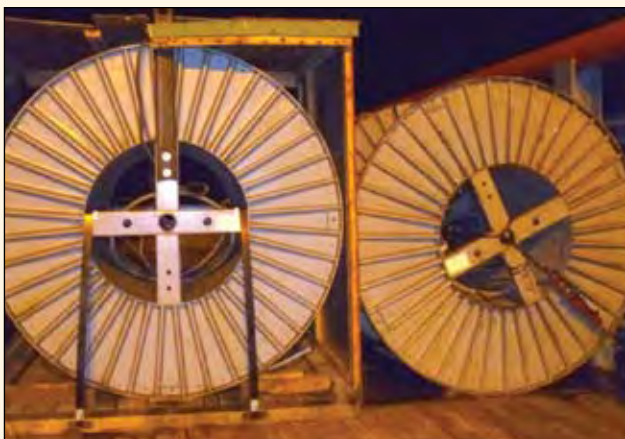
▲ Unpacked cable reel blocked by another cable reel packed on a wooden skid

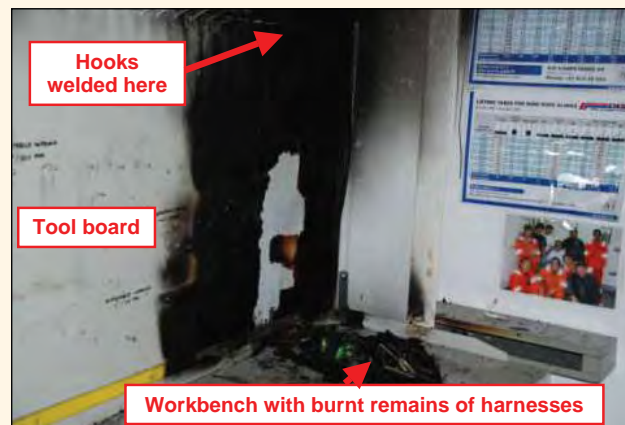
The bosun completed a permit for hot work form, which was approved by the OOW (2/O), who failed to detect several factual and procedural errors and did not conduct a proper discussion or risk assessment. Working alone, the bosun welded one of the hooks to the bulkhead and attended briefly to another errand. The second hook was then welded adjacent to the first one, this time with a seaman also present. Neither of the men paid attention to the cardboard box containing harnesses (made of flammable synthetic fibre) that was lying on the workbench directly under the weld site. They then left the area for a short break. Some minutes later, as the master exited the wheelhouse, he found thick black smoke billowing from the open door of the workshop. He shut the door, returned to the wheelhouse and informed the bosun on the radio that there was a fire in the deck workshop. While the bosun rushed to the site with the other ratings, the master sounded the fire alarm and ordered the 2/O to take the nearest fire extinguisher to the location. Upon arrival at the scene, the bosun opened the door and could see flames on the work bench through the dense smoke. He briefly entered the space and rapidly discharged a portable CO₂ and a foam extinguisher. This was followed by a water jet from a charged fire hose and the fire was soon extinguished.

1. No proper risk assessment was conducted;
2. Combustible materials were not removed from the worksite prior to the commencement of hot work;
3. No dedicated fire watch was in place either during the hot work or after it was completed.

▲ View of interior of deck workshop cum store showing fire damage

1. A system for the delivery of training in use of the permit-to-work system, risk assessment methods, and the general management of hazardous tasks is developed and implemented. The system shall include a review of training in general to determine if training is also required in other areas;

3. The definition of hot work (previously only gas-cutting and welding) is expanded to include burning, brazing, grinding, soldering, thermal resistance heating, etc;
