Seaways

Mariners' Alerting and Reporting Scheme

MARS Report No. 238 August 2012

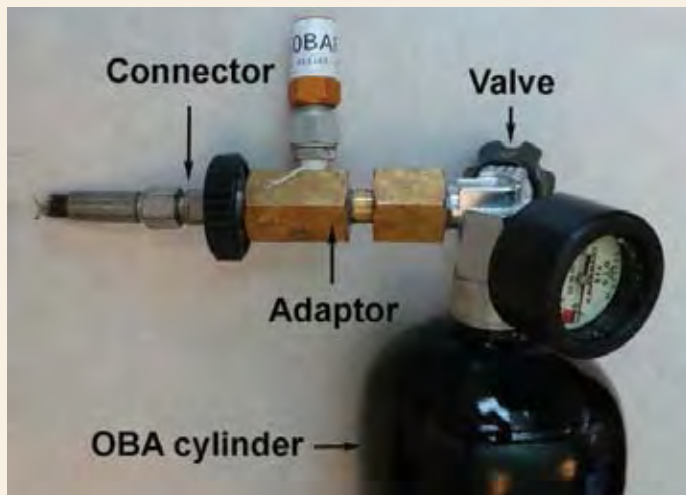
- 4 There are internationally recognised colour schemes used in industry so that high pressure cylinders containing different gases can be easily identified. There are also a number of different types of engineering controls that prevent a high pressure cylinder from being connected to an incompatible system – e.g. an oxygen / acetylene set - the threads on the high-pressure oxygen cylinder are right handed, whereas the threads on the acetylene cylinder are left handed, preventing incorrect connections. The SCBA and OBA sets supplied on board were compliant with European and Japanese standards respectively, and had different threaded connections. But, due to an unfortunate coincidence, the spare compressor discharge hose adaptor that was found in the box near the SCBA compressor allowed the connection of the Japanese-made OBA cylinders to the European-made air compressor.

View of adaptor that allowed the dangerous connection of SCBA air compressor discharge line to OBA oxygen cylinder

- 1 The ship's safety management system documentation to include appropriate guidance in relation to the operation and maintenance of OBA sets;
- 2 The company has forwarded a safety bulletin to all ships advising staff to:
 - re- fill all OBA oxygen cylinders ashore;
 - clearly mark the word 'oxygen' in English on all OBA oxygen cylinders;

- post signs on all breathing apparatus compressors stating that they are only to be used to re-fill air breathing apparatus and emergency escape breathing device (EEBD) cylinders;
 - seek approval from a responsible person prior to re-filling cylinders; and
 - assign more than one crew member to the task of re-filling cylinders.
- 3 All OBA cylinders to be supplied in the future will be permanently labelled to indicate that the re-filling of the cylinders with oxygen must only be carried out ashore.

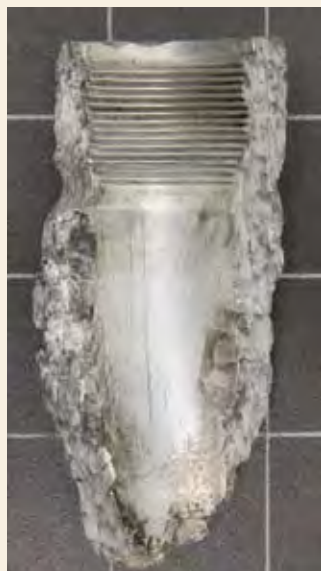
1 The investigation found that the explosion occurred as a result of a fire that started within the compressor when oil ignited in the hot, oxygen-rich environment. When the 3/O opened the OBA cylinder

outlet valve, gaseous oxygen (pressurised to about 7 MPa) flowed from the cylinder into the compressor discharge hose and tube which contained air at atmospheric pressure (0.1 MPa). The oxygen continued to flow until the pressure inside the discharge hose and tube reached equilibrium with the pressure inside the OBA cylinder. During this process, it is likely that the temperature of the oxygen-rich environment within the discharge hose and tube dramatically increased as a result of adiabatic compression. Calculations indicate that the temperature of the oxygen may have reached about 700°C as a result of adiabatic compression alone.

- 2 When oxygen within a system is compressed rapidly, with no heat loss to the surrounding materials, it causes a rapid temperature rise in the gas. Within seconds, the temperature of the oxygen-rich environment would have exceeded the auto ignition temperature of any oil that had been trapped in the discharge tube filter, or any other part of the discharge circuit. Once the oil ignited, a near instantaneous over-pressurisation within the compressor caused the rupture of the discharge tube and hose. A flame front was then blown out of the compressor, engulfing the 3/O.

View of fragment of discharge tube after explosion

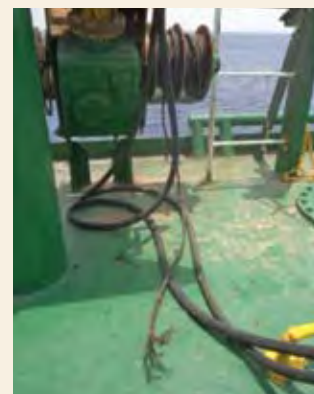
- 1 The fall wire had a kink in way of the failure location, believed to be a permanent stress point when the gangway is swung out to upper deck level;
- 2 The reeving arrangement of the fall wire consisted of a multi-drum winch, meant to rotate simultaneously for lowering / hoisting. It is believed that a slight disparity in synchronisation imposed high stress on the fall wire;
- 3 The crew failed to properly monitor the stress on the wire and the movement of the winch drums when preparing the gangway;
- 4 Inadequate inspection by the crew prior to breaking out the gangway;
- 5 Ineffective inspection/maintenance/record-keeping of the gangway, wire and fittings by the crew during routine maintenance;
- 6 There was no crew standing by in the vicinity when the gangway lashings were removed and the gangway was being prepared for use;
- 7 The fall wire had a fibre core.

View showing parted fall wire and gangway winch with multiple drums

- 1 Properly inspect the gangway, fall wires, and all standing and moving parts for proper condition and operation prior to unlashings / rigging and after securing the gangway;
- 2 Confirm that the winch drums are properly synchronised;
- 3 Update and keep inspection and maintenance records as per PMS;
- 4 Do not leave the gangway unattended once the lashings are removed until the gangway is fully rigged or secured.

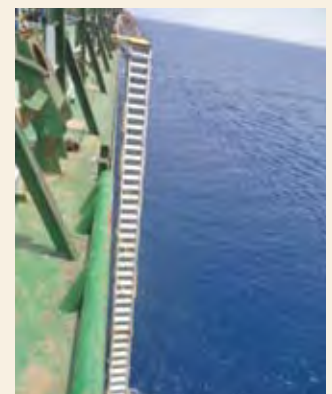
Ladder section trailing in the water after fall wire parted

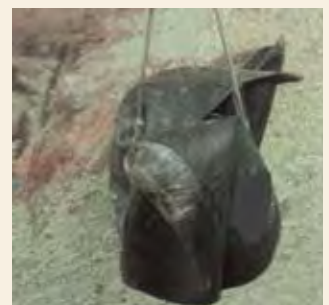
- 1 Too much reliance being placed on the Mooring Master's knowledge and experience;
- 2 Own ship's bridge team failed to observe the approach of strong gust, being fully engrossed only in the mooring operation.

Damaged pneumatic fender hanging by wire sling and chain

- 1 Be aware that the master is overall in charge of STS operations and the Mooring Master operates only in an advisory capacity;

- 2 Promptly raise any concerns with regard to the manoeuvre(s) being planned or executed, with the master exercising his authority to override actions of the Pilot / Mooring Master to ensure safety of life, property and environment;
- 3 Be aware of the prevailing and developing environmental and traffic conditions, and abort the manoeuvre or operation in progress if the safety of the vessel should be compromised;
- 4 Record all events and information in the bridge log book correctly.
