Seaways

The International Journal of The Nautical Institute

Mariners' Alerting and Reporting Scheme

239 September 2012

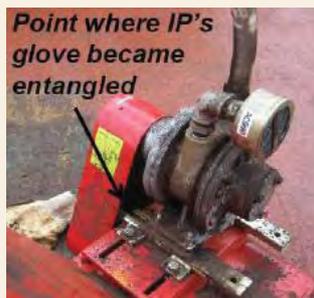
→ A ship's crew member sustained a serious hand injury while using an air driven deck scaler during maintenance operations. The crew member was wiping clean the base of the scaler with the air motor running, when his glove became entangled in the moving drive belt, trapping his fingers. He sustained crush injuries to the tips of two fingers, and was medevaced for treatment and subsequent surgery. Fortunately, no amputation resulted.

- 1 The deck scaling machine had no 'dead man' control i.e. automatic stoppage when the start control is not deliberately held in the 'on' or 'run' position;
- 2 The crew member inadvertently placed his hand near the gap between the belt guard and the body of the scaler, bypassing the safety barrier;
- 3 The crew member violated existing company procedures for the use of this pneumatic device which clearly required the disconnection of the air line before carrying out any trouble-shooting or maintenance.

View of gap in guard through which the crew member's fingers got trapped in moving drive belt

- 1 All power-driven deck scalers of this type were temporarily withdrawn from service pending effective implementation of appropriate control measures. These included 'hard' barriers such as more effective guards and a dead man switch, and 'soft' barriers such as risk assessment and understanding of proper operating procedures;
- 2 A 'hazard hunt' exercise was conducted whereby other equipment onboard was identified as posing a similar injury hazard i.e. drilling machines, lathes, bench grinders, etc. and appropriate control measures were stipulated to appropriately manage the risks;
- 3 The incident was communicated to the manufacturer of the deck scaler, highlighting the lack of a 'dead man' switch on the device, and a swift and positive response was received.

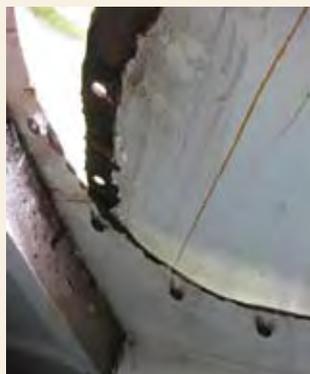
→ A crewman was injured whilst using a power tool in an incorrect manner. He had been instructed by the C/E to clean paint and corrosion off the stud threads of a manhole cover in preparation for a tank entry. He was instructed to perform this task using either a hand-held wire brush or an angle grinder fitted with a wire wheel. However, presumably because of excessive corrosion on the fasteners, he unilaterally decided to fit a 5mm cutting disk on the angle grinder instead of the wire wheel, and then proceeded to cut off the nuts of the studs securing the manhole cover. Suddenly, the grinding disk rotating at high speed jammed between two adjacent studs. The disk shattered. The detached piece was flung at great velocity and inflicted a bruise on the crewman's left shoulder after cutting through his coveralls.

- 1 Existing company procedures and C/E's clear instructions were not followed;
- 2 Risk assessments were not conducted;
- 3 The crewman had received no training in this specific task and consequently demonstrated a lack of safety awareness that put himself, his colleagues and the vessel at risk.

View of opened manhole cover from inside tank after all stud nuts had been cut off

View of broken rotary cutting disk – the missing segment which was flung at high speed could easily have caused very severe injury to the crewman or other personnel in the vicinity

- 1 Complacency in the use of power tools must be guarded against;
- 2 All persons involved in a task, from deck officers down to supervisors and ratings, must have a clear understanding of the nature of the task and safe work procedures;
- 3 All crew must understand the purpose and requirement for risk assessments for all routine and non-routine tasks;
- 4 All crew members must remember the importance of accepting personal responsibility for safety and that they all are empowered to stop work until safety concerns have been adequately resolved;
- 5 Shipboard training and familiarisation should include specific training on particular tasks and equipment.

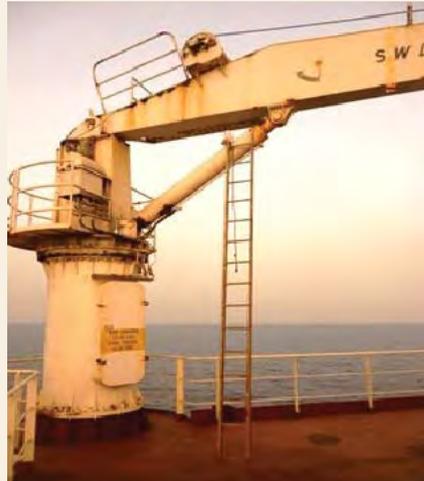
With the top section of the ladder secured to the crane jib, the A/B ascended to the top rung of the ladder and attempted to pass the fall restraining line of his safety harness around the crane jib. Due to the large dimensions of this section of the jib girder, the A/B had to lean out from his precarious perch to grab the free end hook of the line. Suddenly, the ladder became unstable, and the A/B lost his balance.

Unsafe method used: The top of the 6-metre long portable aluminium ladder is lashed to the crane jib

- 1 A proper risk assessment was not conducted due to perceived lack of time;
- 2 During the toolbox meeting, the Bosun explained the precautions to the assisting crewmembers;
- 3 It was considered that there was sufficient number of crew assigned for the job and they had all donned proper PPE;
- 4 The work team was sufficiently rested before starting the work;
- 5 It was established that working on the crane jib from a portable ladder was patently unsafe and a safer access to the jib was available by slewing the jib over the adjacent compass (monkey island or flying bridge) deck;
- 6 It was determined that if the other A/B had positioned himself on the crane jib girder by climbing on to it from the crane pedestal, he could have safely secured the casualty’s lifeline.

- 1 Substandard acts
 - a. Incorrect use of equipment;
 - b. Failure to secure;
 - c. Improper position of task.
- 2 Substandard conditions
 - a. Inadequate guards or barriers;
 - b. Hull and structure condition.
- 3 Personal factors
 - a. Restricted range of body movement;
 - b. Poor judgement;
 - c. Lack of coaching.
- 4 Job factors
 - a. Inadequate work planning or programming;
 - b. Inadequate instructions, orientation or training;
 - c. Inadequate or improper controls;
 - d. Inadequate assessment of needs and risks;
 - e. Inadequate standards and specifications;
 - f. Inadequate monitoring of compliance;
 - g. Inadequate conduct that is not condoned, intentional or unintentional.

- 1 A fleet alert sent to all vessels on the incident requiring Masters to confirm full discussion and understanding of incident among all on board;
- 2 SMS amended to include new checklist to rectify procedural lapses exposed by this incident;
- 3 A visual training programme was distributed throughout the company and fleet highlighting safe working procedures for crane maintenance;
- 4 New officers and those on leave will be briefed on this case at the earliest opportunity;
- 5 The knowledge, understanding and proper implementation of these actions will be verified during internal audits and superintendent visits.

Editor's note: Maintenance work on lifting gear requires a stable and secure platform, particularly if the work is to be performed at heights exceeding 2 metres above the deck. Senior officers on board and shore management teams must consider equipping the vessels under their care with a reasonable quantity of scaffolding materials of suitable design and strength for greater safety and efficiency.

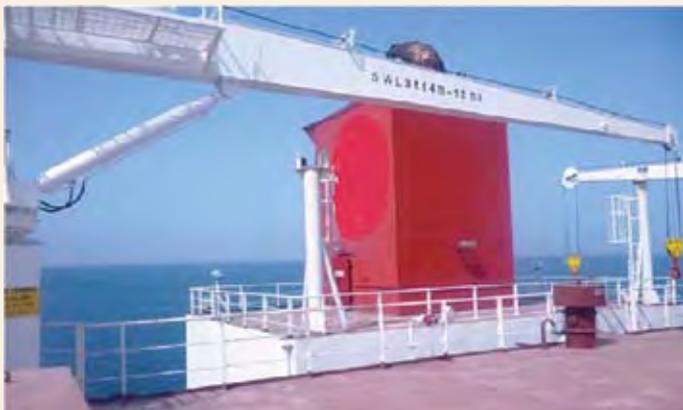
Post-maintenance photo showing the crane raised from stowage crutch and slewed over the bridge deck, permitting safe and efficient access from portable scaffolding

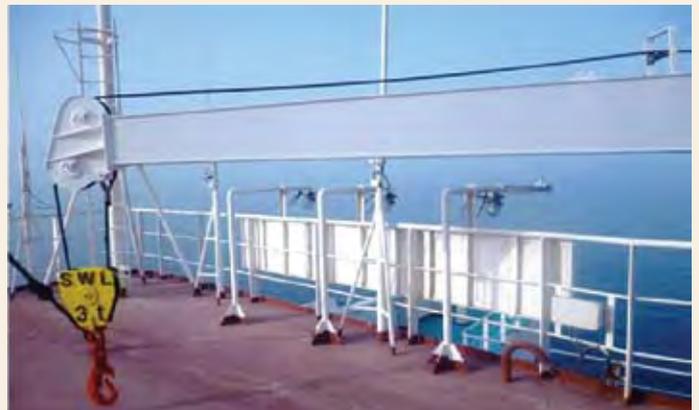
Slewing the crane over the compass deck permits safer access to the jib

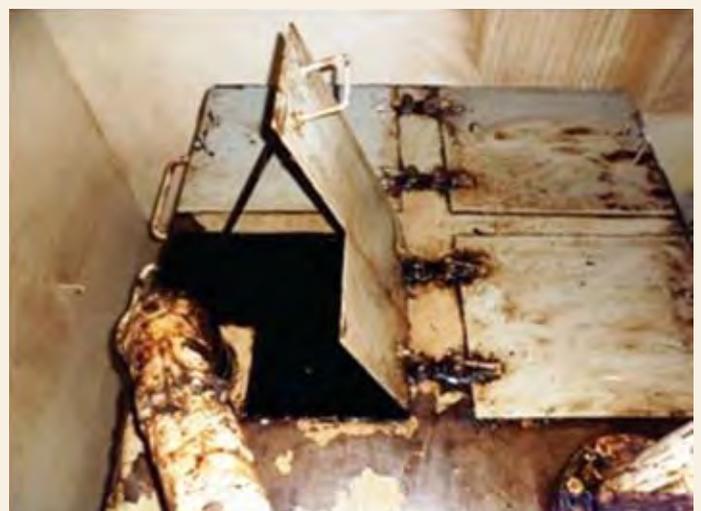
➔ A bulk carrier was at an anchorage port, loading coal. A trainee engine cadet was instructed by a senior engineer to clean the top of the waste oil tank, the contents of which was being maintained at about 70°C. The top of the tank was fitted with four hinged flap lids, one of them being held open by means of a stopper rod. Whilst carrying out the assigned task, the cadet unknowingly placed his foot in way of the opening and his left leg stumbled into the tank and plunged into the hot oil, scalding his leg below the knee. After being given first aid on board, the injured person was transferred to a shore hospital and later repatriated home. The senior officer who assigned the task to the trainee cadet declared in his statement that it was the practice on board to leave one lid of the waste oil tank always open and that he had warned the cadet about this and that the oil inside was hot.

- 1 Unsafe work practices
 - a. No risk assessment conducted when the job was planned, in violation of Company SMS;
 - b. There was no justification for the established practice of keeping one flap lid open on the waste oil tank;
 - c. An inexperienced cadet was assigned a hazardous task, without adequate briefing / supervision by senior officer;
- 2 High temperature of tank contents and no warning notices displayed at site;
- 3 Inadequate lighting at location.

View of waste oil tank with one lid kept open

- 1 Fleet circular issued with instructions for this incident to be discussed at the next onboard safety meeting;
- 2 Company's SMS procedures for the planning and execution of routine/ non-routine jobs on board suitably revised to prevent recurrence of this incident – tank openings to be kept closed at all times;
- 3 The company will review the contents of in-house Safety Officer Course to include notes on work planning, delegation and supervision;
- 4 Crews instructed to:
 - a. conduct and record a risk assessment before commencing any task;
 - b. Carefully identify all hazards in the work area and implement appropriate control measures;
 - c. Use the Daily Work Record Book to plan/ assign the daily work to crew;

- d. Be vigilant to new hazards at all times;
- e. Ensure that trainees are only assigned tasks under direct supervision of a senior crewmember.
