Seaways

Mariners' Alerting and Reporting Scheme

MARS Report No. 241 November 2012

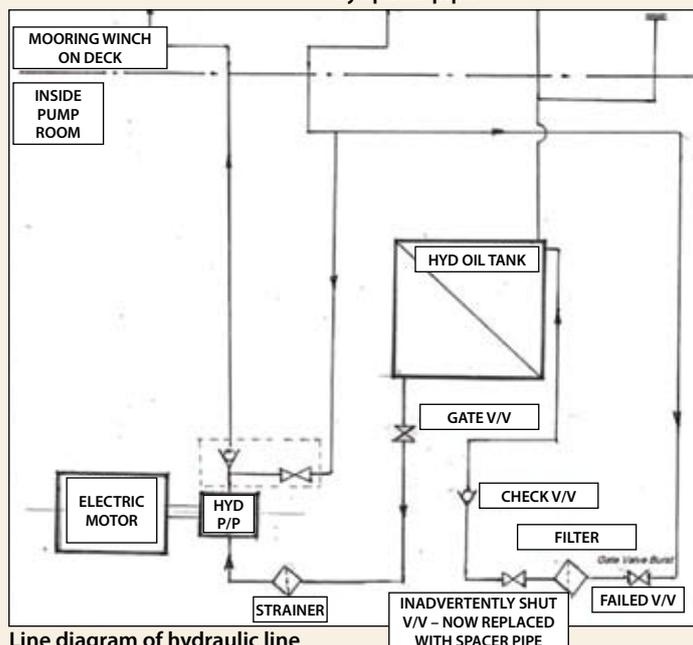
During an earlier trial, it was noticed that one of the valve flanges next to the filter was leaking. After isolating the line, the crew renewed the gasket, and then opened the valve before the filter, but forgot to open the one after the filter. When the pump was subsequently started, the sudden build up of high pressure on the upstream side of the valve resulted in its violent disintegration.

Line diagram of hydraulic line

- 1 The second valve (after the filter) was considered redundant. It was removed and replaced with a spool piece, reducing the risk of the inadvertent closure of the return line;
- 2 A sign was permanently installed next to the hydraulic pump motor starting switch warning personnel to 'Ensure all return line valves are fully open'.

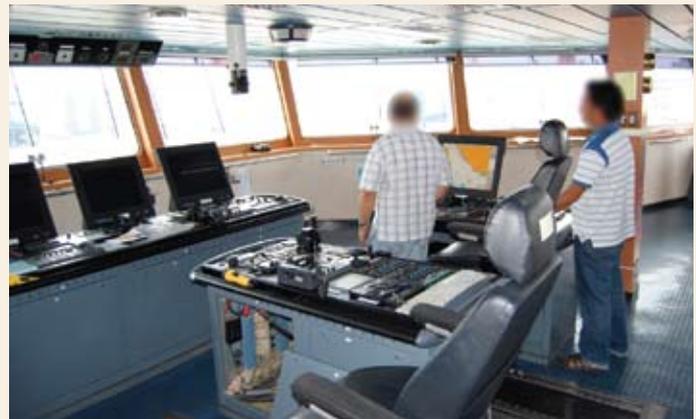
- 4 Both the present and past crews were unaware that the ECDIS anti-grounding audible alarm had been disconnected in the past for unknown reasons;
- 5 The vessel's ECDIS display was located some distance abaft the bridge front and orientated so that the OOW had to face to starboard to look at the screen. Had the ECDIS display been located on the forward console, the OOW would have been more likely to routinely consult it when monitoring the navigational situation and also been alerted by the visual grounding warning alarm;

View of bridge showing the offset location and athwartship orientation of ECDIS display.

- 1 The ship operator implemented the following corrective actions in the drydock:
 - i. Repositioned the main ECDIS unit adjacent to the starboard radar, enabling its viewing while facing forward;
 - ii. Reconnected the ECDIS unit to the bridge alarm monitoring unit to provide a functioning audible alarm;
 - iii. Arranged for the vessel's bridge officers, and company's Designated Person (DPA) and marine / nautical superintendent to attend an equipment-specific training course on the ECDIS type fitted on board;
- 2 Arranged for the fleet's bridge officers to attend a bridge resource management course;
- 3 Arranged for the marine / nautical superintendent to provide on board ECDIS training to the fleet's other vessels fitted with ECDIS or electronic charts.

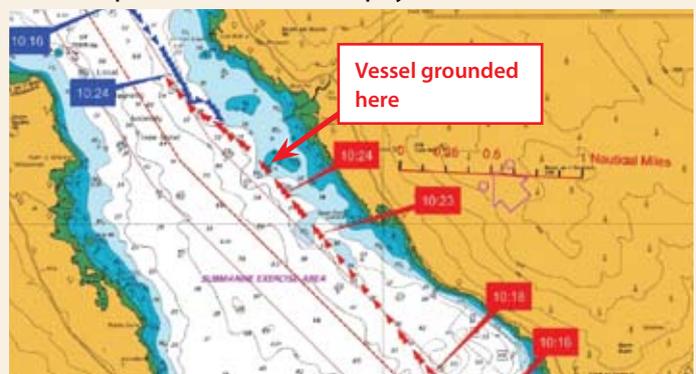
- 2 Before reaching the waypoint, the 3/O wrongly assumed that risk of collision existed with the sailing vessel on the next planned heading and prematurely initiated a turn to starboard and then continued to alter course to starboard, illogically intending to pass between the sailing vessel and the steep-to shore;

- 3 After initiating the course alteration, the 3/O did not monitor the vessel's position and projected track on the ECDIS display, for over 15 minutes, and failed to notice that the visual grounding warning alarm had been activated;

Track of vessel (in red) showing planned track, unchecked deviation to starboard, site of grounding, subsequent track recovery and near-miss with incoming sailing vessel (in blue).
