Mariners' Alerting and Reporting Scheme

MARS Report No. 242 December 2012

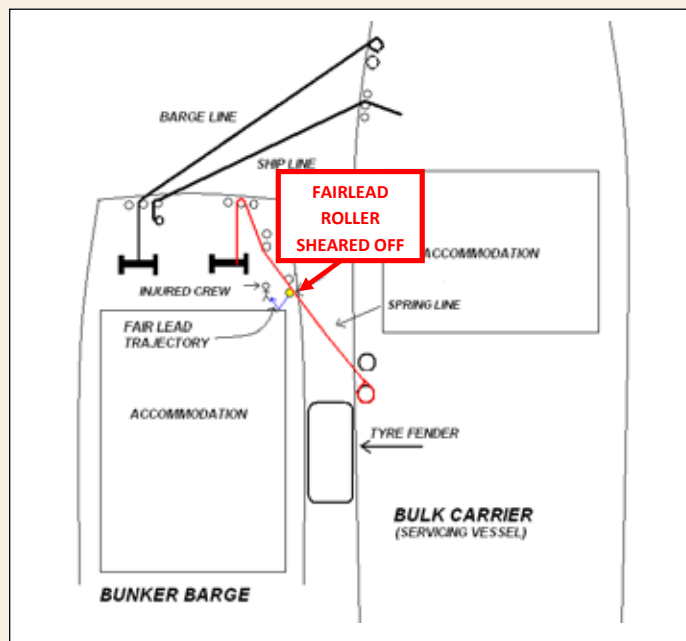
Due to the large difference in freeboard between the two vessels, the mooring lines from the barge's deck were all leading upwards subjecting the roller to a combination of large cyclical sideways thrust and lifting force. Ultimately, material weakness and fatigue caused by corrosion and wastage within the roller's body caused it to shear off from the base.

Diagram showing mooring arrangement at time of accident

View of failed fairlead roller showing the spindle and sheared base

- 1 A proper risk assessment must be conducted before commencing mooring operations, taking into account the effects of sea state, difference in freeboard, lead angles of lines and prevailing circumstances and conditions;
- 2 Mooring plan must be jointly discussed and approved by both supplying and receiving vessels;
- 3 If additional safety measures are not considered to mitigate risks to an acceptable level, the bunker transfer must be cancelled / postponed;
- 4 Mooring equipment must be properly inspected and maintained as per a documented planned maintenance system (PMS).

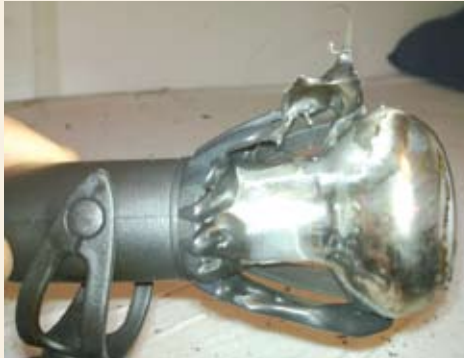
- 1 The cabin was originally provided with a proper bedside reading lamp, but as the switch could not be reached from the bunk, and because there was no spare to replace the fused bulb, a previous occupant had jury-rigged a non-approved light fitting by clamping it to the defective light fixture on the bulkhead;

- 2 The mate had neglected to turn off the portable light before going ashore. During his absence, the clamp had loosened and the light had fallen on to the bunk, heating the mattress spot in contact with the lamp to beyond its self-ignition temperature;

The detached clamp-on spotlight with partly melted shield and exposed bulb

The temporary light was removed and the original light fixture was restored and fitted with new electrical wiring incorporating a dimmer / switch combination secured within easy reach of the bunk.

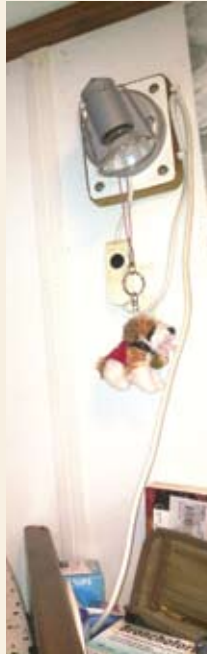
The original light fixture now made operational with new power cord and switch fitting after implementing corrective action

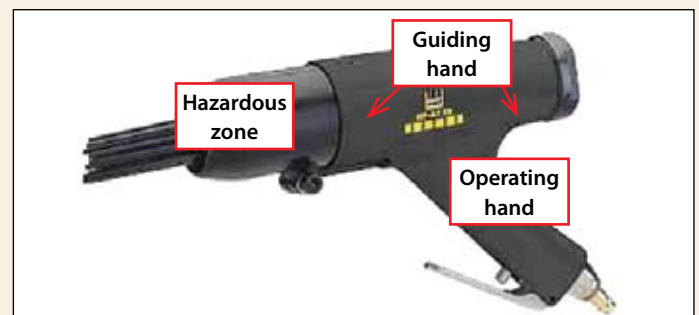
- 1 Proper PPE was in use;
- 2 A momentary lapse in concentration resulted in the finger coming into a hazardous zone;
- 3 Difficult access to a restricted space requiring the operator to manually guide the needle gun.

Typical compressed air-operated needle hammer gun with pistol grip showing safe and hazardous hand grip areas

- 1 It is important not to lose concentration when operating power tools and to keep body parts away from exposed moving components;
- 2 The operator must never grip the needle guide of a running pneumatic needle or chisel hammer gun;
- 3 Incidents must be reported as soon as they occur.

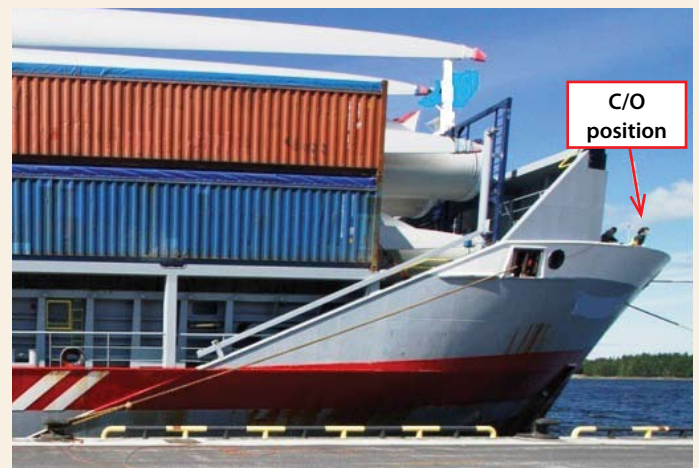
View of ship's fore end showing location of C/O during mooring operation

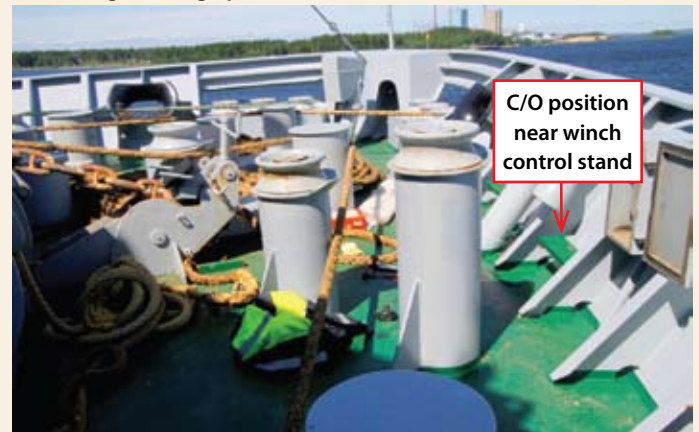
C/O was standing in snap back zone when rope parted

- 3 The C/O failed to move away from snap back zone even after being warned by Master;
- 4 Poor design - Confined/restricted area on the forecastle deck and improper location of winch remote control unit;
- 5 The company had no specific guidelines for mooring and the company management had not identified mooring to be a hazardous operation.

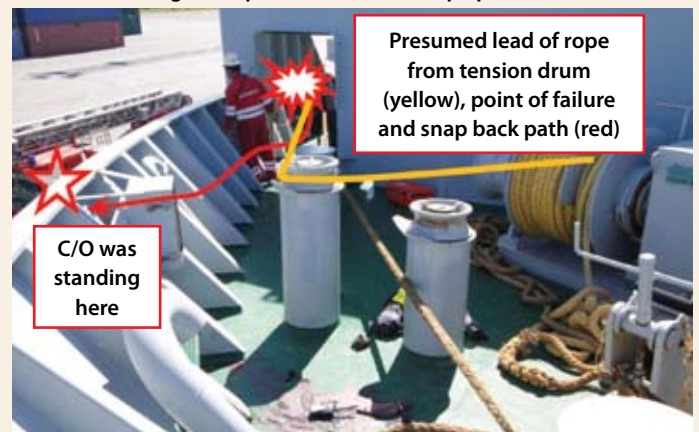
Possible path of fatal snap back

Editor's Note: Although the report does not specify the actual point of failure of the hawser, it is likely that the newly inducted line parted at a stress point or nip that would have developed at the multi-angle fairlead when the vessel was moved with a prolonged ahead engine kick. This incident clearly illustrates how the sudden linear contraction of a synthetic fibre rope parting under excessive tension can cause injury/damage at a considerable distance from the point of failure.

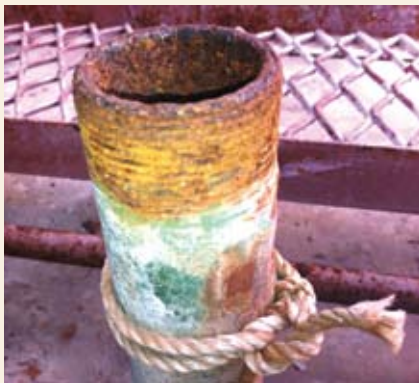
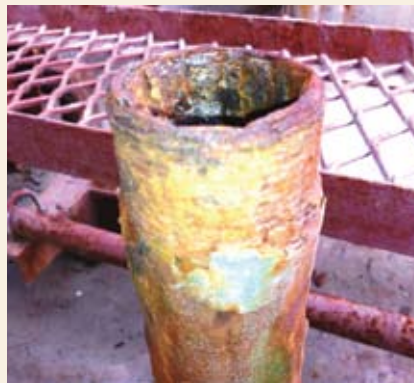
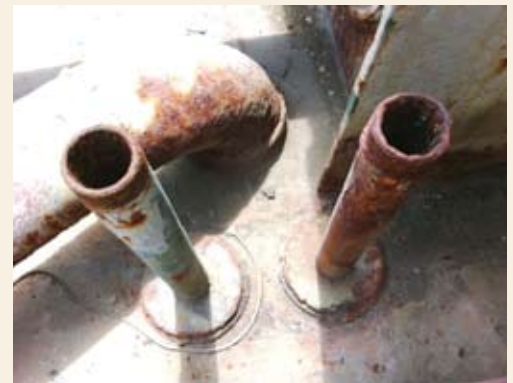
→ The three photographs below show evidence of the lack of regular tank/ bilge monitoring on board. Sounding pipes with missing/ ineffective caps can potentially lead to progressive flooding and cargo damage. Such vessels are clearly unseaworthy and must be detained by authorities for violation of the loadline and SOLAS conventions until effective closing arrangements have been fitted. It is good practice to include sounding pipes in the ship's planned maintenance system, ensuring that every sounding pipe is regularly inspected along the entire length to the extent possible and the section exposed to the weather is kept free of corrosion and wastage, and threads of the pipes and caps are regularly dressed and greased.
