# Seaways

# Mariners' Alerting and Reporting Scheme

MARS Report No. 244 February 2013

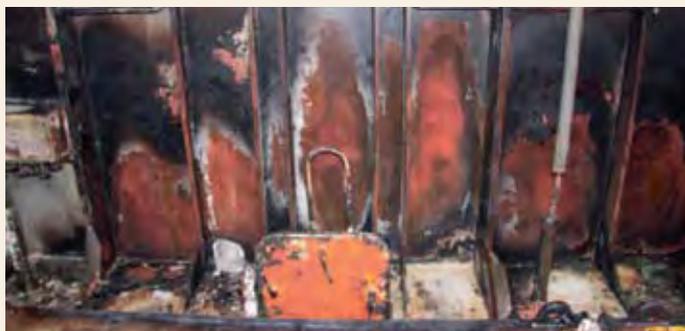
Earlier during the voyage, linseed oil had leaked from a container that had been discharged at the previous port, after which the deck crew had mopped up the oil from the deck. It was intended to land the oil-soaked material at the next port, so the crew had collected and stowed it on deck overnight on a rubber mat abaft the forward wavebreaker. The rags spontaneously heated to above the self-ignition temperature of the vegetable oil. The resulting fire caused substantial burn damage to adjacent electrical fittings and paintwork on the deck, vertical surfaces of the bulkhead and a ventilator cowl.

Fire damage to paint and fittings on wavebreaker and deck

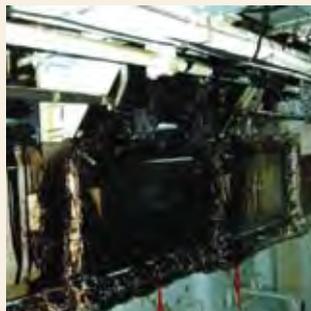
→ A product tanker was proceeding on a long voyage after the completion of drydocking and associated surveys. During the ocean passage, the fire alarm suddenly activated in the engine room. Instead of a fire, the cause of the alarm turned out to be a large leakage of fuel oil from a flange on the inlet pipe of the main engine no. 4 fuel injection pump.

Fuel oil leakage at camshaft side

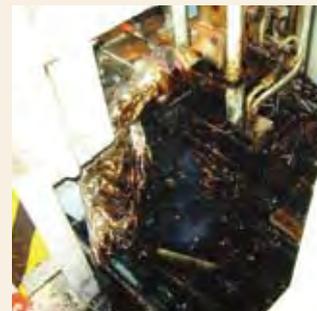
Fuel oil leakage on fuel pump side

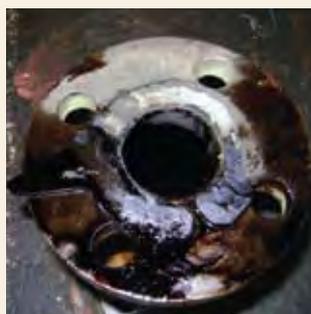
- 1 The fuel system had been overhauled, but no senior ship's engineer supervised its refitting in drydock. As they did not have a new spare, the yard workers had reused the gasket of the flange connection on the suction side of the fuel injection pump even though it was damaged;
- 2 The insulation and leakage containment cover over the fuel line had not been renewed/refitted.

Reused torn gasket that caused the leak at the flange connection

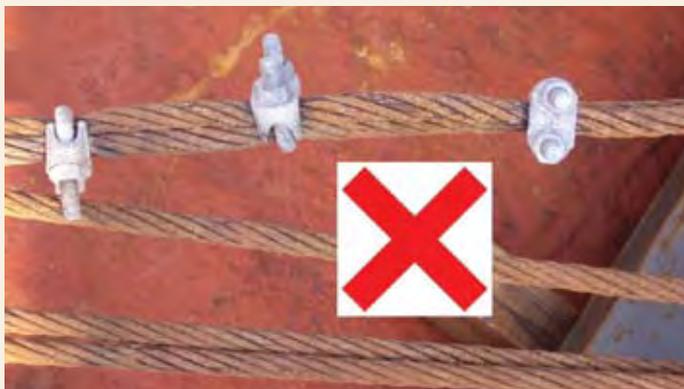
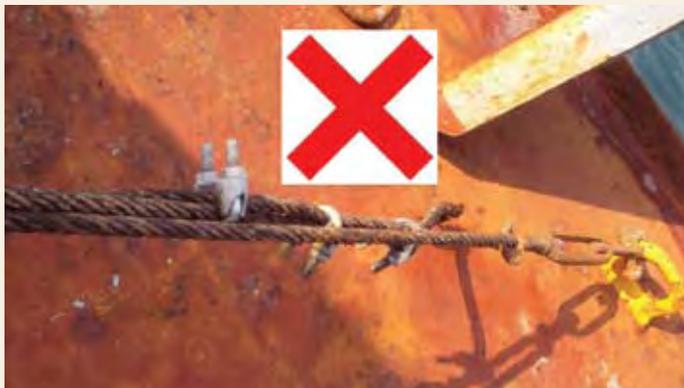
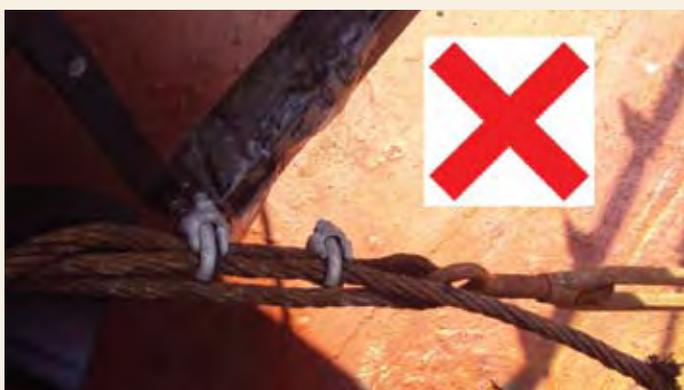
In my present role as a shore-based superintendent, I continue to encounter wrong methods of fitting of these clips as shown in the following photographs.

■ **Editor's note:** One easy way of remembering the right way to fit wire clips is – The 'U'-bolt of the clip is placed over the 'U'nstressed part of the wire and the 'S'addle of the clip is placed over the 'S'tressed part of the wire.

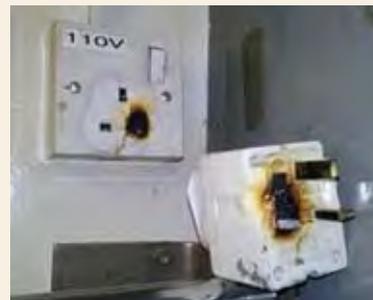
➔ A newly-joined crewmember reported to the ship's safety officer that many galley electrical appliances were connected to a single power outlet by using an adaptor. It was also observed that the cable terminations within the socket were loose and there was poor contact within the multiple outlets of the adaptor. Over a period, both the socket and the adaptor had overheated and could have led to a fire if the fault had gone unreported and prompt remedial action had not been taken.

Overloaded and damaged electrical outlet and adaptor

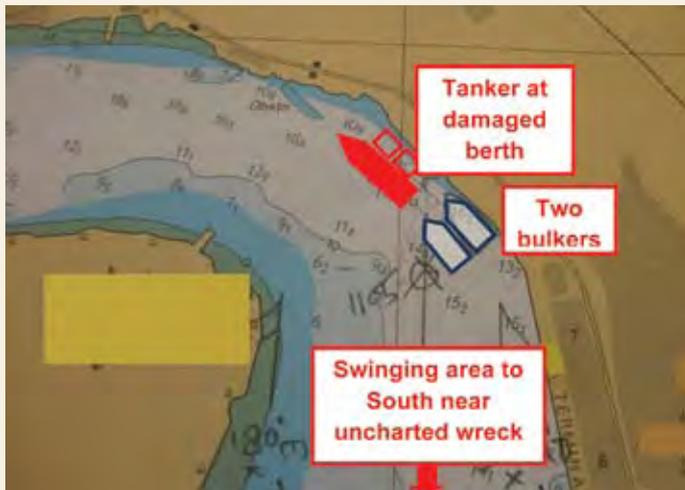
After securing to the shore with unusually long lines, it was discovered that the empty fore peak tank was holed below the waterline. Fortunately, the ballast pump was able to cope with the inflow and a zero tank sounding was easily maintained. The company's emergency procedures were followed and appropriate reports were sent to the office. The next day, when the tank was carefully opened for the class surveyor, a mooring bollard was found tightly wedged in the hole at the bottom of the tank, partly stemming the inflow. It was decided not to disturb the bollard, which fortuitously acted like a plug. It is presumed that the impact dislodged the bollard from the submerged collapsed section of the pier. The surveyor issued a temporary permit to sail to the nearest drydock for permanent repairs and the vessel departed from the port.

Representation of tanker after berthing (not to scale)
