# Seaways

March 2013

# Mariners' Alerting and Reporting Scheme

MARS Report No. 245 March 2013

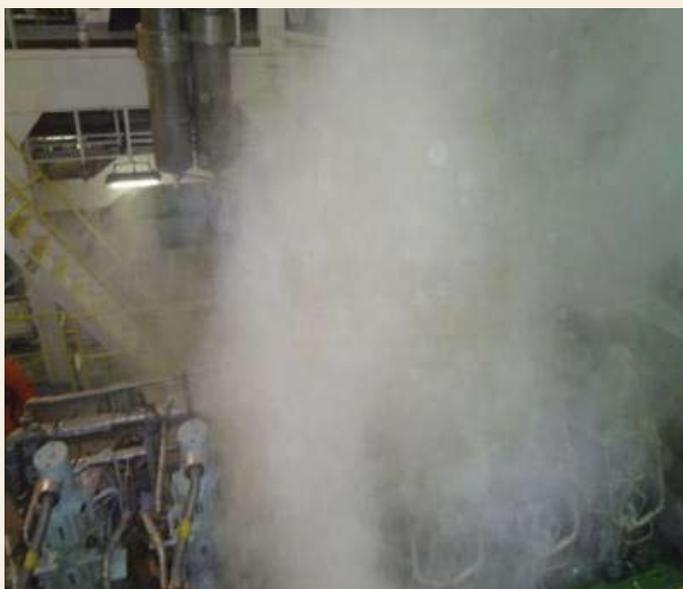
➔ On a tanker on passage, the fire alarm suddenly sounded. At the same time, the engine room crew saw small flames and smoke rising from the after exhaust manifold and cylinder heads of the running main engine. After extinguishing the localised fire, it was discovered that hydraulic oil from the cargo pump system had leaked from a flange connection in the vent/overflow line situated directly above the main engine cylinder head platform.

View of smoke as fire-fighting team began extinguishing the fire

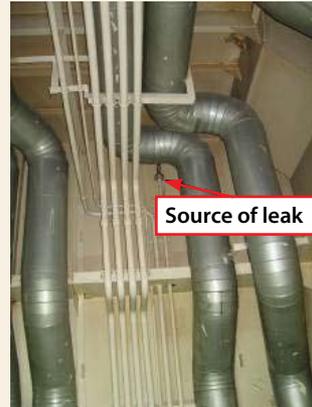
- 1 At the previous discharge port, a submerged cargo pump hydraulic motor had malfunctioned. In preparation for carrying out repairs, an engineer had closed the vent-cum-overflow line valve located before the service/header tank without draining the line;
- 2 Due to the residual pressure in the line, the flange connection (later found to have loose fasteners) leaked and a fine spray of hydraulic oil began falling on the hot surfaces on the top of the exhaust manifold and ignited after attaining self-ignition temperature.

- 1 Inadequate work planning – line was not depressurized/drained before closing of valve before header tank;
- 2 Inadequate management of change – the hydraulic piping had been modified some years ago to tap off a new branch line before the header tank leading to an offline oil filtering system. A stop valve was fitted before the branch without properly assessing risks;
- 3 Inadequate communication – the engineer who closed the valve failed to inform other members of this fact.

Flange joint on vent / overflow line with loose nuts located high above after exhaust manifold of main engine

- 1 Ship's staff removed the stop valve from the vent line, and the piping was re-modified to ensure that the offline filtration circuit was independent of the vent/overflow line;
- 2 All joints in the hydraulic system lines were inspected for proper condition and tightness;
- 3 Sister vessels fitted with the same filtration plant were advised to check the lines to ensure that the overflow line could not be inadvertently shut. All vessels were instructed to thoroughly inspect all nuts and bolts on flange joints and tighten them.

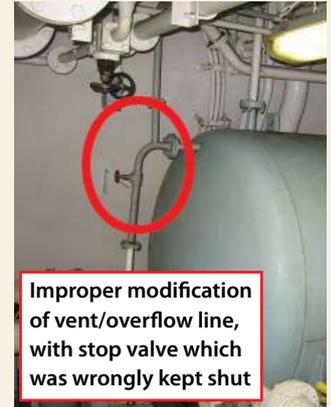
View of hydraulic header / service tank before corrective action

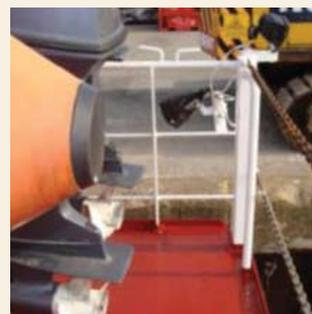
- 1 No task-specific risk assessment was conducted for the assigned work – especially to consider the difficulty in accessing, working and moving in the area;
- 2 The two safety chains were excessively slack;
- 3 The two senhouse slips did not have a 'lip' on the end of the arm to prevent unintentional release.

View of after end of platform showing restricted room between FRC and safety chains

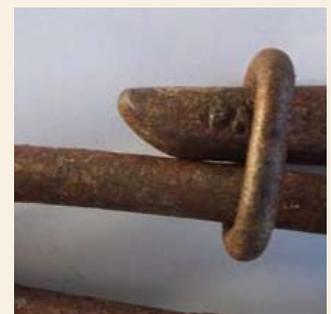
Straight arm of the senhouse slip aided its unintended release

■ **Editor's note** Senhouse slips meant for emergency applications should preferably be oriented vertically so that gravity assists in keeping the locking oval link in a safe position until a deliberate operator action is initiated to manually release the device. For added safety, the arm must incorporate a curved end or a raised 'lip' or a 'bump' at its end. For rigging horizontal safety chains, snap hooks are more convenient and efficient. See illustrations below.

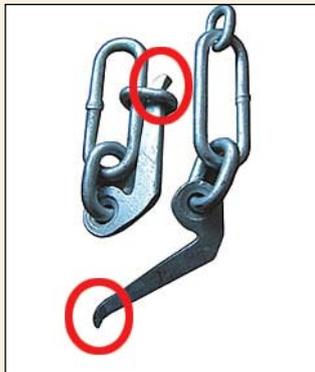
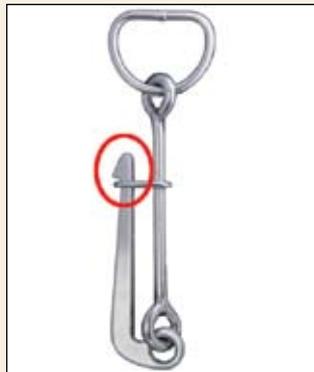
Senhouse slips incorporating a curve, raised lip or hook at the end of the lever arm are safer

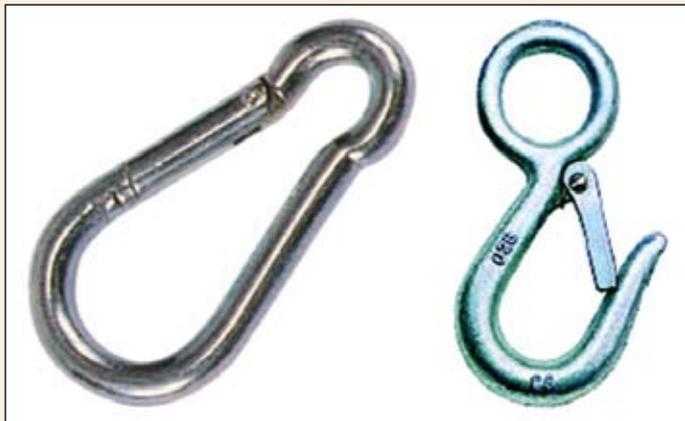
Carabiner-type snap hooks with spring gates are more efficient for securing safety chains

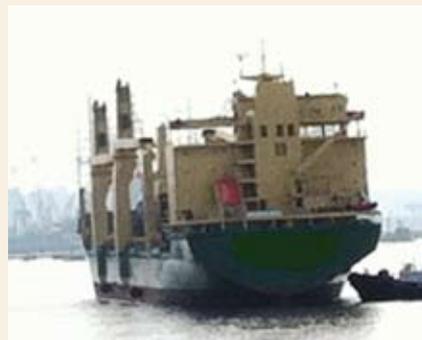
➔ A cargo ship of a novel design called at our terminal recently on her maiden voyage. She had all her deck cranes fitted along the ship's port side and the pedestals extended beyond the shell plating like vertical sponson or blister tanks. As such hull protuberances can potentially damage the fenders on the berth, it is important that vessels provide this information well before the ship's arrival. Indeed, the Master of the vessel did admit that a port had filed a claim for fender damage against another sister ship. Accordingly, it may be prudent for shipowners, naval architects and shipbuilders to avoid designs that involve projections beyond the side shell of vessels.

View from astern showing two vertical projections on port side shell

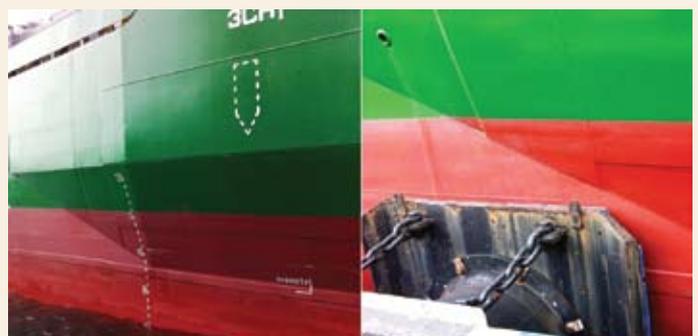
Closer views of hull projection showing risk of fouling and damaging fenders at wharf
