April 2013

The International Journal of The Nautical Institute

MARS Report No. 246 April 2013

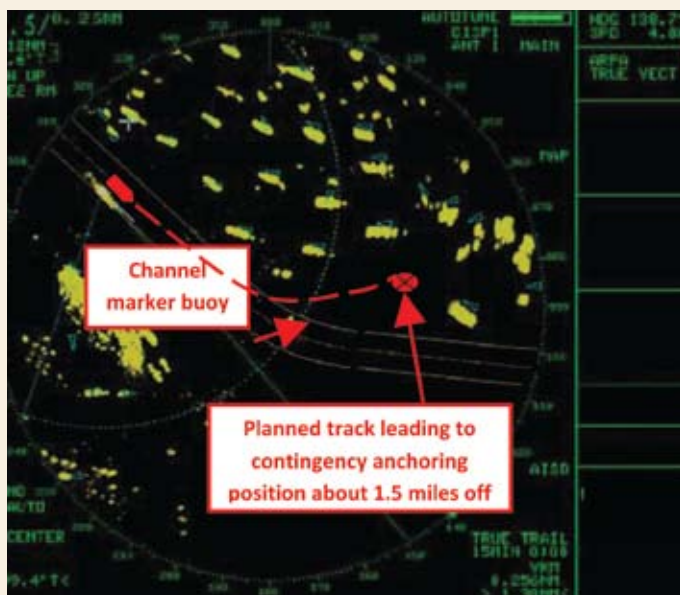
→ After completing repairs at a shipyard, a tanker concluded sea trials and was approaching her assigned anchorage berth. As she negotiated the buoyed channel to the south of a crowded anchorage, a sudden fault in the main engine lubricating system resulted in the automatic shutdown of the main engine. In response to the vessel's safety (SECURITÉ) alert, the port quickly identified a contingency anchorage berth in the nearest clear area among other anchored vessels. It was reckoned that even if propulsion was not restored, the tanker would have sufficient steerage way to safely pass the nearest vessels before a gentle turn to port would lead her to the position. However, due to the combined effects of a tidal stream and loss of steering due to decreased speed, the vessel drifted on to the channel marker buoy, which got fouled briefly with the rudder. After some minutes, the tanker drifted clear of the buoy and no damage was observed on the vessel or the buoy.

- 1 After departing from the shipyard, all the tugs were dismissed – it would have been prudent to retain at least one escorting tug;
- 2 The outward pilot was apparently unaware that the vessel was intending to conduct engine trials off port limits (OPL) and was scheduled to return and anchor in the waiting area;

- 3 The Master failed to properly respond to the emergency – the operation of the main engine manual override facility and a prompt astern movement could have taken the way off and, with the consent of the port, the anchor(s) should have been let go while stopped inside the channel;

- 4 After the engine stopped, neither the Master nor the port control issued a timely call for tug(s) assistance;
- 5 Communications between the bridge and engine room were ineffective and did not convey the vessel's dangerous location and the seriousness of the engine problem;

- 6 The approach to the contingency anchorage did not adequately consider the vessel's limited manoeuvring ability in very light ballast condition and the influence of the tidal stream;

- 7 The better option of passing the buoy to port before turning into the anchorage was overlooked.

With a significant residual headway at the time of main engine shutdown, the Master was hoping to safely steer the dead ship along the track shown, leaving the buoy to starboard and anchor the vessel in the area north of the channel, clear of other anchored vessels

- 1 The SMS was amended to include new procedures for vessels departing from dry dock, building or repair yard following significant repairs/refits;
- 2 Preparations for sea trial shall incorporate:
 - i) passage plans that ensure ample sea room, avoid transiting congested inshore waters, and provide for contingency anchorages;
 - ii) loading of sufficient ballast to achieve normal ballast condition before proceeding;
 - iii) the provision of at least one escort tug until the vessel has reached open waters or the satisfactory completion of sea trials;

- iv) Refresher training, and, if practicable, the testing of emergency overrides/recovery systems designed to overcome failure of critical equipment/systems;

- 3 Master/Pilot information exchange must ensure that pilots are made aware of planned trials of engines or other critical systems.

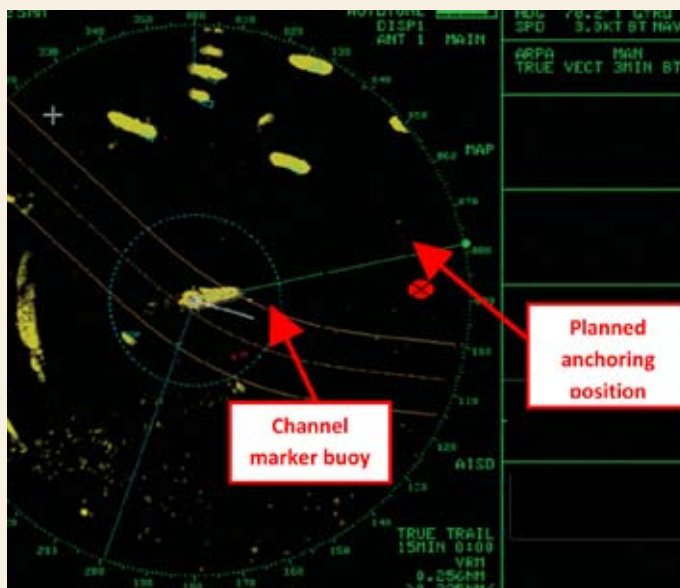
The tanker drifted off the planned track and on to the buoy due to the easterly setting current and loss of steerage way (see true vector setting just south of east)

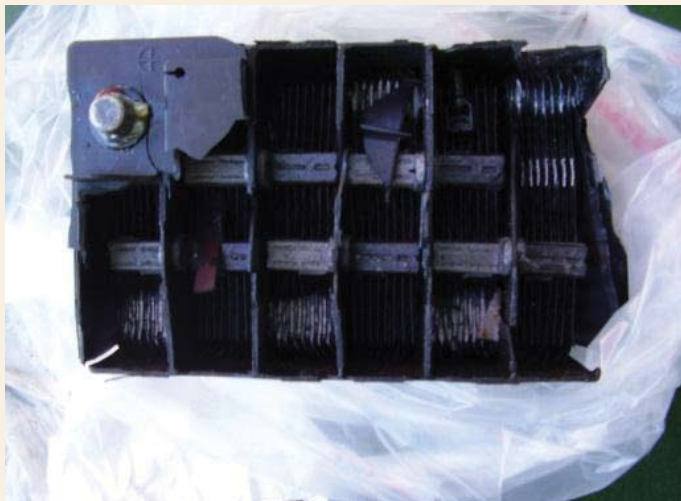
→ A ship's engineer was carrying out planned maintenance of the emergency generator. When he started the generator, he heard a loud bang from the battery container. On investigating, he discovered that one of the starter batteries had exploded, with the top of the battery detaching from the body. The battery was safely removed and the engine was temporarily left in the manual starting mode.

On investigation, it was discovered that for an unknown period of time, the vessel's emergency generator battery charging system was wrongly set up in such a way that two chargers could be charging the battery simultaneously. This resulted in excess evaporation of the water content in the electrolyte, substantially lowering the liquid level and exposing the plates. It is thought that internal arcing occurred across an air gap, triggering an explosion.

View of battery with shattered top

- 1 All charging systems should be checked to ensure that the charging current cannot exceed the specified safe range;
- 2 All battery containers / receptacles should be checked for tightness of fixtures and overall integrity as part of planned maintenance.

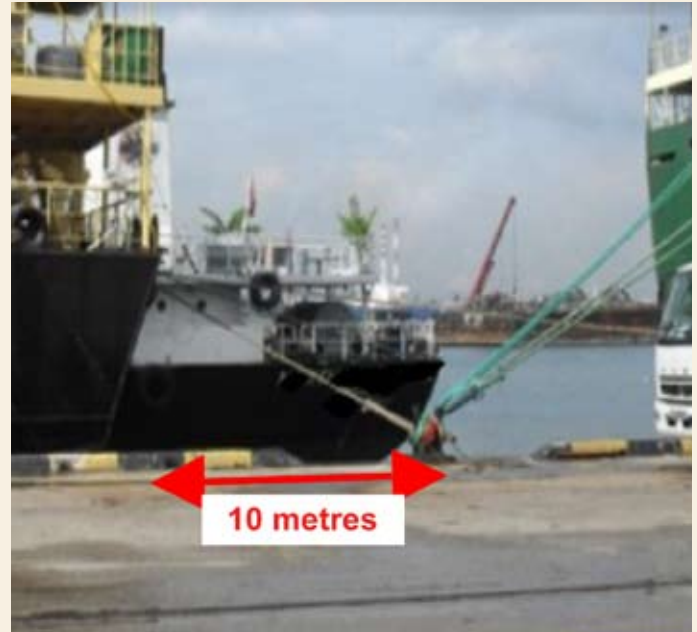
→ In some ports and terminals, bunker supply barges tend to moor on the sea side of ships with a considerable length of their hull overhanging the stern of receiving vessels. Such a practice shows poor seamanship and is hazardous for both the barge and the vessel moored at or manoeuvring off the next berth.

Often, an incoming vessel under pilotage is put in great difficulty when, on approaching the berth astern, she finds the quay length has been effectively reduced by the protruding hull of the barge. The legal implications of a collision between the offending barge and a vessel attempting to berth / unberth under such circumstances and a consequent oil spill can be serious not only for the vessels involved, but can even potentially implicate the port or terminal for negligence.

Unsafe overhang severely restricts manoeuvring room for the vessel berthed astern and increases risk of contact during mooring/unmooring

'Inconvenient' locations of the manifolds on the supplying or receiving vessels should be remedied by joining additional hose lengths instead of inconsiderate positioning of the barge.

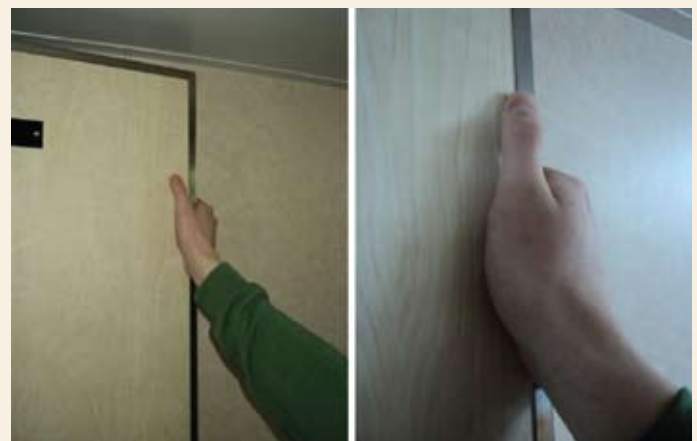
→ A crewmember suffered a serious laceration when his hand came into contact with the edge of the steel finishing strip (usually a pre-formed or extruded 'C' channel) that is commonly fitted around the perimeter of the accommodation door shutters onboard ships. On investigation, it was found that the steel channel that was wrapped around the door margins had become slightly raised and its flange presented a burred and razor sharp lip. This was most likely caused by the cutting process of the steel during the door's manufacture. It was subsequently discovered that several doors had the same hazardous defect. As a remedial measure, the crew spent considerable time and effort in depressing and then blunting the edges of the strips with a smooth file and emery cloth/paper. As a preventative measure, the ship's operator passed the information on the hazard to the vessel's builder and the door supplier.

Peripheral strip edges can be as sharp as a knife blade. Crewmembers engaged in any type of work on the doors and fittings must take all precautions and don appropriate PPE.

■ **Editor's note:** Similar sharp edges can potentially exist in pressed stainless steel or aluminium fittings around the living and common spaces onboard ship, eg air louvres, galley countertops and sinks, insulated bulkhead claddings, deckhead panelling, corrugated / perforated shelving, gratings etc. Direct contact with unprotected hands with these fittings must be strictly avoided during handling or cleaning.

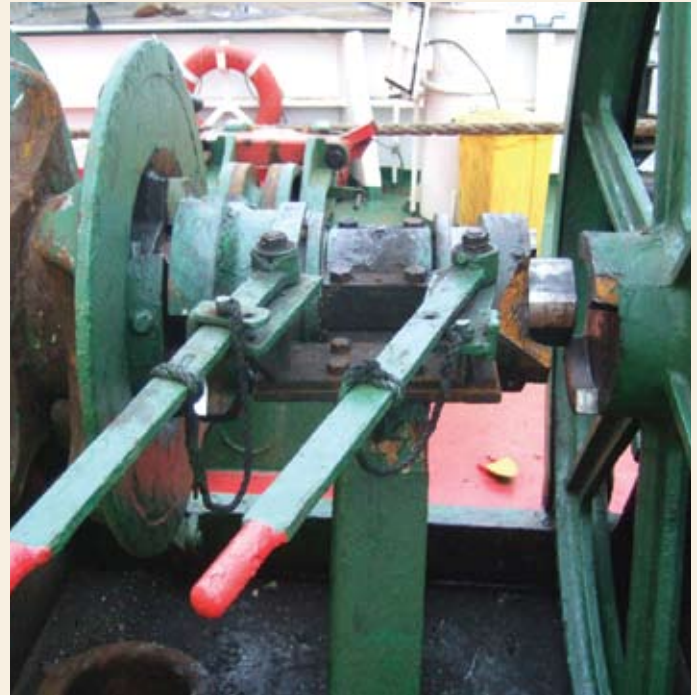
➔ A vessel was anchored in an exposed roadstead with gale conditions expected after a few hours. As a precaution, the Master had brought the vessel up to 8 shackles on the port anchor with the starboard anchor on the seabed to reduce anticipated yaw. A short time after anchoring, the vessel began to yaw. The intensity of the yawing increased, and eventually, the port cable began to slip, overcoming the combined holding power of the brake and the guillotine stopper.

The decision was taken to get underway, and the starboard anchor was weighed. The crew then began to weigh the port anchor, using engines to reduce the load on the cable. The wind strength was increasing steadily and the windlass struggled to recover the cable when, suddenly and without warning, the dog clutch shattered and the cable ran out of control. Fortunately, no one was injured and the securing arrangement of the bitter end held. The cable was subsequently slipped and the vessel was taken out of service due to the damage to the windlass and the loss of her anchor.

- 1 The selected location for anchoring did not provide sufficient shelter to prevent the vessel's anchoring equipment from being subjected to excessive loads;
- 2 The guillotine bar's locking pin had not been engaged;
- 3 The vessel's SMS for anchoring operations contained no reference to the use of the locking pin when anchoring;
- 4 The severe yaw that developed was due to the windage of the vessel's superstructure, which generated forces in excess of the design load of the anchoring equipment.

Broken dog clutch and bent shaft on port windlass

Owners and operators are strongly advised to review their SMS procedures for anchoring to ensure they address the above safety issues and, specifically:

- i) That masters have clear guidance on the capability of their vessel's anchoring system, including any limitations of the anchor system components, including that of the windlass;
- ii) Effects of windage in various load conditions;
- iii) Risks associated with excessive yaw;
- iv) Guidance on anchoring is vessel-specific and highlights that, when at anchor, the weight of the cable should be taken on the guillotine fittings, which should be correctly engaged (Nautical Institute, *Mooring and Anchoring Ships*, Volume 1, 2009. ISBN: 978 1 870077 93 4).
