Seaways

MARS Report No. 252 October 2013

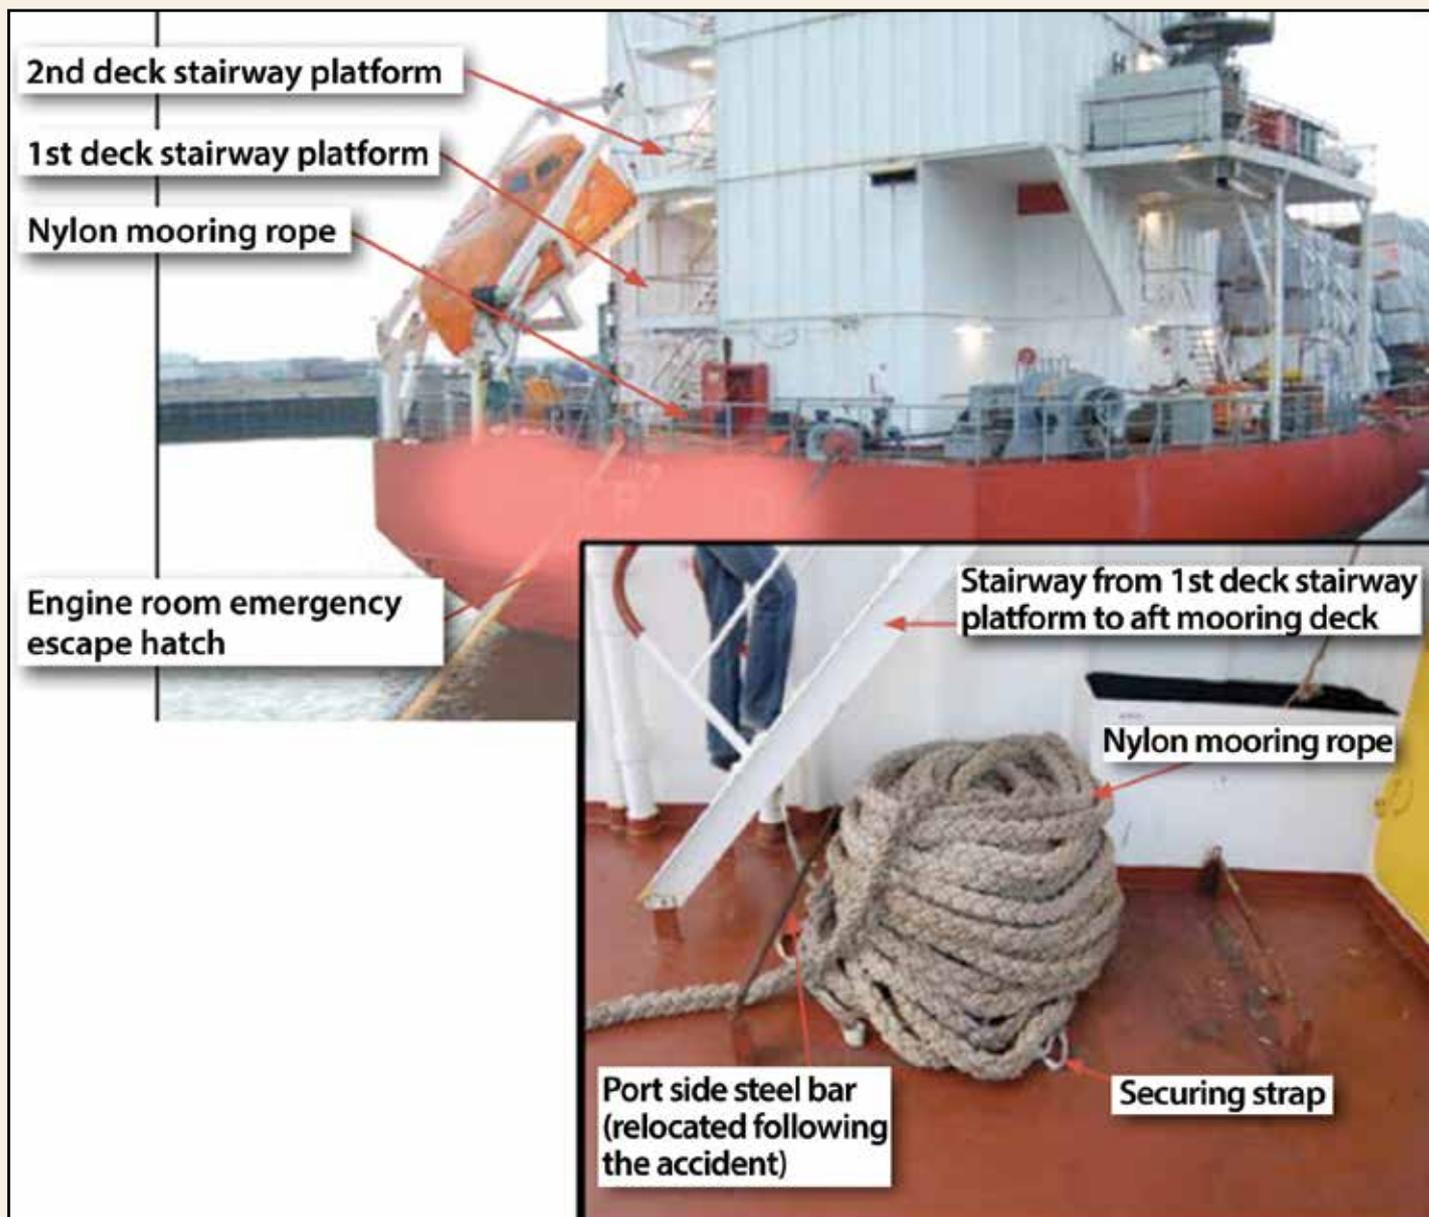
As the two crew began their work on the aft mooring deck a large wave was shipped, the force of which washed them overboard and caused the safety crew to release their grip on the lifelines. As the two crew were washed away, their lifelines parted. The same wave crossed the first deck stairway platform, forcing one crew member to the deck and causing another's lifejacket to inflate. Despite the best efforts of the vessel and search and rescue (SAR) services, the two men could not be recovered.

- 9 The strength of the fire-fighter's lifelines was insufficient to withstand the loading exerted on them by the large wave that washed the crew members overboard.

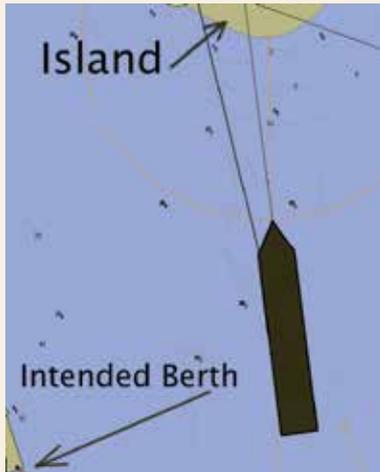
Situation as forward tug was secured

- The speed at which the vessel was travelling during the final approaches to the pier was in excess of what was required. The vessel had little sea room to complete the turn, with no margin for error.

- The bridge team appeared to have lost situational awareness. The vessel's speed was such that the tugs were not able to connect in sufficient time nor was the bow thruster effective in assisting with the turn.

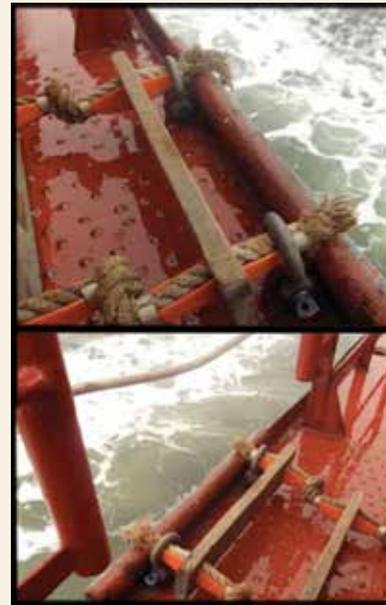
As soon as the pilot committed his full weight to the ladder, the ropes on each side of the ladder parted simultaneously at the point where they went over the rounded fishplate at the sheerstrake (see photos). The pilot fell two metres to the deck of the pilot launch, bruising and spraining his right foot and ankle which took the impact of the fall. His injuries could have been much worse had the freeboard of the vessel been greater.

The root cause of the accident was the failure of the pilot ladder due to inadequate maintenance and inspection.

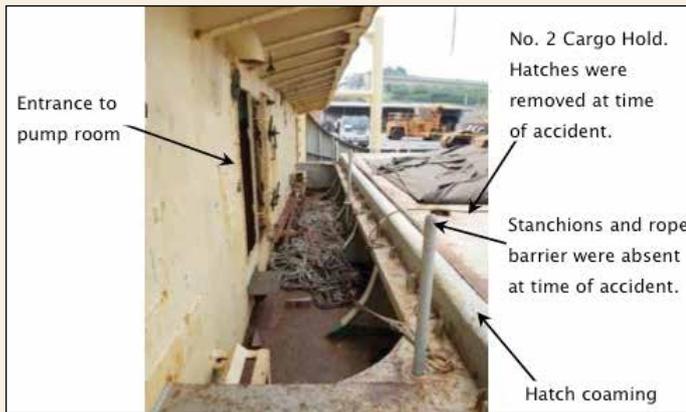
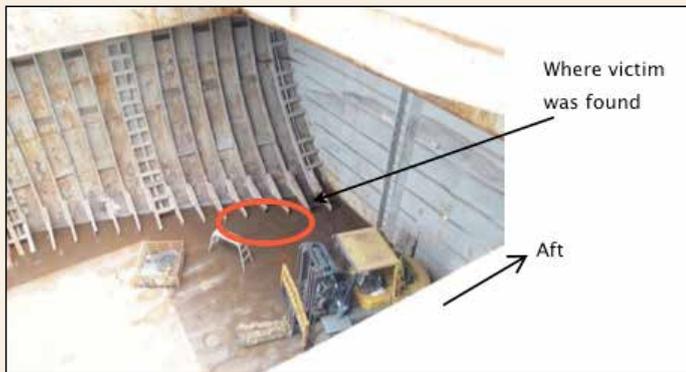
As the vessel made for the berth the second officer reported to the Master that he would stand by at the aft mooring station. Two crew, both on the main deck, saw the second officer pass in front of them and enter the pump room just aft of No. 2 cargo hold. Soon afterward they heard a scream and they raised the alarm. After the inside of No. 2 cargo hold was lit, the second officer was found lying and bleeding at the starboard aft end of the hold. He appeared to have fallen over the one metre high hatch coaming to the bottom of the empty hold, 8.5 metres below. The victim was later confirmed dead at the hospital due to a comminuted fracture of the skull among other injuries.

- Set up a safety barrier such as a fall protection fence while hatch covers are removed.
- Ensure that the crew move safely on upper deck passageways.
- Give the crew a warning when hatch covers are removed before berthing.
- Light up the cargo holds, to the extent that doing so will not interfere with safe navigation while sailing at night with hatch covers removed.
