# Seaways

# Mariners' Alerting and Reporting Scheme

MARS Report No. 253 November 2013

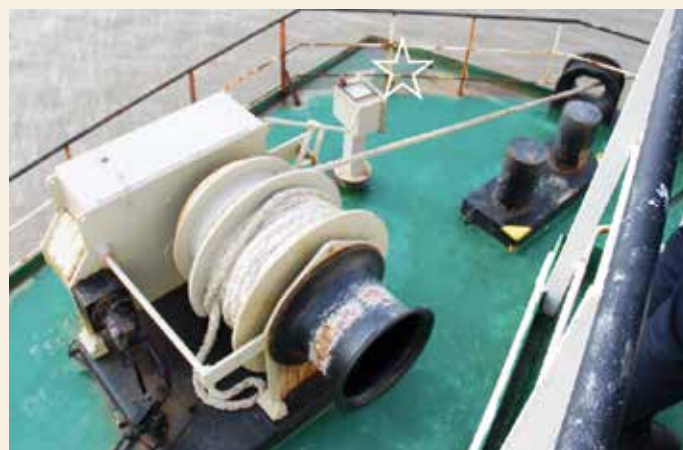
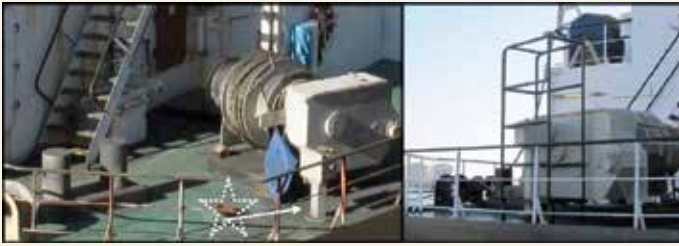
➔ The vessel was to berth port side to. Four crew were working at the aft manoeuvring station, two of whom had VHF radios in contact with the bridge. Two of them deployed the spring on the port side; the slack was taken in using the capstan head of the port winch. The two other crew took care of the simultaneous deployment of the two stern lines. After the eyes of the two stern lines were ashore on a bollard, the slack in the lines was to be taken in using the hydraulic winches. However, on the port winch it was first necessary to stop the spring still located on the capstan head in order for it to be secured on a bollard on deck.

At the same time, the slack on the starboard stern line was taken in by a crewmember on the starboard side, alone and without a VHF radio (his position indicated by white star above). Initially, the crewmember pulled the slack from the line on deck by hand. After that, he began to haul in the section of the stern line now on deck with the winch. While doing this, he noticed that the slack on deck was beginning to form a loop, causing a risk of the line being mis-wound onto the drum. To counter this risk he attempted to remove the loop by kicking it with his right foot while the winch was in motion. In the process, his foot got caught in the loop which dragged him towards the hauling winch. He immediately let go of the winch's spring-loaded operating lever, which then clicked back to the neutral position. However, due to the normal stop delay of the winch control he was nonetheless dragged nearly two metres across the deck. When the winch stopped, the loop in the stern line together with the trapped right leg of the victim had already reached the winch drum.

The winch had come to a standstill just before the victim's upper body was brought onto the winch drum, which in all likelihood would have been fatal. Initially, the crew on the other side of the vessel were not aware of what had happened; from where they were they had no visual contact with the scene of the accident. The victim's situation was soon discovered by two other crew who attempted to help. However, the assisting crew briefly moved the operating lever of the winch in the wrong direction by mistake, causing the victim to be pulled slightly further onto the winch. The error was quickly corrected, the victim freed and first aid applied. He was taken to the hospital where it was found that he had suffered a femoral fracture of the right leg and injuries to his back.

The accident shows that it is easily possible to confuse the winch's direction of rotation and that doing so can have serious consequences. The handwritten and only partially readable 'label' on the winch's control station shows that uncertainty with respect to the direction of rotation of the winch in relation to the respective lever position apparently also existed before the accident.

The control units of the winches on the stern of the vessel (and her sister ship) have been moved to a position further forward and each equipped with a safety cage for the winch driver.

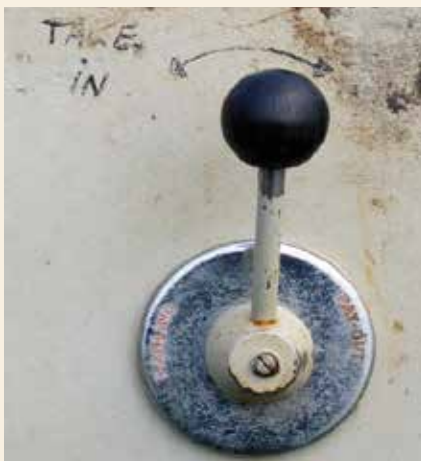
The crewmember risked life and limb by making an ill-considered foot movement towards a line that was being hauled in. That one and the same person controlled the winch and cleared the line being

wound onto the drum simultaneously contradicts the principles of good seamanship.

Working alone in one of the two separate work areas without a radio appears to be highly problematic. For safe execution of a berthing manoeuvre, it is essential that information can be exchanged at all times between the various work areas of the manoeuvring station, but also between the work areas and the bridge, in particular.

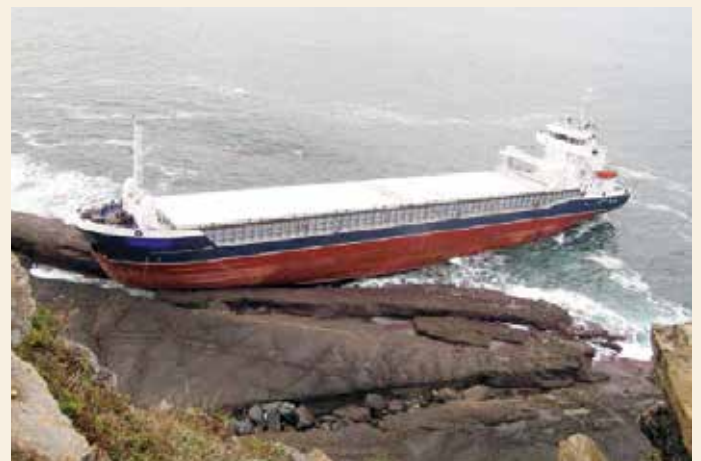
In the days leading up to the accident, the OOW had maintained the 0000-0600 watch. However, for the 24-hour period preceding the accident this routine was reversed. While the vessel was alongside he was the duty night officer, but was expected to rest from midnight (when he would normally be on watch) and work through from 0700-1200, (when he would normally be asleep). It is likely that this change

of routine impacted upon his quality of sleep during the night in port. He did have over four hours rest before taking over the watch from the Master at midnight and appeared to be fit and well at that time. However, within one hour of taking the watch the OOW failed to call the pilot station, despite specific instructions in the Master's night order book (which he had signed) and the Master's verbal reminder to him at the watch handover. This suggests that weariness was already affecting his cognitive ability.

- The OOW fell asleep on watch as a result of insufficient stimulation and probable fatigue following a change of work and rest pattern.
- There was no lookout on the bridge, as required during the hours of darkness, allowing the OOW to fall asleep unnoticed. It was not unusual for lookouts to be dismissed from the bridge during the hours of darkness.

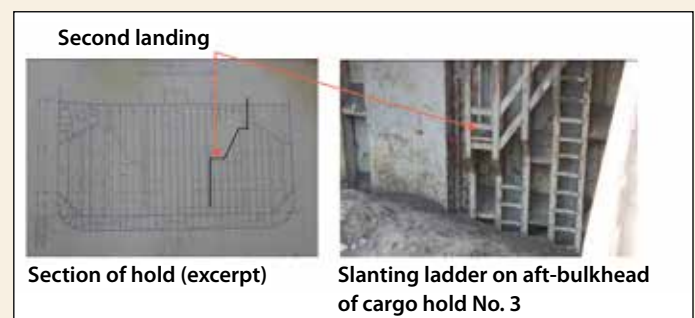
Oxygen content was apparently measured at various points in both holds and found to be normal (20.9%). The driver of the backhoe for hold No. 3 entered the hold via an access hatch and went down a straight ladder (about 2.5m length), across a landing, and another slanting ladder (about 4m vertical). When he moved to the second landing, he fell feet-first, landed on his behind, and remained motionless. The crane operator who witnessed the fall put the backhoe down on the cargo pile and raised the alarm. He then got off the crane and ran to the entrance hatch of cargo hold No. 3.

Two stevedores entered the cargo hold through the entrance hatch leaving the self-contained breathing apparatus (SCBA) on the upper deck.

Because they entered the cargo hold without SCBA, another stevedore followed them to prevent them from going down. When the third man had climbed halfway down the slanting ladder he felt breathless and one of the men in the hold signalled him to go back. He exited the hold, as did the man that signalled, but the third man had collapsed.

The subsequent report found that oxygen in cargo hold No. 3 was consumed by the copper concentrate through oxidation. Some of the
