# Seaways

# Mariners' Alerting and Reporting Scheme

MARS Report No. 254 December 2013

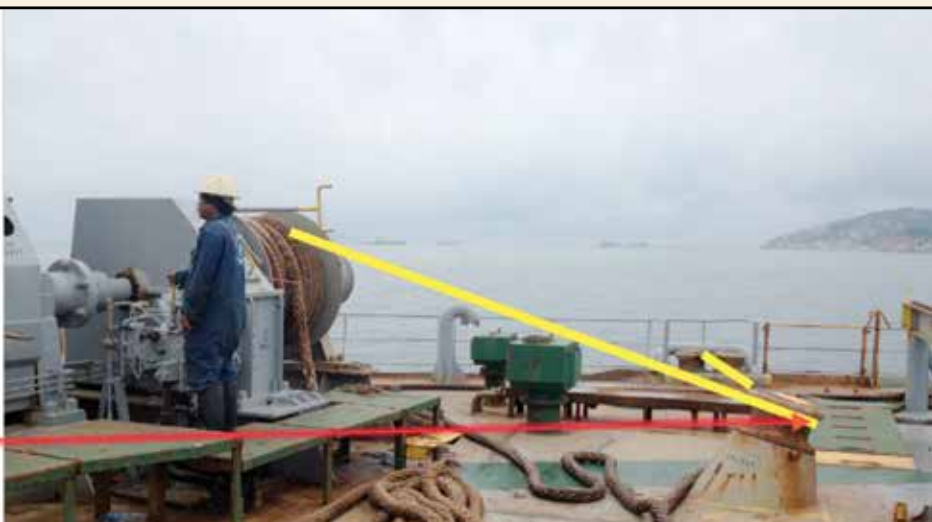
- The plan of mooring equipment at forecastle deck shows that the breast line is passed through the pedestal roller fitted aft of the mooring winch on deck. In this arrangement the winch operator's position is in the snap back zone of the breast line.

- It is likely that the OS did not realise that he was standing in the snap back zone for the rope he was hauling as the snap back markings were no longer clearly marked on deck.

The starboard breast rope which parted was passed as illustrated in this picture.

The ill-fated seafarer was operating the winch from the position, as pictured.

The rope parted just after the pedestal roller.

- The snap back zones have been re-established and now include the pedestal fairlead position. All fairlead rollers at the forecastle deck have been de-rusted and painted to smooth the surface.
- Crew educated on the snap back zones at forward and aft mooring stations.
- A campaign on mooring safety has been carried out in the company fleet. Every vessel in the fleet reviewed their mooring arrangement and prepared a risk assessment for mooring as per fitted mooring arrangement and in normal weather conditions. The countermeasures to these hazards were also identified. The quality and quantity of mooring ropes required for each vessel must be identified and documented.

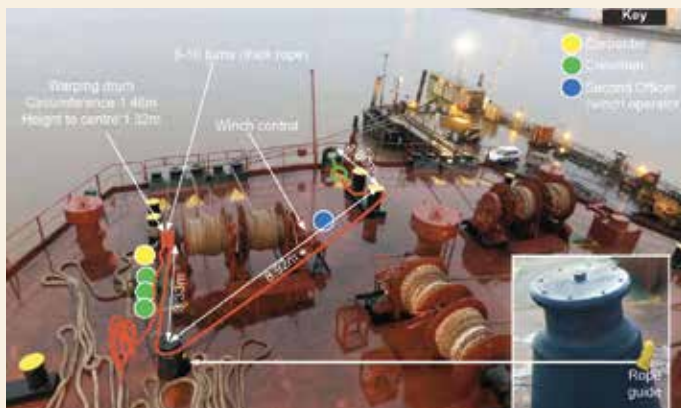
The cargo vessel's mooring team then decided to arrange the hauling operation as pictured below.

The carpenter had taken approximately eight to ten turns of the thick messenger line around the drum. These turns accumulated towards the outboard end of the drum as it rotated due to the angle of the lead from the pedestal fairlead. The free end of the messenger line then became entangled in 'riding turns', causing it to be heaved back into the warping drum with the part under tension. As this was happening, the tow wire came up onto the cargo vessel's deck and the towing eye nearly reached the aft bitt.

- Once the aft mooring team decided to use the starboard winch to heave up the tow wire, they chose, and then persisted with, an unsuitable lead for the messenger line. The messenger line not only damaged the winch's hydraulic pipes, but also led onto the pedestal fairlead from the wrong direction. (The pedestal fairlead was designed to assist in taking a breast or spring mooring line from ashore, with the line exiting from the pedestal on its inboard side.)
- The aft mooring team did not follow the recommended practice of taking only sufficient turns on the drum to get traction (normally

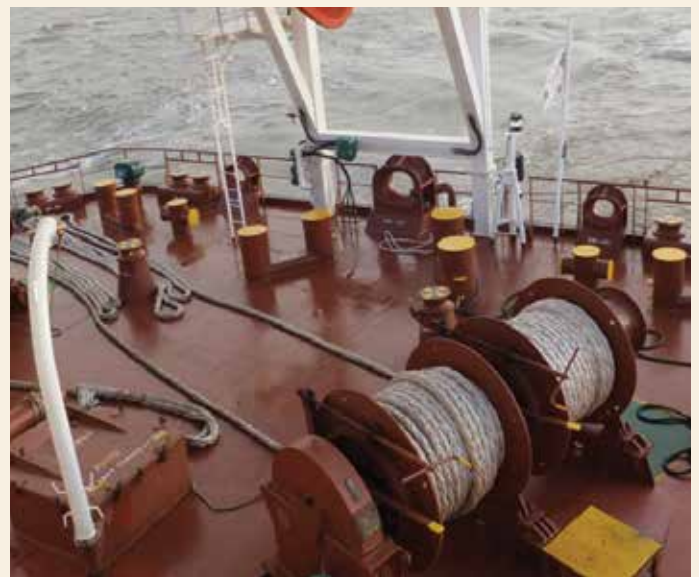
- The configuration for heaving up a tug's topline onto the aft deck of the cargo vessel was poor. The relative ease and speed with which the operation of securing a tug can be achieved on better laid out mooring decks (such as that shown below) illustrates the importance of good design. Well-designed, ergonomically efficient equipment has a major role in preventing accidents by naturally encouraging people to work safely and discouraging bad practices. Conversely, poorly designed equipment, such as in this case, increases the likelihood of people taking short-cuts and making errors.

An example of good design, which in turn promotes safe practice

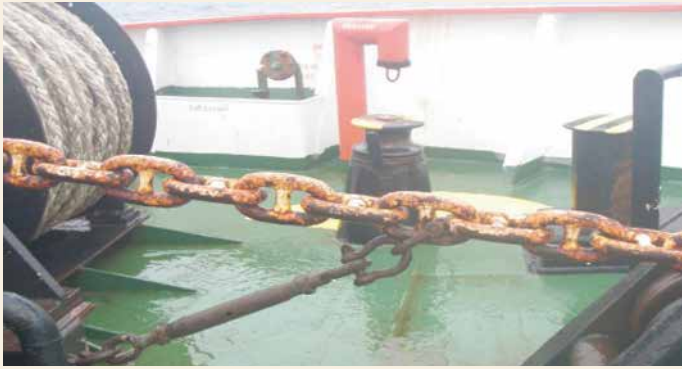
A tongue type stopper is fitted such that the horizontal link of the chain rests on the tongue, thus taking the weight of anchor chain and the anchor, when the anchor is fully housed. It is believed the anchor,

Anchor as secured

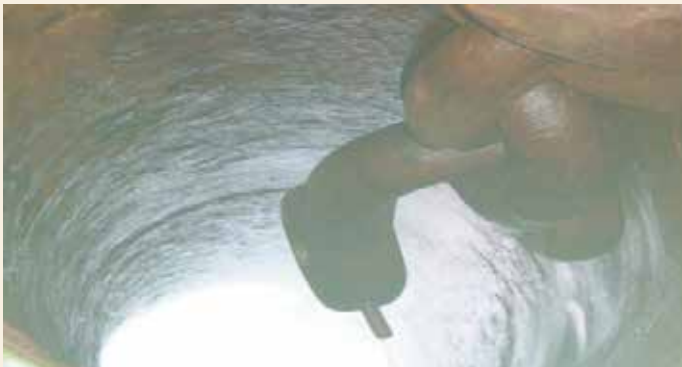
Missing starboard anchor

although lashed and secured with turnbuckle, was not fully resting on the chain stopper. This is supported by the fact that the anchor had been found loose some time earlier and the turnbuckle was re-tightened. If the anchor was fully housed and properly resting on the stopper, the lashing would not have been found loose. So the anchor, hanging slightly, was subject to heavy movements due to bad weather. This caused the pin of the D-shackle to be lost, resulting in the loss of anchor.

After the incident, corrective action was taken such that the anchor chain was properly resting on the stopper when the anchor was in the fully stowed position. Also, the locking pin on the D-shackle has been welded to avoid accidental release.
