Mariners' Alerting and Reporting Scheme

MARS Report No. 255 January 2014

Fatigue and dangerous conditions lead to fatality

Edited from official Canadian Transportation Safety Board report M02L0061

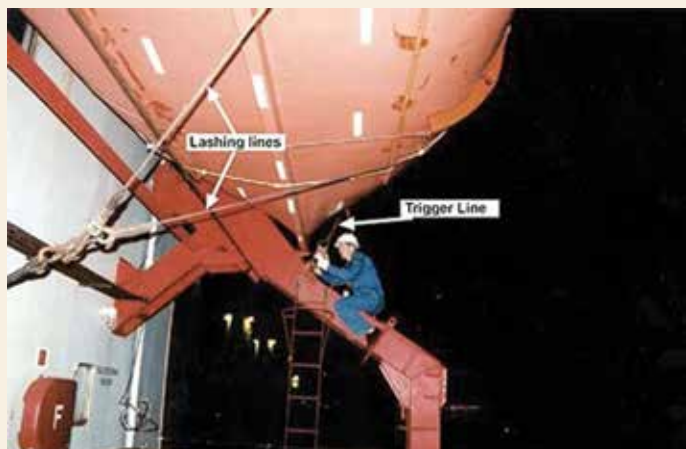
→ While underway but not yet in open sea, the bosun was instructed to properly secure the port lifeboat for sea. He called on a seaman to help him with the work. By the time the seaman arrived at the lifeboat station the bosun had already begun the task. The bosun was sitting astride the forward davit cradle, close to the underside of the lifeboat, trying to secure the forward trigger line to the trigger mechanism on the cradle (see photo). The seaman climbed the aft cradle ladder and attempted to do the same with the aft trigger line. When the seaman realised there was not enough slack in the line to permit the connection, he descended the ladder with the intention of lengthening the turnbuckle at the other end. Shortly after reaching the deck he heard a noise; he then saw the lifeboat sliding down the cradle of the roller gravity davits.

The noise also alerted the ship's electrician who was nearby. Both the electrician and the seaman rushed to the lifeboat davit winch and applied the brake. The lifeboat stopped descending but not before hitting the bosun, sending him backwards. He clung to the trigger line momentarily, but lost his grip and fell overboard into the water 15 metres below. 'Man overboard' was quickly communicated to the bridge where the OOW, a helmsman and a pilot were navigating the vessel. The pilot immediately put the engine to dead slow ahead, but the confined area of the channel prevented a turning or full astern manoeuvre. The pilot also released the port smoke buoy, but this fell into the partially deployed port lifeboat. The Master arrived on the bridge and released the starboard smoke buoy. Another life ring was also thrown into the water, and persons on deck could see the bosun apparently swimming some 20 metres from one of the buoys; however, they lost sight of him within minutes. Five days later, the bosun's body was recovered approximately 10 miles from the site of the accident.

- 5 With the davit winch brake disengaged, the corroded lashing line failed to hold the weight of the port gravity davits and the suspended lifeboat, allowing the assembly to slide down the davit cradle, knocking the bosun overboard.

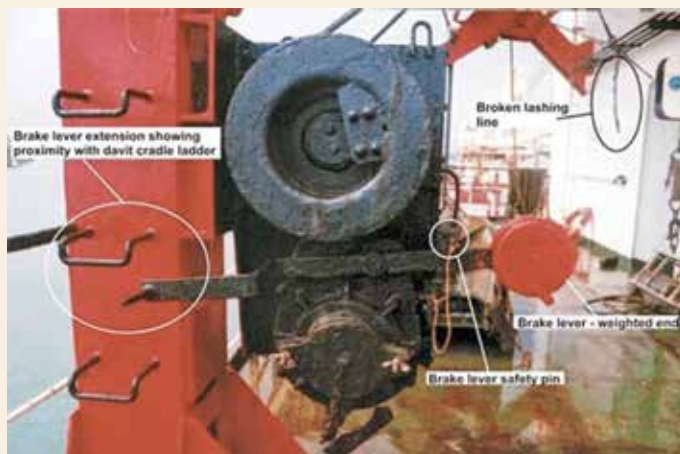
It was observed during the course of the investigation that the outboard end of the brake lever (opposite the weighted end) was

extended such that the handle was near the vessel's side to enable the person who controlled the brake, by pushing down, to view the lowering of the lifeboat. The handle was in very close proximity to the second rung of the aft cradle ladder (6 cm below and 5 cm away, see photo above).

- 1 The 12 mm gap between the safety pin and its brake release lever, and the less-than-adequate maintenance on the brake-lever mechanism, contributed to the unexpected release of the lifeboat down the davit cradle.

- 2 The wire rope used as the lashing line was in a severe state of corrosion and well beyond a serviceable state.
- 3 The davit cradle ladder rungs were located in very close proximity to the faulty winch brake lever, and as the seaman descended the aft davit cradle, he probably stepped on the winch brake lever extension, instead of the ladder rung, and released the lifeboat.

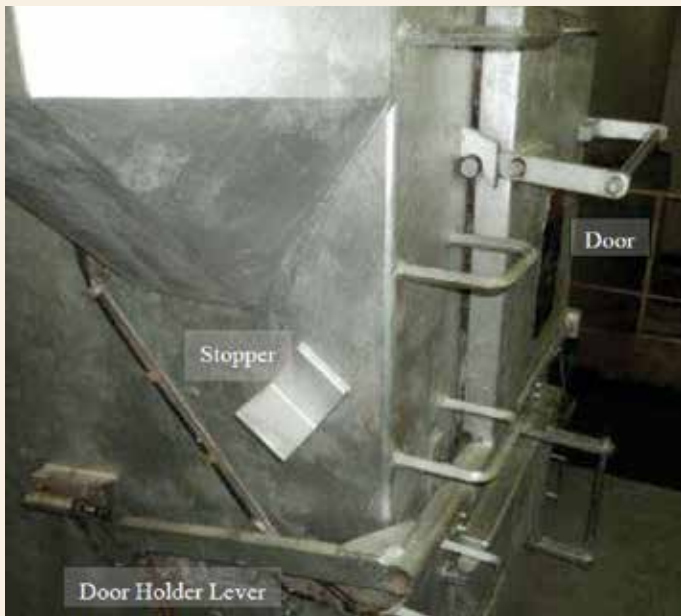
Incinerator with door closed

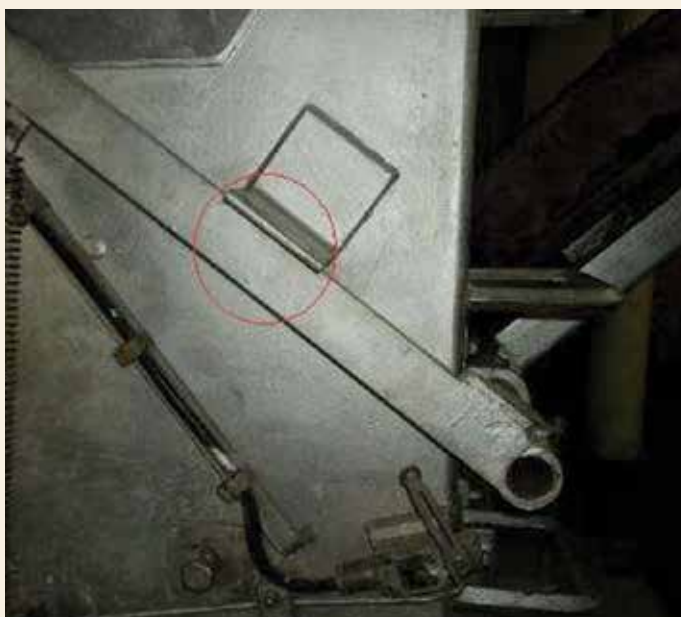
➔ An engineer attempted to open the incinerator door while underway. His thumb was trapped and crushed between the door holder lever and the stopper plate (see photo). He was quickly transferred to the ship's hospital and first aid was administered. The victim was disembarked and at the hospital a fracture of the thumb was diagnosed and orthopaedic surgery was necessary.

With door open, red circle indicates where crushing ensued

- 1 Inappropriate handling of the equipment.
- 2 Improper decision-making and lack of judgement.
- 3 Fatigue due to violation of resting hours the previous day without adequate compensatory rest.

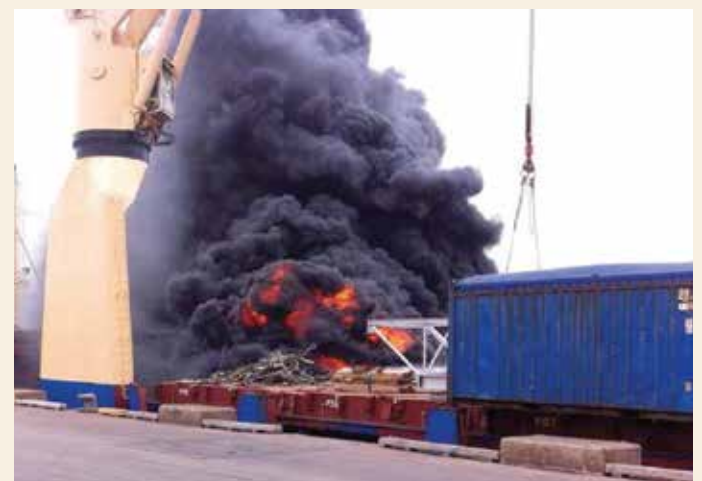
➔ In preparation for hot work by shore workers the crew placed three fire hoses, two dry-powder fire extinguishers and a number of fire blankets in the hold. As gas-cutting began no fire watch had been established at the hot work site(s) inside the cargo hold. A tarpaulin cover caught fire, and the shore workers raised the alarm. None of the ship's crew were in the hold and there was no attempt to use a fire extinguisher or the other fire-fighting equipment that had been prepared. The chief mate saw smoke coming from number one cargo

In carrying out the hot work on board the vessel, neither the ship's crew nor the shore personnel properly considered or mitigated the risk of fire. Not all of the precautions listed on the ship's hot work permit were taken, nor was the permit completed properly. Similarly, not all of the measures listed on the shore gang's job safety analysis were taken.

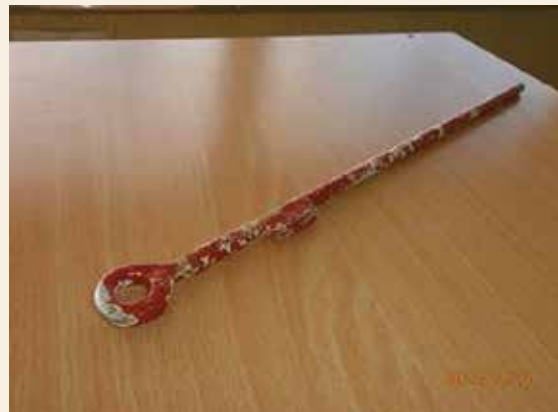
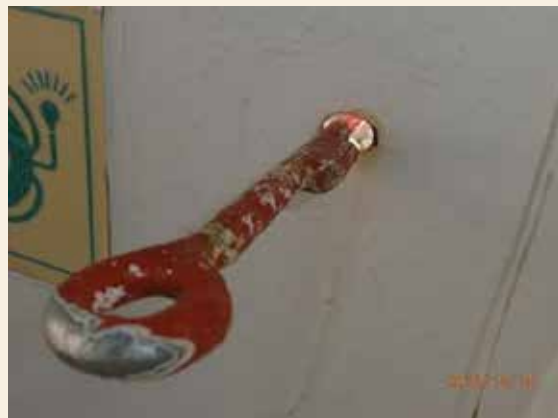
Before

It was found that the securing pin of the life-ring was able to loosen on its own and back off from the as-installed condition. It would appear that the rather light construction of the pin allowed it, through vibration and vessel movement, to move to a point where it self-released.
