Seaways

The International Journal of The Nautical Institute

Mariners' Alerting and Reporting Scheme

MARS Report No. 261 July 2014

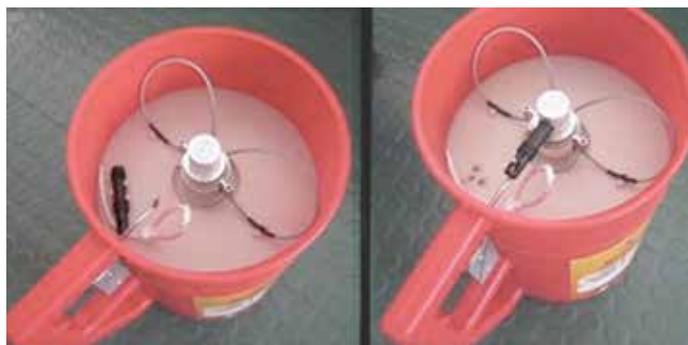
Line thrower not ready for use

→ At a recent flag inspection in conjunction with a PSC inspection, we found that the line throwing apparatus was not armed for use.

The vessel was provided with an IKAROS line throwing apparatus. The units were found in the un-armed condition; that is, the black plastic cylinder was not fitted between the rocket and the trigger. This means that the line throwing apparatus would not activate if the trigger was pulled. The plastic cover to the line throwing apparatus has a small label which states 'For safety during transit rocket is not armed. Rocket should be prepared for use once on board ship in accordance with enclosed instructions.'

It is unknown why the rocket was not armed upon receipt on board the vessel.

Unarmed

Armed

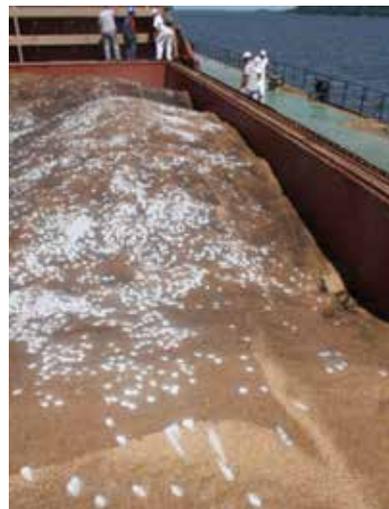
While phosphine is a well established insecticide, it is also poisonous to humans at relatively low concentrations and can form flammable gas/air mixtures. Failures to follow correct application procedures include:

- Failure to unfold or uncoil belts, blankets, blister packs and ropes. This presents a fire hazard, and possibly an explosion hazard which worsens if moisture that condenses on the upper parts of the cargo space (sweating) drips onto the fumigant product. Under these circumstances a flammable phosphine:air mixture is more likely to form. If this mixture accumulates within an enclosed space such as a cargo hold or a drum fitted with a lid, it may ignite spontaneously and cause a fire.
- Too many pellets or sachets clustered together (see picture).

- **Do not** pile residues onto an open deck exposed to damp or wet conditions. This may cause a fire and toxic gas hazard.
- **Do not** under any circumstances store residues in a closed drum or other sealed container. This may result in an explosion if a flammable phosphine:gas:air mixture ignites spontaneously, accompanied by the continuing escape of toxic phosphine gas.
- **Do not** store residues in an open drum exposed to damp or wet conditions.
- **Do not** place an open drum of waste in a compartment or locker, such as a forecabin store, because of the risk of build-up of phosphine in the space.

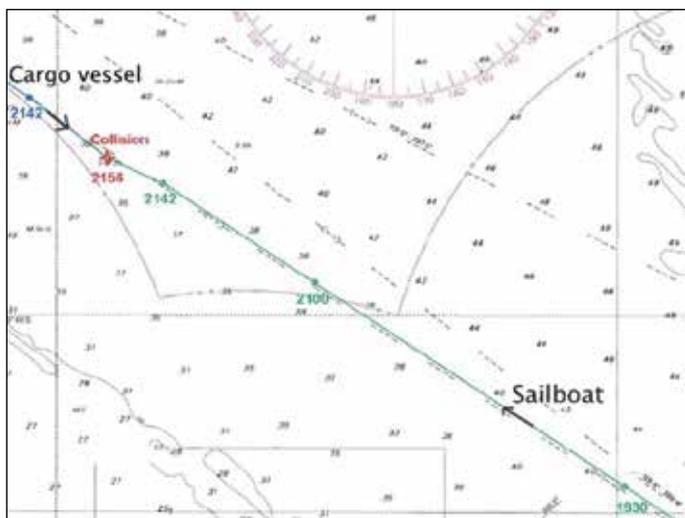
➔ While underway on a general cargo vessel, the OOW was listening to music on a personal computer and, from time to time, he hummed or sang along with the music and chatted with the lookout. The visibility remained good and they could not see any ships or other traffic nearby. The S-band radar, AIS unit and both very high frequency (VHF) radios were switched on. Shortly after 2100, the lookout reported a white light fine on the vessel's port bow. The OOW told the lookout that the light was a distant lighthouse some 30 miles away. About 18 minutes later, the lookout reported that the white light he had seen earlier was flashing. The OOW could see no radar targets in the general direction of the light and told the lookout that it was the distant lighthouse that he had previously mentioned. At 2142, the lookout reported a green light fine on the port bow. The third mate thought the green light was from an expected isolated danger beacon and he responded to the lookout that the light was a distant 'light buoy'. In fact, the green light was the starboard sidelight of a sailboat underway, about 4 miles ahead and on a collision course with the vessel.

At about 2149, the sailboat's AIS unit 'target alarm' sounded. Alerted, the skipper's wife called the skipper to come inside the cabin and have a look at the AIS display. Together, they noted from the AIS data that the approaching ship was making good a course of 122° (T) at 11.5 knots. The skipper then went back on deck to look for the ship. Within a minute, he saw its green sidelight fine on his starboard bow. The skipper decided to alter course to port to a heading of about 280°, with the aim of passing well clear of the ship.

Just after 2153, the cargo vessel's lookout reported that the green light he had been observing seemed very close. The sailboat was in fact now less than one mile ahead of the ship and the two vessels were closing at a combined speed of nearly 18 knots. In response to the lookout's report, the OOW checked the radar and the AIS unit but saw no target in the direction of the green light. About two minutes later, the sailboat called the vessel on VHF channel 16 and identified themselves. The yacht was now about 200 m from the ship's bow. Alerted by the unexpected radio call to his ship, the OOW stopped humming. A few seconds later, he broadcast on VHF channel 16 that the ship's course was being altered to starboard. He then ordered the lookout to engage hand steering. He could no longer see the yacht's green light when he ordered the rudder hard-to-starboard. At 2156, with the vessel's heading at about 130°, it collided with the sailboat, the yacht scraping along the ship's starboard side.

When the Master came to the bridge after the collision, one of his first actions was to adjust the radar gain and clutter controls. The yacht (as a target) was then easily identified on the radar display. Had the OOW correctly adjusted the controls on the ship's radar, he may have determined that the green light the lookout had identified was a vessel. As a result, he would have been in a better position to make a full appraisal of the situation, the risk of collision and to take early and appropriate action.

While the cargo vessel's lookout sighted the sailboat's starboard sidelight, the OOW was not keeping a proper lookout. He made a series of assumptions based on limited information instead of following a systematic approach to confirm what had been observed. As a result, he did not conclude early enough that the lookout had identified a sailboat and that the yacht posed a risk of collision.

Had the OOW correctly adjusted the controls on the ship's radar he would have been in a better position to make a full appraisal of the risk of collision allowing for early and appropriate action.

It is possible that the OOW was distracted from his primary task, the safe navigation of the ship, by his conversations with the lookout and the music that he was engaging with through his constant humming and singing.

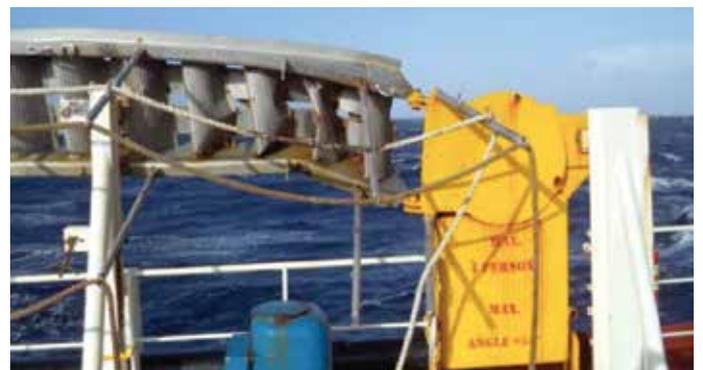
Caught between gangway and ship's rail

➔ A cargo vessel experienced heavy weather while underway resulting in damage to the port gangway. Once in a secure anchorage and in good weather it was decided to bring the gangway on deck for inspection and to prevent further damage. As the gangway was being lifted on deck via the deck crane, a crewman who was assisting the work was caught between the gangway and the ship's rail. His upper body was crushed; first aid was applied and he was quickly evacuated to hospital.

- The crewman had unwittingly put himself in a dangerous situation. The management of crew for this non-routine operation was less than adequate.
- There was a lack of vessel procedures for handling/lifting heavy objects.
- The risks for the work in question were not thoroughly analysed.
- The gangway was likely improperly secured in the first place to have suffered damage.

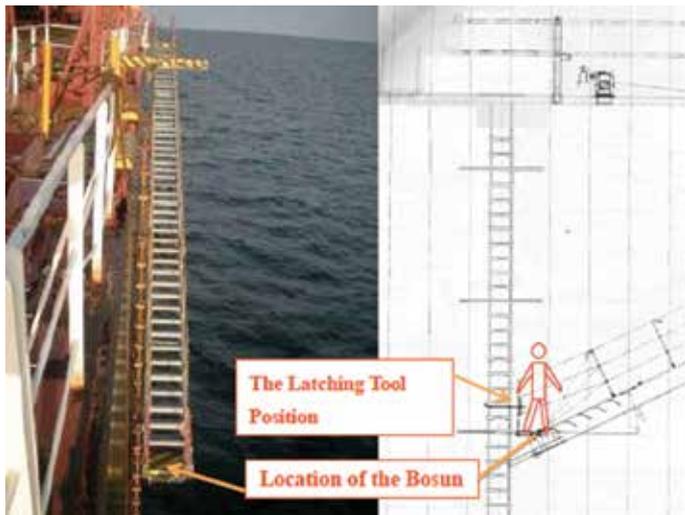
→ A vessel was underway in darkness having just disembarked the pilot. Winds were modest at B6 and there was a swell of about three metres. Air temperature was a cool 8C. The bosun, assisted by three other crew, was bringing on board and securing the pilot boarding arrangements. The bosun descended to the lower platform of the accommodation ladder to disconnect the latching mechanism which secured the pilot ladder to the accommodation ladder.

After the bosun had pulled up the lower section of the pilot ladder and placed it on the accommodation ladder, he asked one of the assisting crew to heave up the accommodation ladder. Each time the crew tried to hoist the ladder, it descended rather than moving up. After a few attempts, the crewman stopped the operation, but at this time a noise was heard and the crew realised the accommodation ladder was now hanging vertically down. The bosun could not be seen; he had not been wearing a lifejacket or a lifeline. A life ring and light were thrown into the water and the bridge informed.

The investigation found it probable that when the ladder was mistakenly lowered (instead of raised), the weight of the ladder transferred from the hoisting wire to the latching mechanism. The mechanism failed under a load that it was not designed to hold, and the resulting shock load on the wire caused failure and free fall of the lower end of the accommodation ladder, leaving it in the vertical position.

The investigation also found it probable that the non-permanent air hose connections for powering the hoist/lower function of the accommodation ladder, which were unmarked, were mistakenly inverted when connected initially, hence the lowering action achieved when the crew wanted to hoist.

Additionally, it was found that the wire on the failed accommodation ladder was in fact only 55 metres long instead of the manufacturer's recommended 67 metres. This probably caused undue stress and further undermined the wire's integrity, especially considering that at least two wraps were needed on the drum at maximum payout.

The investigation further found that the bosun was working in contradiction to the company procedure for this operation, having no lifejacket nor safety line. None of the other crew working with the bosun had interjected to advise him of these shortcuts.

■ **Editor's note:** As with almost every accident, a series of unsafe acts and unsafe conditions conspired to bring about a very serious consequence. Had any one of these been absent from the sequence of events, the accident may very well not have happened. But first and foremost I see an absence of safety culture here. Had safety been a true value of the crew, the bosun would never have gone over the side without a lifejacket and safety line. But also, had he wanted to do so nonetheless just to get the job done quickly, the other crew would have called him out on those dangerous shortcuts.
