The International Journal of The Nautical Institute

Mariners' Alerting and Reporting Scheme

MARS Report No. 263 September 2014

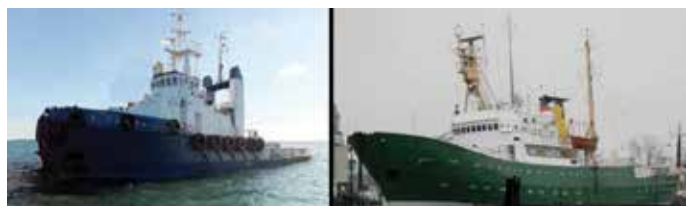
The Master immediately attempted evasive action to avoid a collision but the towed vessel struck the tow just aft of midships on the port side. As the Master attempted to manoeuvre clear he was informed that there was major water ingress to the engine room. The towed vessel's bow had penetrated the tug's shell plating below the waterline in way of the hydraulic motors in the engine room. The Master called the coastguard on VHF, advised them that the engine room was flooding and requested immediate assistance. Meanwhile, the hydraulic pump motors failed due to water ingress resulting in the immediate loss of all hydraulic power, which disabled the windlass. Concerned that the vessel might sink, the Master released the tow and put both engines full ahead in an attempt to dredge the anchor into shallower water.

Tug (left) and towed vessel (right)

- The Master's lack of appreciation of the dangers resulting from tidal effects on the tow when anchoring was a direct contributing factor.
- The Master contacted the company as soon as he became concerned about the list on the towed vessel. However, there were no instructions or guidance in the company's procedures regarding the use of senior, experienced staff from the management company to assist Masters in planning their response to crisis situations such as this. Had the Master developed a plan in conjunction with senior, experienced staff from the company, it is likely that the tidal conditions would have been taken into account.
- Had the Master taken a pilot, the subsequent anchoring would have been better prepared and therefore (probably) not have resulted in a collision.

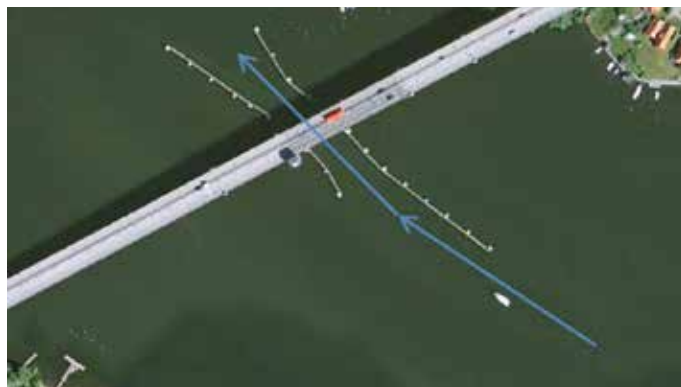
Normal approach to bridge (fendering can be seen on either side)

- VTS did not provide the vessel with any information about the construction works when the vessel reported her position at the various reporting points along the way.
- The bridge repairs were reported in Swedish notices to mariners (in Swedish and English). However, the charts and publications carried by the vessel were British Admiralty, and the UK Hydrographic Office did not publish this particular information on the bridge repair works.
- The fact that the vessel personnel were unaware of the ongoing repair work on the bridge probably affected the Master's actions and contributed in part to the accident.

No anomalies were found with the steering system, so inadequate shiphandling was probably a factor. A substantial decrease in engine power was applied immediately before the turn to starboard in order to reduce speed. This in turn led to an impaired steering effect since the propeller wash had by then decreased or stopped altogether. This, in turn, could have been experienced as though there was something wrong with the steering.

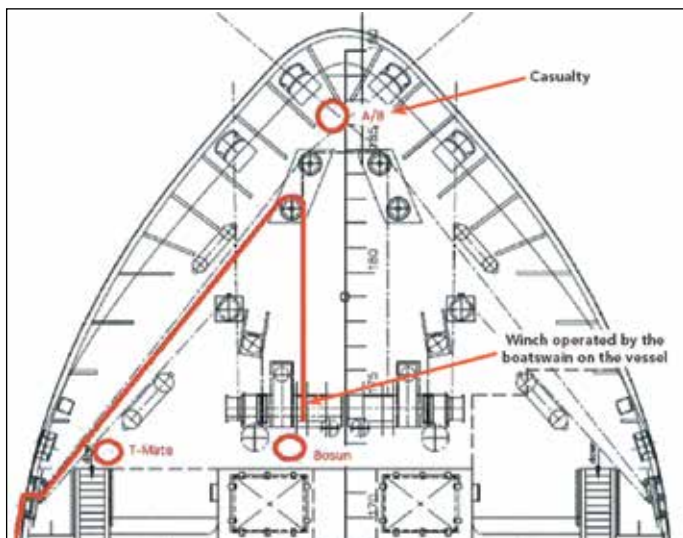
At this same time, a seaman had walked forward a few steps to retrieve a heaving line that had been thrown back to the vessel from ashore. This caused him to enter the snap back zone for the spring just as it broke. The seaman was hit by the mooring line and was killed almost instantly.

- The crew may not have been aware of all of the risks involved for mooring operations.
- Some publications used for informing mariners of snap back zones underestimate the extent of these zones. Other publications, such as those by The Nautical Institute or Seahealth Denmark are more accurate.
- A recently published IMO document (2013), MSC 92/inf.11, also has clear guidance to help prevent accidents while mooring.

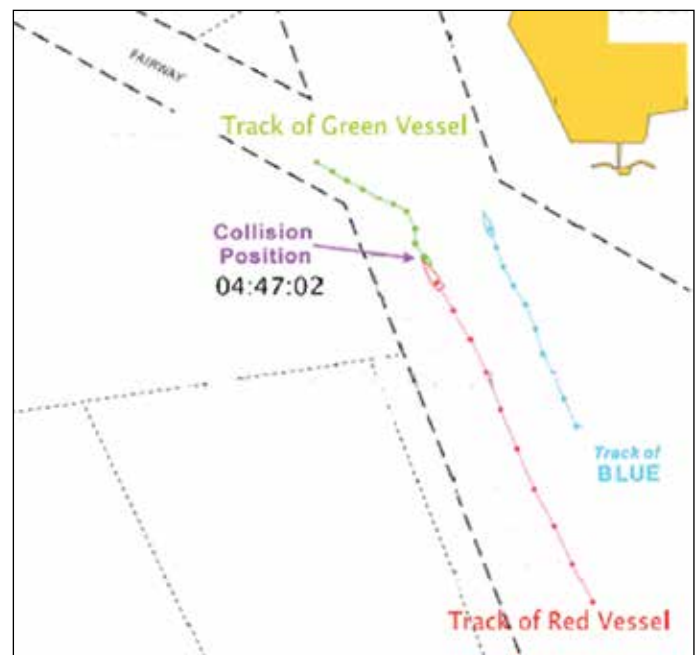
➔ The weather was fine with light winds, a smooth sea and visibility of about 4nm. The red vessel [see image] was making way at about 12.5 knots. The pilot on the red vessel observed a radar target, the green vessel, on a radar bearing two points on the port bow at a range of 1.8 nm. The green vessel was also visually observed to be a crossing vessel that the pilot estimated would cross ahead at 0.5nm. He assessed that a close-quarters situation was developing due to the green crossing vessel and other traffic such as the blue vessel on their starboard bow. A continuous sound signal was given from the red vessel's whistle for about 30 seconds to attract the attention of the crossing vessel. For the time being the red vessel maintained her course (338°T) and speed.

- The green vessel, being the give-way vessel in a crossing situation, failed to comply with Rule 15 (Crossing situation) and Rule 16 (Action by give-way vessel) of the International Regulations for Preventing Collisions at Sea 1972 (COLREGS) for not taking early and substantial action to keep out of the way of the red vessel.

- The red vessel, being a stand-on vessel in a crossing situation, failed to comply with Rule 17 (Action by stand-on vessel) of the COLREGS but [reduced speed and] altered course to port to avoid collision with the green vessel.

- Instead of a continuous sound signal of 30 seconds, or even the three prolonged blasts just before the collision, the red vessel should have sounded at least five short and rapid blasts on the whistle when she failed to understand the intentions or actions of the green vessel.

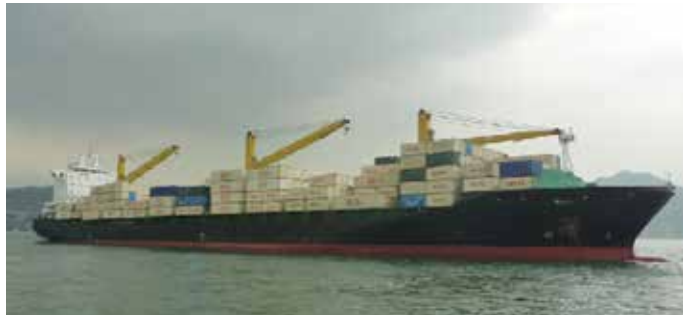
Red vessel

Following the collision the green vessel's engine compartment was flooded and the vessel finally foundered some two hours later. Her six crew boarded the vessel's lifeboat and were rescued. The red vessel sustained paint scratches to the starboard bow.
