Seaways

The International Journal of The Nautical Institute

Mariners' Alerting and Reporting Scheme

MARS Report No. 264 October 2014

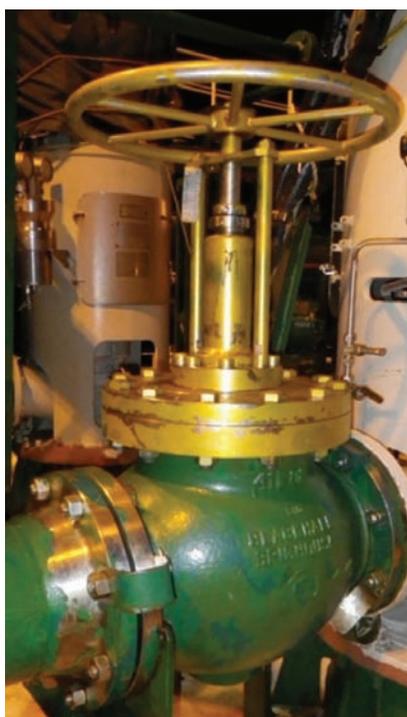
Spindle valve assembly

→ A LPG vessel was outbound under pilotage. On deck, preparations were being made for the changeover from the last butane/propane cargo to the upcoming full propane cargo. The cargo discharge valve of cargo tank 3S had stuck during the previous discharge and could only be used with a limited rate. The chief officer (C/O) decided to remove the valve spindle assembly as soon as possible because bad weather was forecast before the next loading operation. This job had been done several times in the past, so the C/O considered it a routine operation; as such, a risk assessment was not performed. The Master was unaware of the maintenance operation at the time.

With the bosun and one AB, the C/O completed steps 1-4. Then, with the cadet and another AB joining them, the C/O started to joggle the valve assembly. As soon as the spindle assembly was lifted off, liquid propane streamed out and was blown by the strong wind to the starboard side. The AB received a significant amount on his upper legs

- Chronic repairs: The company had recognised the chronic nature of the valve/spindle assembly problem, as breakdown reports had been already issued and spare parts had been delivered on several occasions. Alternatives to this valve type were being sought, with the intention to replace all six at the next dry docking.

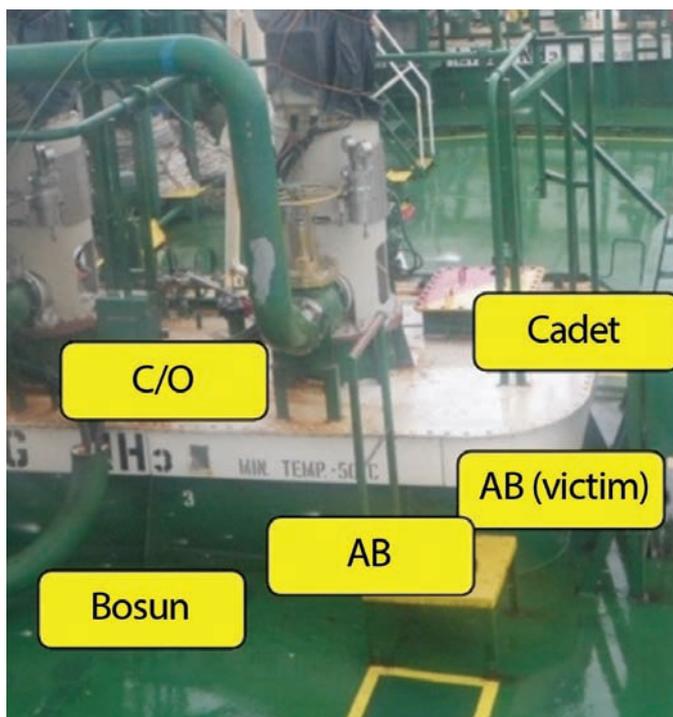
Layout of the accident site

while the cadet received somewhat less on his upper leg and ankle, as did the C/O. He immediately managed to reposition the assembly on the valve body, which stopped the outflow. The AB and the cadet exited the area and received first aid. The vessel was still heading towards the pilot station but as the injuries appeared superficial it was decided not to return for a medical evacuation. Mediport was informed for assistance.

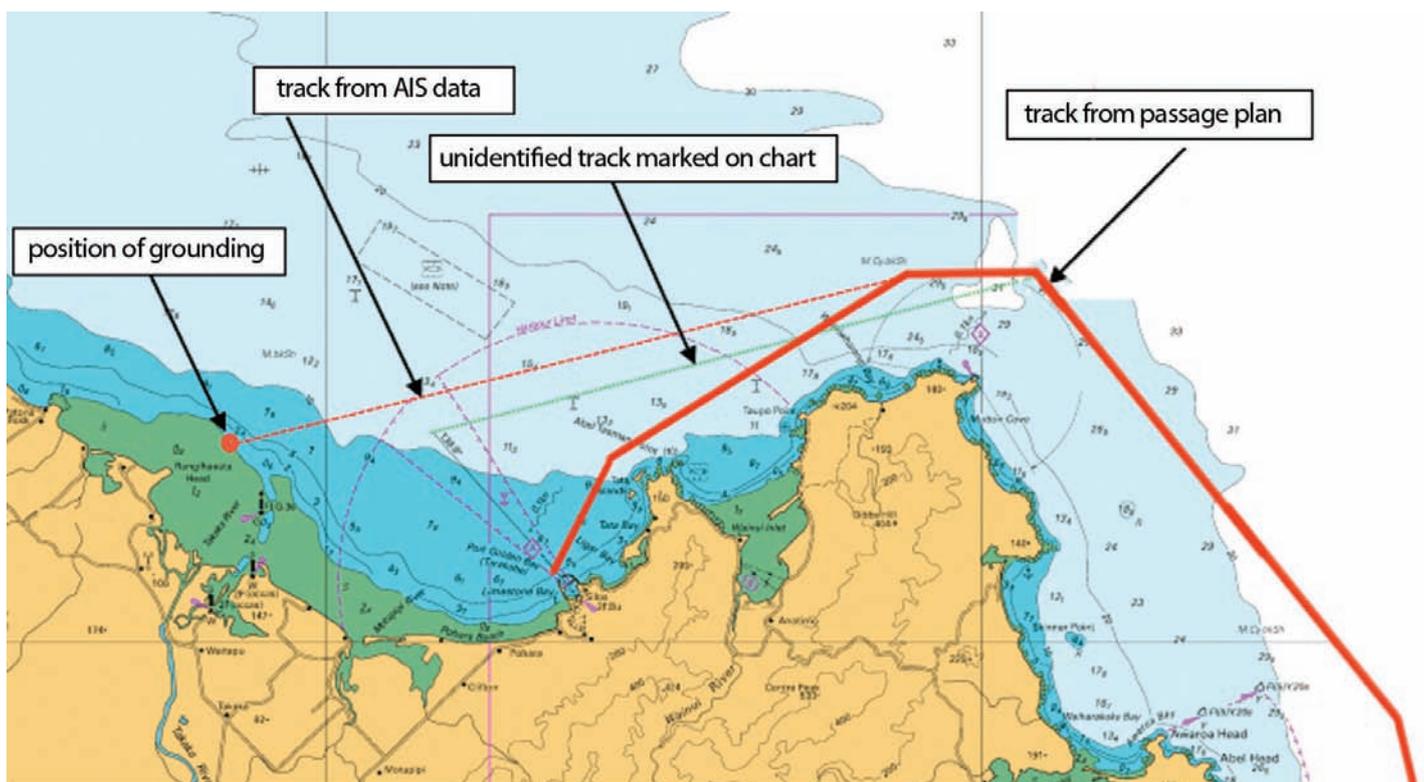
At about 0015, the OOW arrived on the bridge and took the con of the vessel from the Master. The mate was still on the bridge when the OOW arrived, but left the bridge about five minutes later. The OOW maintained the vessel on its designated track, regularly plotting the vessel's position on the chart. At 0350, as the OOW altered course off a prominent point, he called the mate for the 0400-0800 watch. The mate arrived on the bridge at about 0403 and after reading and signing the Master's night orders, took over the watch. At about 0408 a course alteration to about 253° was performed. At about 0506 the vessel grounded while still on a heading of 253°.

During the course of the investigation, the mate was adamant that he had not fallen asleep after altering the vessel's course to 253°. Yet, the sequence of events (see photo) show this as a strong possibility. If not asleep, he must have been doing something other than monitoring the progress of the vessel.

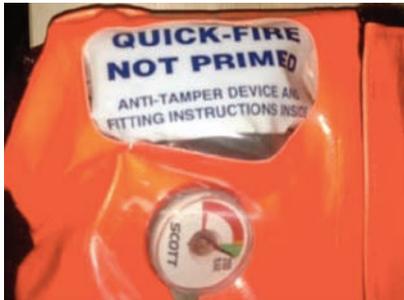
→ During recent inspections, it has been discovered that numerous SABRE Emergency Escape Breath Devices (EEBD) / Emergency Life Support Apparatus (ELSA) were in an unprepared status. The 'Quick Fire' functionality that puts the EEBD into operation when the bag is opened up and hood is worn was not in its 'primed' state. This can have fatal consequences when time is of the essence to escape a hazardous atmosphere.

When purchased or returned from servicing, this equipment will have a small removable label viewable through a window on the bag that states 'QUICK-FIRE NOT PRIMED ANTI-TAMPER DEVICE AIR FITTING INSTRUCTIONS INSIDE'. This means the unit is not ready. Once received on the vessel, the EEBD should be prepared for use by opening the bottom left corner flap, attaching the 'Quick Fire' cord and removing the label.

■ **Editor's note:** Although this safety alert concerns SABRE brand, you should check all EEBDs carefully for their proper functionality.

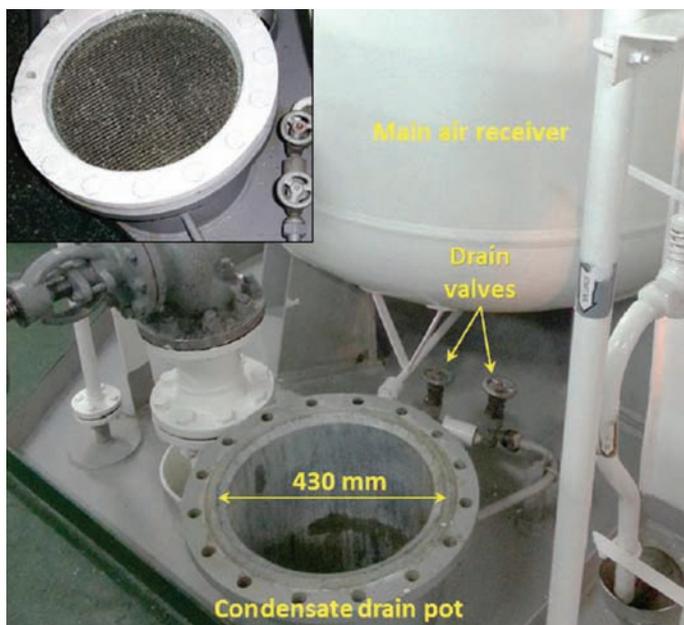
Drainage pot arrangement. Inset shows observation glass in place.

flow of condensate through the observation glass of the drainage pot. Shortly afterwards, and without warning, the observation glass exploded.

An analysis of the accident showed it was likely that condensate had accumulated in the air receiver overnight. When the drain valves from the main air receiver were opened, the condensate flowed into the drainage pot in sufficient quantity to cover the bottom of the pot and the discharge hole. This flow of liquid was probably followed by a marked increase in pressure due to the inrush of pressurised air (about 30 bar) from the receiver. The pressure increase in the drainage pot was sufficient to fracture the observation glass, leading to its catastrophic failure. The positioning of the drain valves behind the observation pot meant that the fourth engineer's upper body was positioned directly over the observation glass and therefore in the path of the explosive force and debris from the pot.

- The drainage pot observation glass failed catastrophically when the pot was subjected to significant air pressure from the pressurised air receiver. Pressure accumulated in the drainage pot when liquid condensate from the air receiver restricted the flow of air and liquid out of the pot into the drain piping and to the bilge.

- **Editor's note:** When in doubt, or for any ad hoc modifications to vital machinery, consult class.

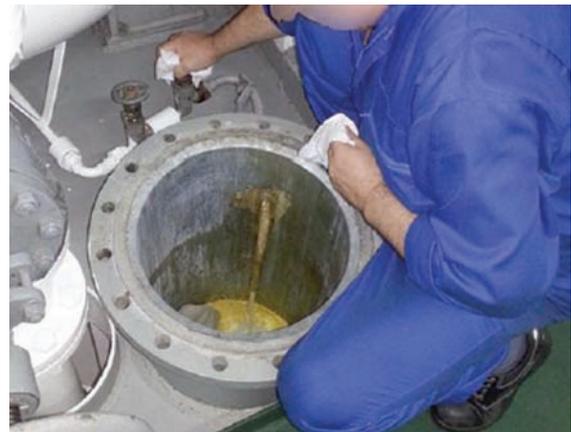
The condensate drain pots fitted on the vessel were not of a design normally fitted by the builder, or commonly encountered on board ships. They were a modification that was implemented at the request of the shipowner's representative to eliminate splashing of condensate. He had provided notes outlining the fitting of glass observation windows. Although the design of the drainage pots suggests that some consideration was given to the likelihood of pressure accumulation, no quantitative engineering analysis of the design was undertaken. When considering the working conditions and component deterioration over time, failure of the observation glass at some time in the future was almost inevitable. Importantly, any failure would probably occur while the operator was positioned over the observation glass to operate the valves or to look into the pot, as in this case.

- The condensate drainage pots fitted to vessel's main air receivers were not fit for purpose as they were not capable of withstanding the internal pressures that were likely to accumulate in service.
