# Seaways

The International Journal of The Nautical Institute

# Mariners' Alerting and Reporting Scheme

MARS Report No. 268 February 2015

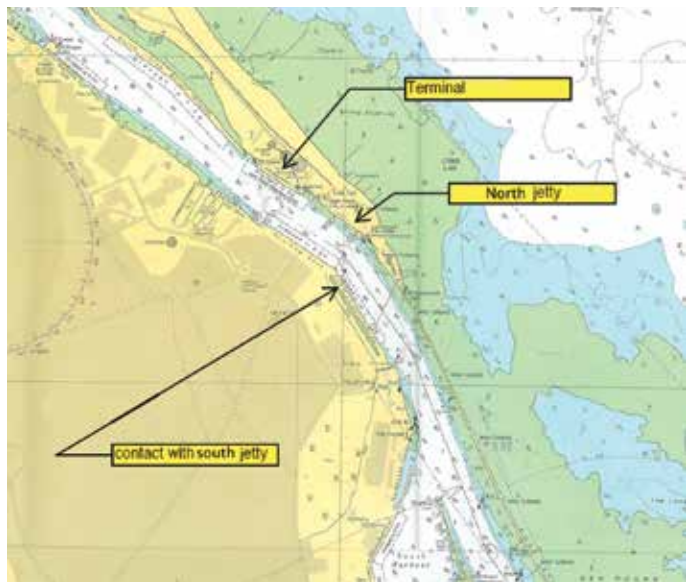
→ On a clear night, a small feeder ship with controllable pitch power (CP) was brought out of a restricted port in order to shift berth from port to starboard side. It was to be turned around and brought back in. A passage plan was presented and discussed during the Pilot/Master exchange prior to leaving the berth. The passage down river to the sea was uneventful. The vessel turned outside the port and began the approach to re-enter.

While passing the breakwaters the vessel's speed was approximately 8.5 knots (40% pitch). As they progressed in the gyro was checked against leading lights and found to be out by up to 8°. The pilot suggested that another bearing be taken on the inner harbour leading line. During this phase of the transit, verifying the gyro occupied the bridge team to a great extent.

On approaching the jetty, the pilot ordered a reduction of speed to minimal ahead. The pitch was subsequently reduced from 40% to 10% but this sudden reduction caused a large swing to port. The pilot ordered starboard helm and more propeller pitch to aid steerage. Now at about 2-3 cables from the terminal berth, the pitch was put to 0% and then full astern which swung the bow to starboard. This resulted in the vessel grounding south of the terminal berth at about 3 knots.

Coming full astern brought the vessel off the ground very quickly, but caused the stern to swing rapidly to port. The vessel then made heavy contact with the south jetty on the opposite side of the river. At this point, control of the vessel was regained and the vessel completed berthing starboard side to at the terminal berth.

- The gyro error distracted the bridge team during a critical period of the berth approach.

- Background lights and darkness made visual observation of the berth, and the closing distance, more difficult to judge.
- The Master was unaware of the pilot's contingency plan, which was to overshoot the berth (go further up-river). This was not communicated during the Master/Pilot exchange.
- As is common with CP power vessels, the abrupt decrease of speed caused the vessel to lose steering and take a shear.
- The Master played a passive role during the manoeuvres and could have been more aware and involved in the handling of the ship and its movements.

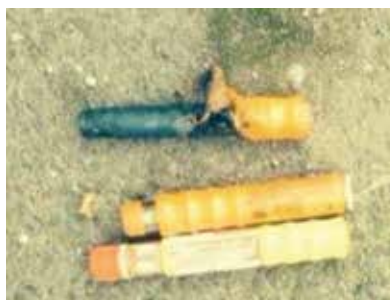
→ A discarded marine flare ignited on the picking line at a depot where ship's garbage is sorted. Fortunately there was no injury to personnel but some damage was done to the conveyor belt.

Flares and other special wastes should not be disposed of within the waste receptacles provided by the port for the use of ships. Disposal of expired ship's flares or any marine pyrotechnic should only be arranged through an approved provider for such services.

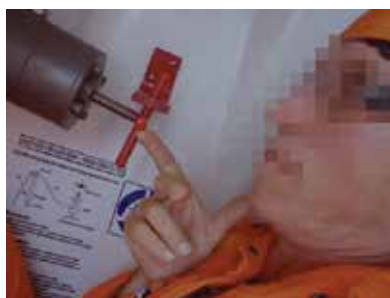
→ There are concerns that freefall lifeboats being installed in vessels currently under construction may not be compliant with the Life Saving Appliance (LSA) Code. Despite type-approval and acceptance by a major classification society the design does not comply with LSA Code

(Chapter IV 4.7.2.2), which calls for at least 650mm free clearance in front of the backrest. In this design the distance is only about 150mm. Under certain circumstances such a limited distance can be dangerous or even fatal to any person sitting in that seat. In addition to the personal injury hazard the non-compliance could put the vessel at risk of detention in the event of a port state control inspection.

Efforts are underway to resolve the situation with the lifeboat manufacturer in question. However the same issue may arise with other lifeboat designs, and crew should be aware of the issue.

1. Even classification societies and the class inspector on board during the vessel construction can make mistakes or miss something. Mariners should remain vigilant as ultimately they will be the ones using the equipment.
2. Shipowners, Masters and mates should ensure that lifeboats aboard their vessels are compliant with the LSA Code and, in event of non-compliance, advise their owners and class society.

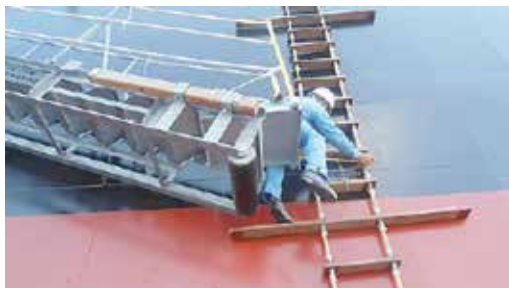
Often, accidents occur while the gangway is being rigged. Rigging the stanchions and the side ropes is inherently dangerous as there can be little for crew members to hold on to until this is completed. On the other hand, many ships are now fitted with a gangway safety wire to which the safety harness line can be attached or even fall inertia blocks which allow for greater freedom of movement.

No lifejacket or safety harness

1. Crew should always wear a safety harness and lifejacket while rigging a gangway. Even though installing a safety harness line can sometimes be difficult and movement restricted by the length of the harness line, a life saved is well worth the effort. Gangways should be inspected regularly. Particular attention should be paid to areas where there are aluminium alloy to steel connections. The absence or deterioration of the insulating gasket can lead to electrolytic corrosion, which will cause wastage and hence weakening.

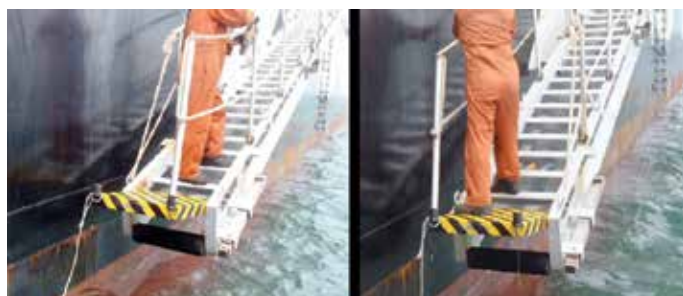
Consider how best to rig stanchions and safety chains. In the photo below on the left, it is clearly difficult to step onto the bottom platform from the bow of the launch, while on the right access from a launch to the gangway or vice versa is much easier.

Wrong

Correct

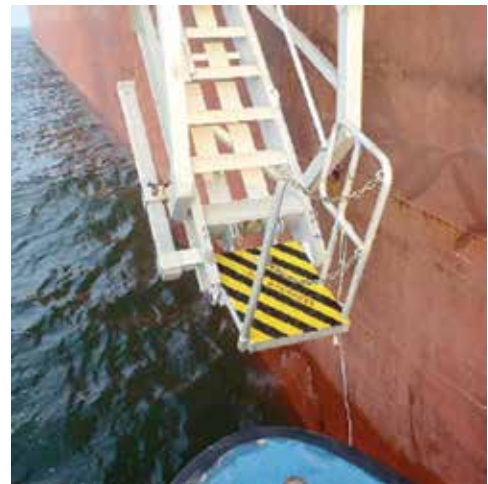
Sometimes the bottom platform has not been adjusted to suit the ship's draught. The bottom platform should be as close to the horizontal as possible to ease access and increase safety.

Bottom platform not horizontal

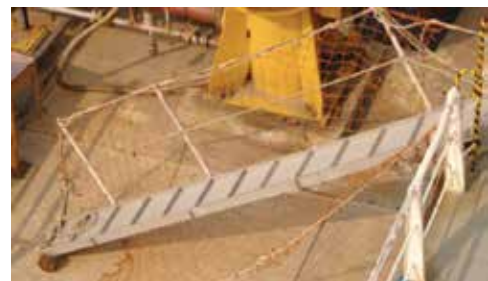
Other common faults with gangways include incorrectly rigged safety nets, slack sidelines, slippery steps and loose or missing stanchions.

Missing stanchions

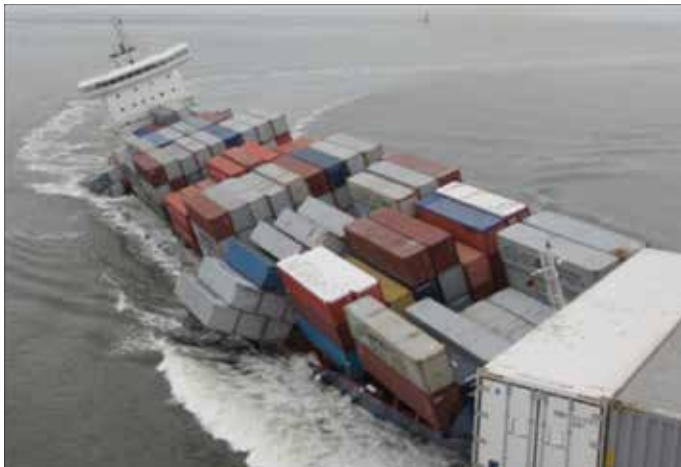
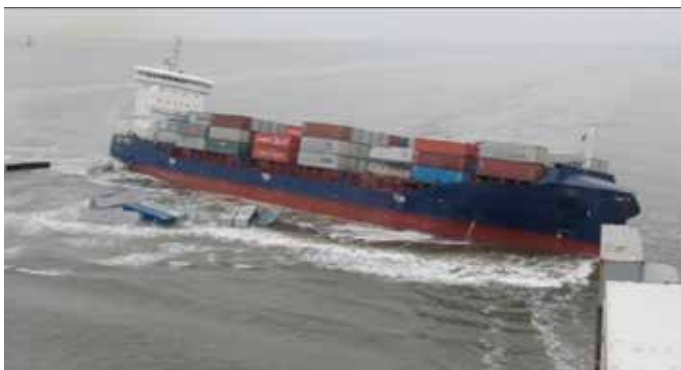
→ A small container vessel was making way in a restricted waterway under pilotage. Earlier that day there had been intermittent main engine problems due to a drop in lubricating oil pressure, but the exact cause of the reduced oil pressure was not yet known.

The vessel decided to overtake a much larger container vessel. As it was overtaking, the lubricating oil problem occurred again, and main propulsion on the small container vessel automatically shut down. Hard starboard rudder was quickly applied, but the vessel became unmanoeuvrable and was drawn to port towards the larger vessel due to hydrodynamic interactions. The forecastle of the smaller ship rammed into the starboard side of the larger vessel's aft section at an angle of about 60°. The force of the collision caused 15 containers on the smaller vessel to fall overboard. Due to the ebb current and the loss of manoeuvrability, the smaller vessel then ran aground outside the fairway. Both ships sustained material damage above the waterline and the fairway had to be temporarily closed to transiting shipping.

1. The loss of main propulsion on the smaller container vessel caused a reduction in speed, among other things, and made the vessel unmanoeuvrable. Hydrodynamic effects then took over and caused the smaller vessel to move unavoidably towards the larger.
2. Even after extensive investigations it was not possible to conclude, with absolute certainty, the cause of the oil pressure drop of the main engine. However, seizure marks were found on the discharge piston of the pressure control valve of the lubricating oil system. The most probable theory is that this valve became blocked in the fully open condition from time to time enabling a disproportionately large amount of lubricating oil to flow back into the retention tank.

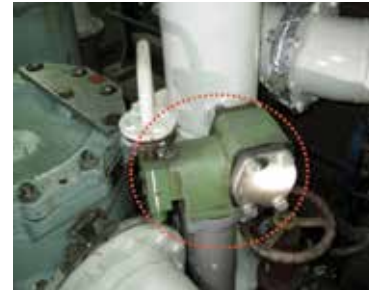
Pressure control valve as installed
