Seaways

The International Journal of The Nautical Institute

Mariners' Alerting and Reporting Scheme

MARS Report No. 270 April 2015

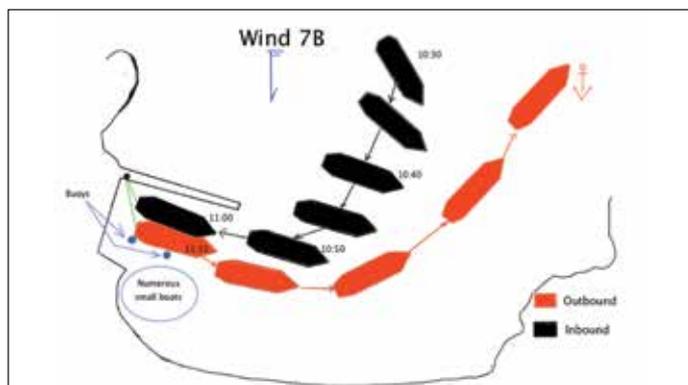
→ A small general cargo vessel in ballast was to enter a port to load logs with drafts fore and aft at 3.5m and 4m respectively, with winds from the north at Beaufort force 7. At 10:30, after the pilot boarded there was a short conversation on the berthing manoeuvre and the vessel headed inbound. The pilot requested the stern line should be secured first to hold the stern. About six minutes later, the Master asked the pilot to repeat the details of the berthing manoeuvre. He also asked if a tug was necessary. The pilot repeated how he intended to back in and pivot and also replied that a tug would take six hours to arrive.

At 10:40 the bow thruster was put to full port and three minutes later the main engine to full astern. The vessel soon started to go astern. As the vessel approached the berth the pilot shouted to send the heaving line. The line was sent and a mooring line set on the berth but the mooring winch could not hold the stern, which was drifting south away from the berth. At 10:54 the pilot ordered to let go and full ahead in an abort manoeuvre. Hard to port helm was also ordered and applied but a grinding noise was heard at about this time.

The vessel was manoeuvred out of the port without further incident and anchored. Divers attended later and found a large bundle of rope fender in the propellor, which itself was slightly damaged.

■ **Editor's Comment:** By any measure this berthing was attempted on a wing and a prayer. With a strong wind pushing south, away from the berth, no tug assistance, and a flotilla of small boats and buoys just south of the berth, the bridge team appears to have given little forethought to the manoeuvre. Given the conditions, the consequences could have been much worse. An inexperienced Master and an apparently impatient pilot met at the wrong time in the wrong place.

- Proper training for the ships Masters/crew was scheduled with reference to proper passage planning, bridge resource management and seamanship.
- The procedures of promotion of seafarers, evaluation of seafarers and office visits by seafarers to be reviewed. Feedback/findings (verbal or in writing) from office departments have to be incorporated in these procedures.

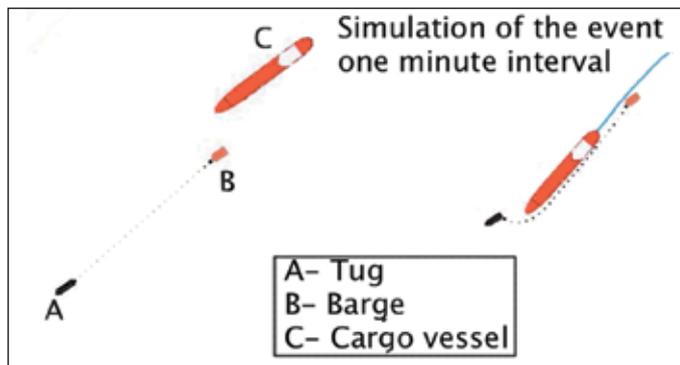
When the cargo ship was almost at the level of the tow, the OOW adjusted the autopilot to port in order to overtake the tug on its port side. Seconds later, the vessel collided with un-manned crane barge; then continued to pass between the crane barge and the tug, catching on the towline on the way through. The OOW on the cargo ship quickly reduced the ahead pitch on the CPP but his vessel continued to overtake the tug. On the tug, the lead of the towline moved from astern to ahead, which pulled the tug through 180° and now saw the tug being towed stern-first by the cargo ship.

The tug's OOW immediately took the main engine out of gear and shouted down to the accommodation to warn the rest of the tug's crew of the situation. Seconds later, the bitter end of the towline broke free from the towing drum; the tug stopped in the water with the un-manned barge off its starboard side. The barge's wheelhouse had been set forward in the collision and crushed. The jib of its crane was buckled, guardrails bent, the tow's hydraulic winch motor seriously damaged and several hydraulic connections ruptured. The cargo vessel suffered a gash in the forecastle.

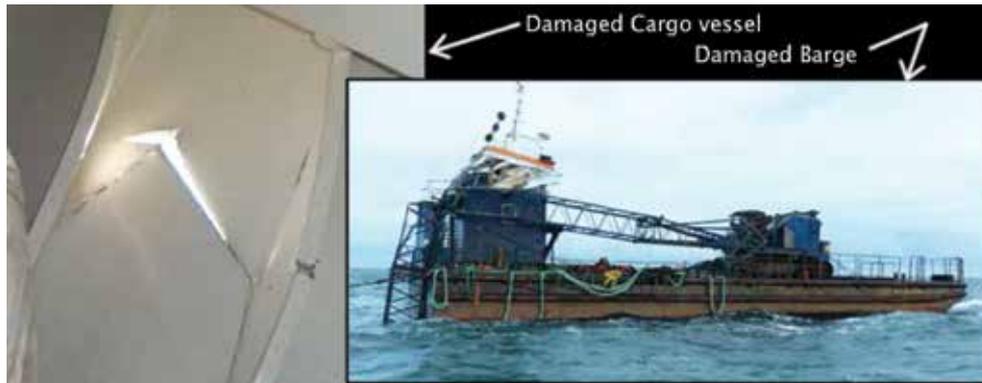
- For nearly 55 minutes before the collision, the radar targets associated with the tug and barge were clearly visible on the X-band radar of the cargo vessel. Additionally, the aft lights on the tow would have been visible from the cargo vessel for at least 20 minutes before the collision. The OOW had ample time to detect, assess and take avoiding action.
- The OOW had not been keeping a proper lookout and had only seen the tug just before he altered to port; he failed to see the un-manned barge at all.
- It is almost certain, as deduced from the sequence of events, that the cargo vessel's OOW was relying solely on AIS information as shown on the ECDIS; but the tug and barge were not transmitting AIS information.

- The radar targets directly ahead and closing should have prompted the OOW to look out of the window and attempt to correlate the targets with visual information. As he took neither of these actions, and the targets were on the radar for almost one hour, it is likely that the OOW was not monitoring this instrument at all.
- The level of arousal of the cargo vessel's OOW was low. Consequently, he was not proactive in maintaining his situational awareness or reactive to changing circumstances. This is supported by his failure to use radar or ARPA and to keep an effective visual lookout.
- It is impossible to determine whether a lookout's presence on the bridge would have assisted the OOW in making a more accurate

For collision avoidance, a balance needs to be struck between over-reliance and effective use of AIS. In this case, the OOW's apparent exclusive use of AIS information displayed on ECDIS indicates that he was not aware that many vessels, such as small fishing vessels, leisure craft, warships and vessels under 300gt, might not be displayed.

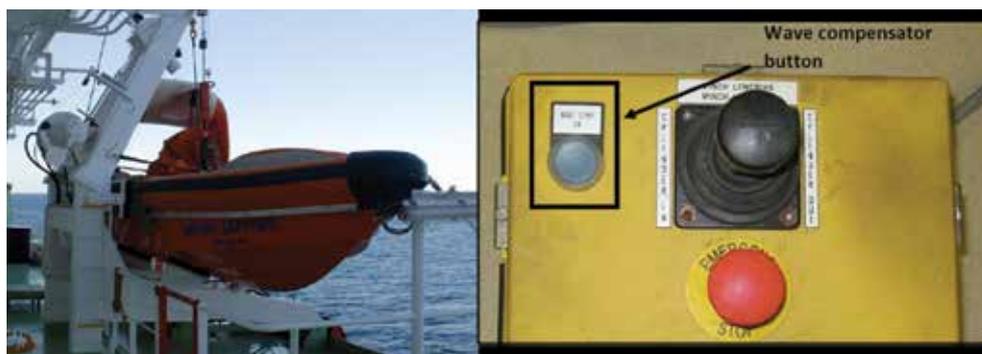
→ The crew of an LNG tanker were in process of lowering the fast rescue boat (FRB). The FRB was nearly 6.5m in length, weighed 2,200 kg and could be launched from a remote control unit (as below) or from inside the boat, using a winch brake release wire.

As one crew was about to release the brake to lower the FRB, another crew reached across and pressed the 'wave compensator' button on the remote control unit. His understanding was it must be activated before the boat reached the water. As soon as this button was pressed the FRB descended at high speed hitting the water about 18 metres below. Several of the FRB crew were seriously injured and had to be evacuated.

The manufacturer's instruction stated that the wave compensation feature should only be activated when the FRB was waterborne. As an additional safety measure, to prevent the wave compensation unit from activating if the wave compensator button was pressed before the FRB was waterborne, the system was fitted with a safety interlock. In this case, the safety interlock did not function correctly.

- The FRB davit wave compensator safety interlock did not operate as designed to prevent the fast rescue boat from free falling to the water. It was found that the safety interlocks on the wave compensator systems on board this vessel and two sister ships had been electrically by-passed thereby preventing them from functioning. As a result, the wave compensators on board all three ships could be engaged regardless of whether the FRB were waterborne or suspended from the fall wire.

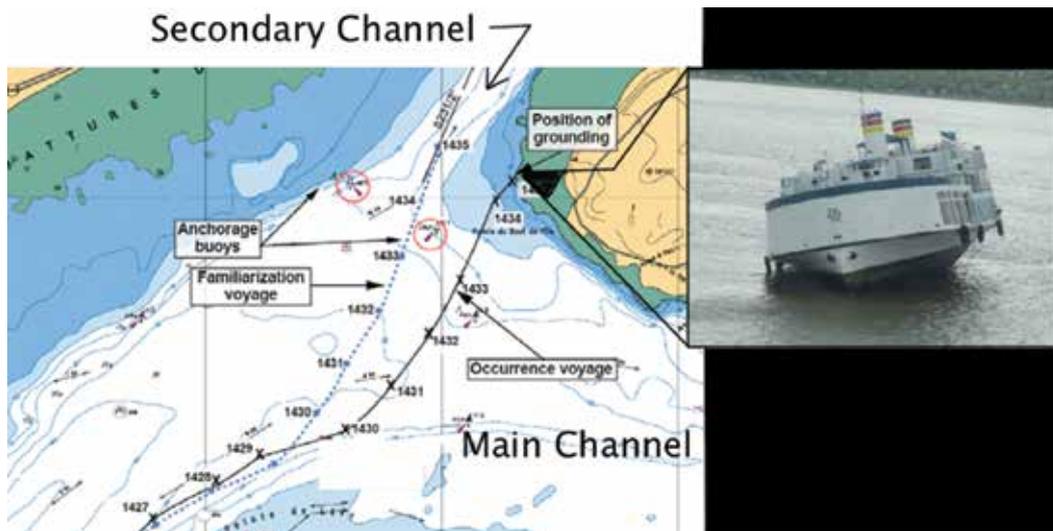
Over the next four to five minutes, as the vessel crossed the channel in a northeasterly direction, the OOV searched in vain for the leading lights, normally between two anchorage buoys, indicating the secondary channel. He was navigating visually, not utilising the bridge navigational equipment or charts. While still looking for the leading

lights, the OOV glanced at the echo sounder and noticed that the water depth was decreasing. The vessel was making approximately 10 knots and a course over ground of approximately 027°. He then glanced at the ECS and alerted the Master, who quickly ordered the rudder hard to port. The OOV put the helm to port but at the same time the vessel struck the river bottom and remained grounded.

- The OOV focused on finding a visual reference and did not utilise the bridge navigational equipment to effectively monitor the vessel's progress as it proceeded off the intended course and went aground. During this time, the Master was not participating in or supervising the navigation of the vessel, and there was no communication between the Master and the OOV. As a result, the deck watch was effectively composed of a single person who was expected to fulfill all of the tasks of navigation, maintaining a lookout and steering.
- The Master did not assess the OOV's understanding of the navigational requirements for the intended voyage following the familiarisation trip on the previous day, and there was no documented plan for the OOV to use for guidance.

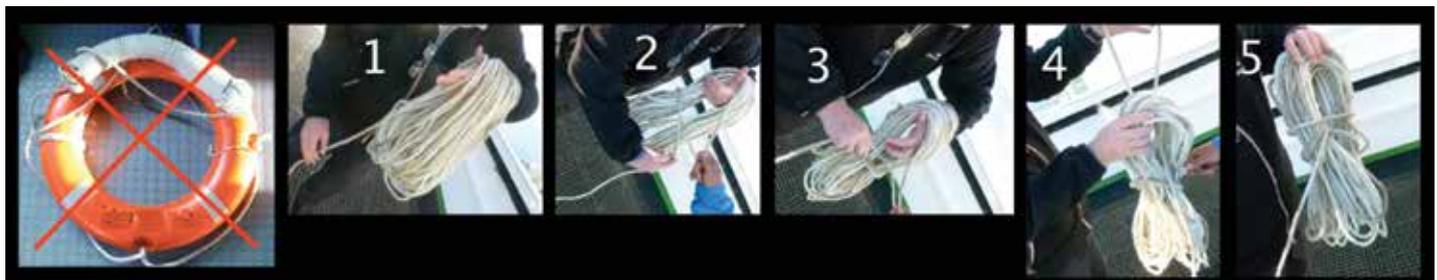
➔ When I was a cadet, one of my friends drowned after he fell from the gangway into the water. Since that time I have taken particular interest in lifebuoys with lifelines. Now, when I visit ships as a marine safety inspector and auditor, I often find the lifebuoy line coiled as a tight 'sausage' (see

below left). When coiled in this manner it takes, on average, two minutes to unravel before the buoy can be thrown into the water.

The proper way to coil a rope for quick and easy use is illustrated in the pictures 1 through 5 below.
