Seaways

The International Journal of The Nautical Institute

Mariners' Alerting and Reporting Scheme

MARS Report No. 274 August 2015

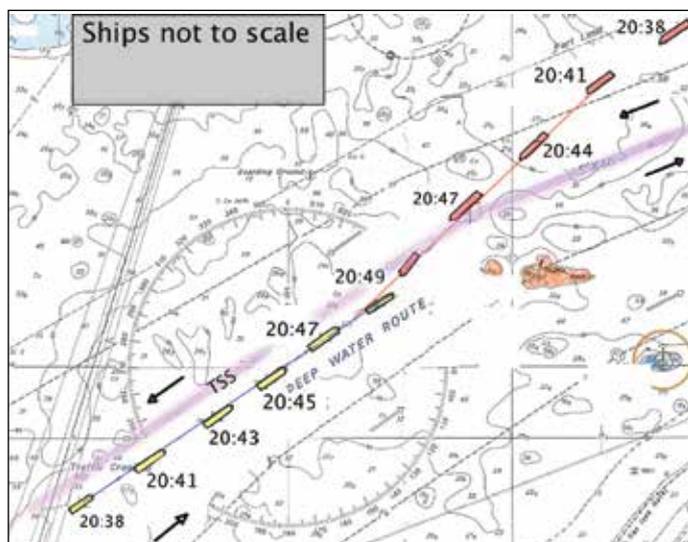
→ A loaded VLCC was making way eastbound in good visibility in the deepwater route of a busy traffic separation scheme (TSS) (VLCC track shown in yellow on illustration below). The vessel entered the TSS at 2035 hours with the Master, OOW and helmsman on bridge and two lookouts forward. A few minutes later, a westbound capesize bulker was noticed on the VLCC's radar entering the eastbound lane (bulker's track shown in red below).

At 2048, when the vessels were about six cables apart, the bulker made a sudden bold alteration to port, bringing it in direct conflict with the VLCC. The bridge team on the VLCC altered to starboard to bring their vessel parallel to the bulker and reduce the impact. One minute later the bow of the VLCC made contact with bulker's starboard side in way of the forward cargo holds.

- It would appear that poor judgment and less than adequate communications, as well as an almost total lack of situational awareness on the part of the bulker's OOW led to this collision.
- Neither vessel used engines to reduce speed.

- In less than 10 minutes, the situation went from commonplace to critical. This is a good example of why active and attentive navigation is always necessary, especially in a busy TSS.
- Using all available means to attract the attention of the other vessel's bridge team (sound and light signal) to give warning of the situation may have helped.
- When confronted with an imminent collision, lookouts on the bow should clear the area.

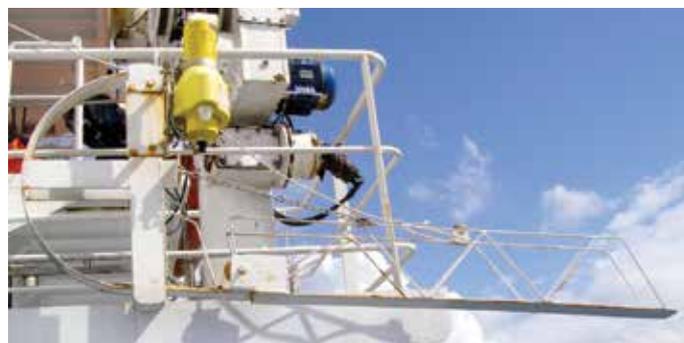
→ An officer was undertaking his inspections of the various life saving appliances on a relatively new (two years) small coastal vessel. His inspection revealed that the starboard man overboard life-ring launcher, located aft and below the bridge due to design considerations, was inadequate from a design standpoint. When activated from the bridge wing, the launching flap deployed to 90 degrees, the retaining chain being too short to allow a greater angle. This meant the life-ring would remain in its holder instead of falling into the water.

- Even after two years, this deficiency remained 'hidden in plain view'. Flag inspectors, class surveyors, port state controls and even internal inspections had failed to catch this deficiency over the two year period.
- Life saving appliances are a crew's last chance at survival if disaster strikes. It is in the crew's own best interests to ensure their proper functionality.

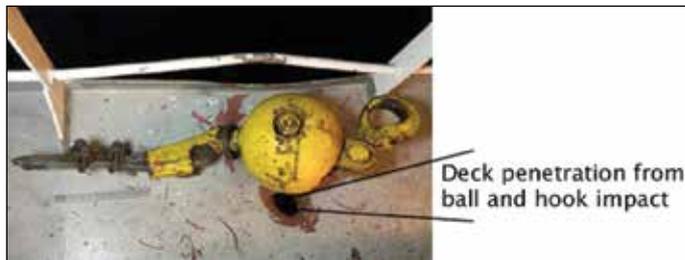
single whip line ball and hook assembly detached from the crane and landed on top of the safe haven of the vessel.

Fortunately the deck crew were standing clear, approximately four metres from the point of impact, and suffered no physical injuries. The assembly weighed 160kg and fell approximately 50 metres giving an impact force of 784KN. This would most certainly have resulted in one or more fatalities had it struck the crew members.

- Be aware and warn all crew of the potential for dropped objects during cargo operations.
- Stand clear of the load route; loads should never be lifted over people.
- Maintain visual contact with the load at all times.
- Check every load to ensure nothing is loose or damaged before dispatch.
- Make sure that all loads are properly secured.
- Stand clear from moving crane boom and/or block even with no load.
- Do not approach the crane slings/hook until the crane is fully stopped and ensure all is safe and secure prior to approaching.

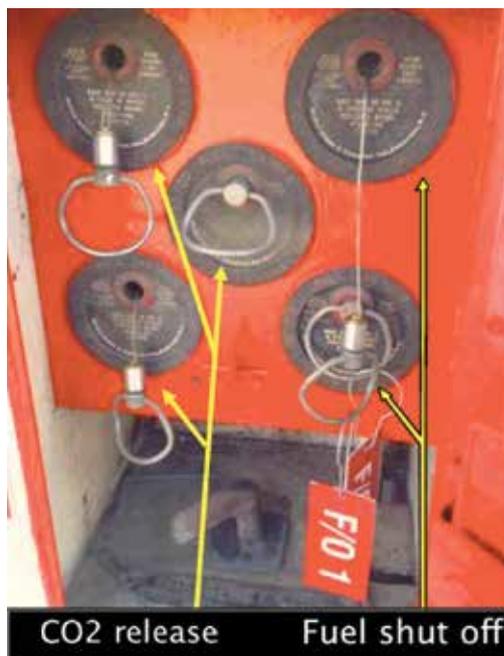
➔ On a towboat, a vessel crew member intended to test the emergency fuel oil shut-off cables. He opened the panel door that contained both the emergency fuel oil shut-off and the CO₂ release handles. He

activated what he thought was the fuel oil shut-off but instead the CO₂ was released. Fortunately, the audible alarm system and release time delay functioned as intended, allowing personnel to safely evacuate the machinery spaces prior to the CO₂ discharge.

- Emergency systems should be designed with human factors in mind; they must be logically understood and easily operated during high stress situations.
- System training should provide the familiarity needed during an emergency or other situations.
- Pre-test coordination and review of procedures will minimise accidental and potentially fatal discharges.

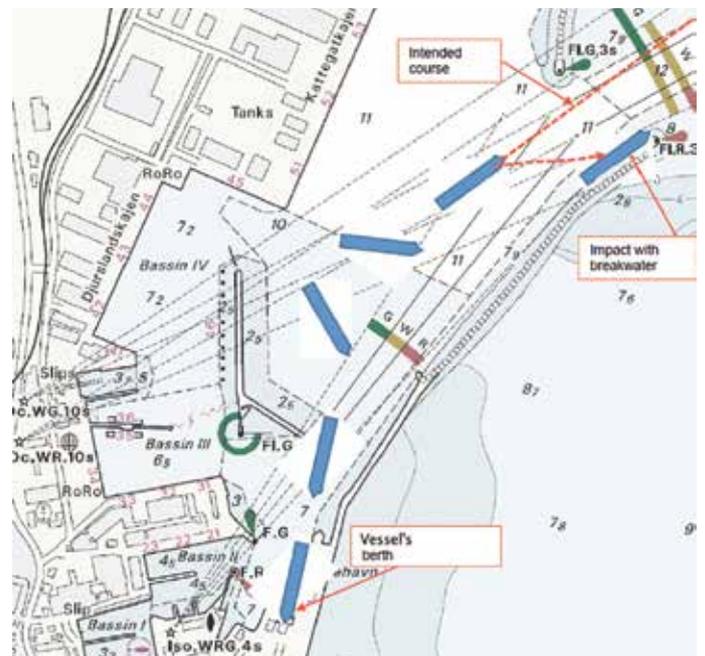
The officer pressed the helm TAKE OVER button and confirmed; the helmsman then confirmed he had hand steering. Immediately thereafter the helmsman expressed doubt as to whether he had hand steering. The Master noticed the vessel was still turning to starboard and ordered port rudder. The helmsman confirmed his wheel had no effect and the officer tried pressing the TAKE OVER button once again, but to no apparent effect. The helm Non Follow Up button was then pushed but did not seem to affect steering, so the Master returned to the port bridge wing to try and regain control. This seemed to work and the Master also deployed a bow thruster to stop the starboard turn, but it was too late; the vessel made several heavy contacts with the breakwater. The vessel was returned to berth for safety reasons as several compartments were flooding.

The investigation found it highly likely that the centre console helm had been turned to the hard starboard position before the transfer but, because of the darkness and the bad ergonomic design of the helm, neither the helmsman nor the officer had realised this. The helmsman assumed the helm was amidship when control was passed to him. When he put port helm on he simply decreased the starboard helm, which was not enough to counter the starboard swing.

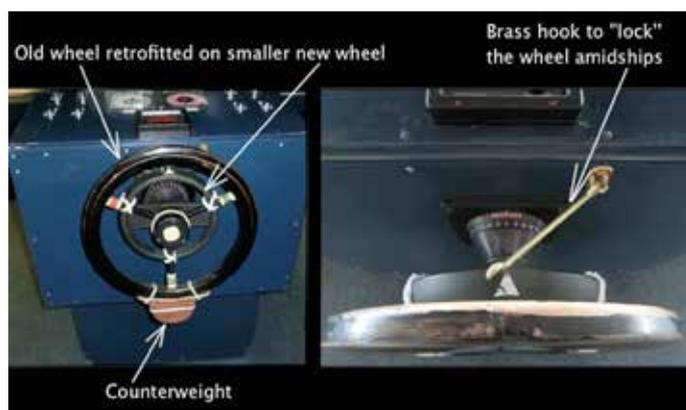
■ **Editor's note:** It never ceases to amaze how bad ergonomic design seems to be endemic in the maritime industry, as shown by the small wheel and inadequate helm position indication in this case. Additionally, the solutions brought to bear after the accident, although well meaning and probably effective, are a wellspring of improvisation and ironic adaptations. Would the airline industry allow such bad design or for that matter, such 'handyman' fixes?

After the accident, the 'old wheel', previously replaced by the new, smaller unit, was retrofitted around the new wheel and a counterweight was added to make the wheel naturally come to midship if no force is applied. Also, a hook was installed to lock the wheel in the amidship position when not in use.

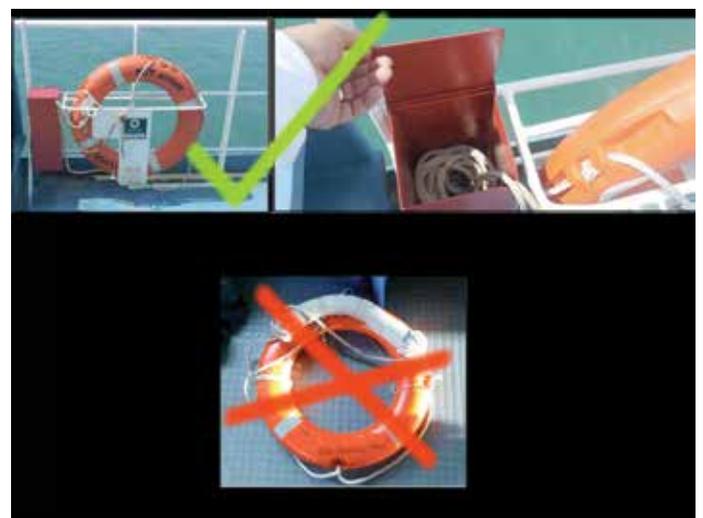
→ In MARS 201523, the importance of properly coiling the line attached to the man overboard lifebuoy was highlighted. On certain ships it has been observed that the rope is tightly coiled and wrapped around itself which makes for a slow rescue. A reader has sent the following photo that gives one way to store the rope for quick deployment.
