# Seaways

# Mariners' Alerting and Reporting Scheme

MARS Report No. 281 March 2016

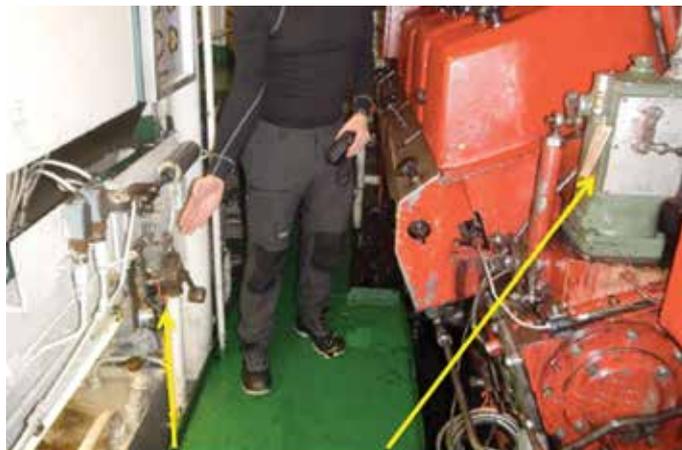
Shut off valve

Speed governor

and went aground due to a reduction in speed. This was caused by the unintentional operation of a shut-off valve that acted on the main engine speed-governor.

- The placement and protection of critical valves and buttons should be carefully considered so as to avoid accidental activation or de-activation.

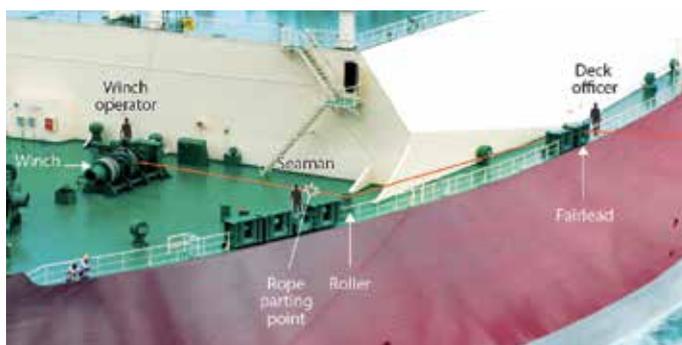
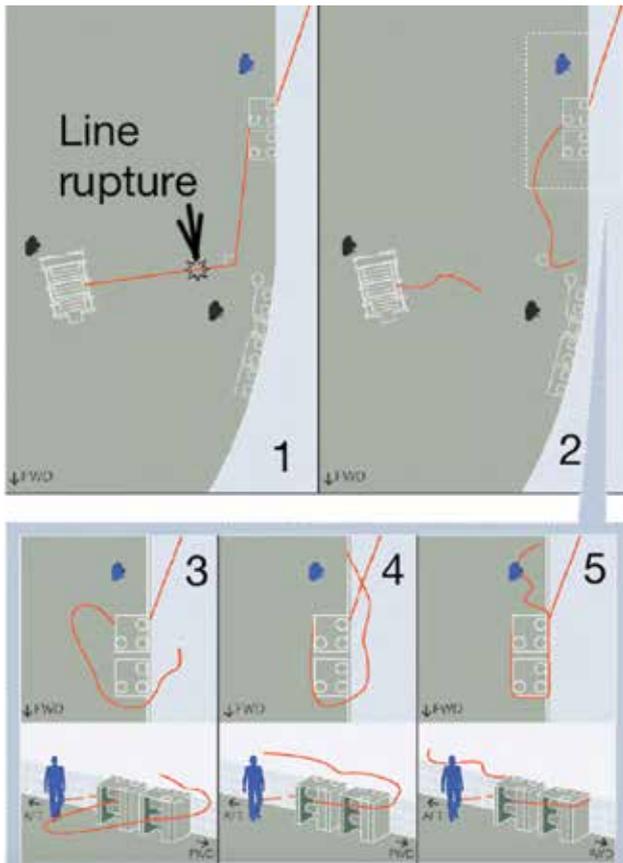
While under tension, the mooring line parted inboard from a pedestal fairlead. The section of the line between the break and the port shoulder roller fairlead struck the deck officer on the head as it whipped back before going overboard through the fairlead. The deck officer was

found lying unconscious forward of the roller fairlead. He had sustained multiple skull fractures.

The mooring line that failed was a 44-millimetre-diameter sheathed ultra-high-modulus polyethylene line. The line was fitted with a 22-metre-long polyester/polyethylene tail. The section of line in use between the winch and the connection with the tail was approximately 68 metres long.

- Snap-back zones can be complex and sometimes counter-intuitive. In this case, computer modelling was used after the accident to assess the dynamic trajectory of the entire length of the rope from its point of failure. The modelling indicated that it was highly probable that the rope would go aft of the roller fairlead and wrap around it before finally going outboard.

- Synthetic tails provide additional elasticity in the mooring system and serve to reduce peak dynamic loads. As a result of the tail's elasticity, the elongation of the total mooring line under tension is increased; this introduces considerable stored energy that will be released if the mooring line fails. The snap-back characteristics of this type of mooring line (ultra-high-modulus polyethylene), initially considered to be relatively benign, will be heavily influenced by the addition of the synthetic tail.

- The length of tail fitted to the mooring line will influence the amount of stored energy in the system. The longer the tail, the greater the elasticity and stored energy, and the greater the likelihood of recoil and snap-back should the mooring line fail.

- Depending on where the line breaks, there can be snap-back zones in multiple locations. Actual mooring arrangements on board require specific analysis to determine the most likely snap-back zones.

- The best protection during mooring operations is not to have line ruptures. Careful inspection, use and well-considered modifications, such as adding synthetic tails, are the best guarantee of safe operation.

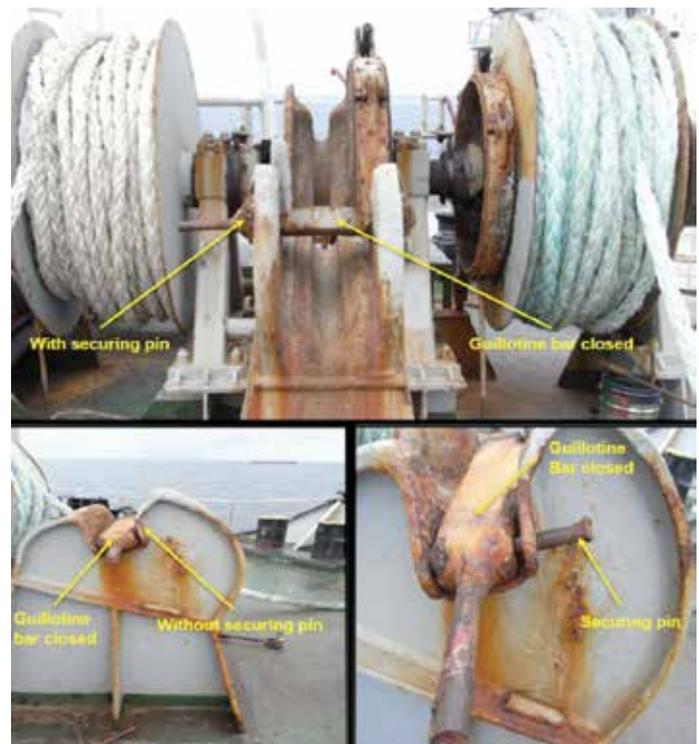
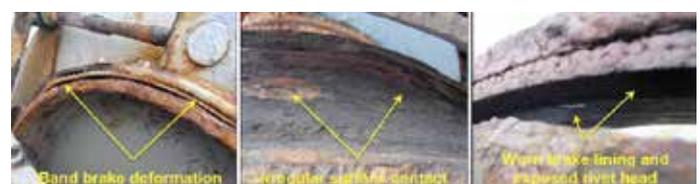
- In adverse weather conditions, the securing pin from ship A's port anchor chain cable stopper bar worked free. As a result, the guillotine bar opened and the cable's load came on to the windlass brake, which did not hold. The anchor cable ran out to its bitter end and the entire cable was lost into the sea.

- The poor condition of ship A's anchoring equipment was indicative of inadequate maintenance. The shipboard management team was not aware of the equipment's maintenance history, nor was it able to provide relevant documents from the ship's planned maintenance system.
- As the sole watchkeeper, ship A's OOW remained on the navigation bridge during the anchor watch. As such, routine rounds of the forecandle deck were not undertaken and no one detected that the cable stopper's securing pin was working free.
- Ship A's main engine was not in an appropriate state of readiness for the adverse weather conditions forecast and the warnings issued.

- The windlass is an essential piece of equipment that should be kept in top notch condition.
- At anchor, rounds to the forecandle deck to check the condition of the anchor and associated gear should be considered best practice.
- While at anchor in adverse weather conditions, the main engine should be on standby.

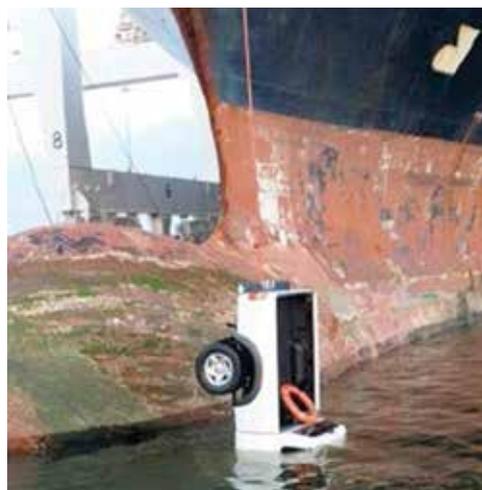
handler in the truck narrowly escaped dire consequences by quickly jumping out before it was dragged off the berth.

Line handlers often use the assistance of powered machinery such as trucks, forklifts and golf carts to help handle mooring lines. The extreme weights of the mooring lines involved and the lack of adequate personnel to accomplish this task safely lead to the unconventional line handling practices.

➔ A vessel was preparing to depart the port. The forward mooring line messenger was secured to the tow hitch of a pick-up truck to assist in the task. When the line was thrown off the bollard, the ship began to haul it in with the messenger still attached to the truck. The pick-up truck was subsequently dragged into the harbour. The shore-side line

- Ship's crew should use caution and remain vigilant when hauling in, ensuring that lines and cables are clear and free of attachments. Special attention should be given to the mooring lines as they are coming off the dock and being hauled aboard.
