Seaways

The International Journal of The Nautical Institute

Mariners' Alerting and Reporting Scheme

MARS Report No. 287 September 2016

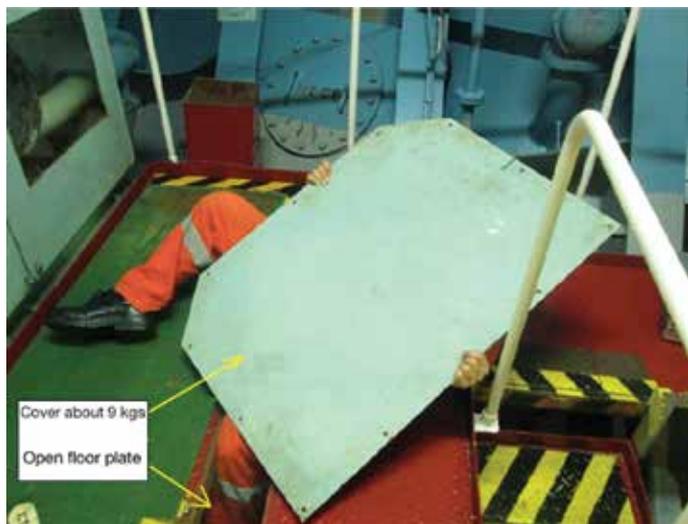
MARS 201645

The crew members working on the overhaul task were preoccupied with their tasks and did not realise the floor plate had been left open. The oiler, with both hands on a cover plate that he had just removed, stepped back into the open floor plate. He lost his balance and fell to the deck. He sustained a deep laceration between his left thumb and forefinger due to the fall, exacerbated by the fact that he was not wearing gloves at the time.

- Although a toolbox meeting was held that morning and the jobs to be carried out were discussed, it was not identified that the two tasks were being conducted in close proximity and whether this required precautions to be taken.
- The victim was wearing gloves at the start of work. However, he took them off in order to remove the bolts of the cover plate.
- There was no supervision; each member of the team was engaged in a task such that no one person had an overview of the area.

- When working, be aware of your environment and the environment of others. If you 'create' a hazard, ensure barriers or risk mitigation measures are appropriate and have been implemented.
- If you remove PPE such as gloves to undertake a specific part of your task, be sure to put them back on at the earliest opportunity.

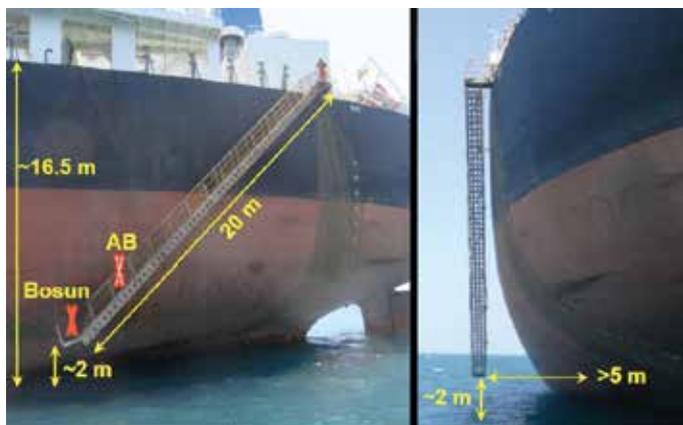
MARS 201646

While rigging the ladder the bosun noticed large numbers of fish around the bottom of the ladder. Once the work rigging the ladder was completed, the ladder was left in the lowered position and the crew stopped for lunch. After eating but still on his lunch break the bosun returned to the accommodation ladder to do some fishing. One of the ABs arrived soon after and saw the bosun on the lower platform. He was getting some fishing gear ready and had the sleeves of his overalls tied around his waist, was without a lifevest and was wearing slip-on shoes. A little later, the AB who was also now on the accommodation ladder, felt it move. He saw the bosun lose his balance and fall off the platform into the water.

The AB threw a nearby lifebuoy towards the bosun, but it fell about 20m short of the victim, who had been carried aft by the current. Nevertheless, he attempted to swim towards the lifebuoy. The AB raised the alarm and other crew members threw two more lifebuoys towards the bosun, who was now about 50m from the vessel's stern. There was a strong current and moderate sea and swell conditions.

- Time spent over the side, whether working or for leisure, should always include a lifejacket and fall protection.
- Certain activities undertaken during leisure time present the same or similar risks as when working. The use of the same risk reduction

measures such as the use of PPE and supervision should be applied.

- Work over the side, such as rigging of the accommodation ladder, is also work at height. This connection is reinforced in numerous marine publications and guidelines, including codes of safe working practice such as the UK MCA Code of Safe Working Practices for Merchant Seamen (2015).

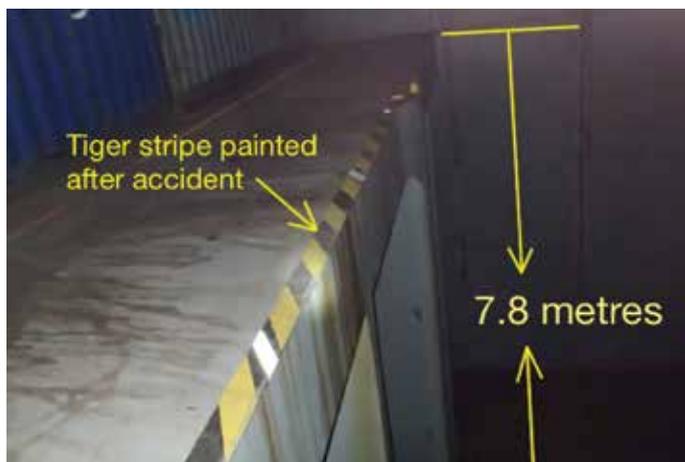
MARS 201648

➔ On a large container ship several cargo hold floodlights needed replacing in hold number nine. The electrician descended on to a raised casing in the hold in order to gain access to one of the lights. The casing

is 7.8 metres (three container layers high) above the bottom of the hold and without fall protection such as railings. Two deck crew were also present but were occupied with other tasks.

As the deck crew went about their business they lost sight of the electrician. Soon afterwards they saw him at the bottom of the hold lying prone on the tank top, where he had fallen. Resuscitation was attempted on site, but the victim was later declared dead.

- If there is a potential for a fall from height always wear fall protection.
- All potential hazards should be examined on a ship and risk reduction measures put into place.

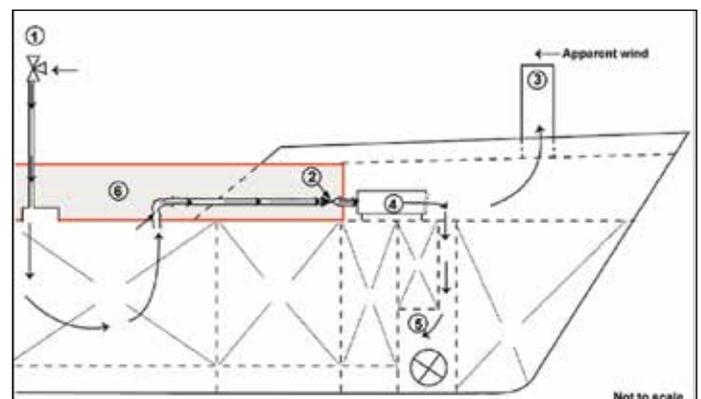
1. PV valve, 2. Non-return valve, 3. Forecabin door,
4. Air-drying unit, 5. Bow-thruster compartment, 6. Trunk

The 1st officer informed the bridge of the forecastle atmosphere and instructed the next watch to stay clear. The forecastle was naturally ventilated for the next hour and 40 minutes. Later, the 1st officer returned to the forecastle and verified the atmosphere with a gas indicator. The reading was at 0 LEL. He then proceeded to the trunk space to verify the valve settings on other tanks. Shortly thereafter, an explosion occurred in the bow thruster compartment that was just below the forecastle. Only minor damage was sustained.

- The inappropriate practice of using the tank-drying equipment for cargo tank ventilation allowed the migration of explosive vapours into the bow thruster compartment.
- It is likely that an electric heater in the bow thruster compartment provided the ignition source for the explosion.
- Without formal procedures and training to mitigate the risks associated with tanker operations, the effectiveness of the vessel's safety management system was reduced.
- Vessels that do not inert cargo tanks or follow accepted procedures for purging and tank venting are at increased risk of fire and explosion, particularly during critical ventilation operations.

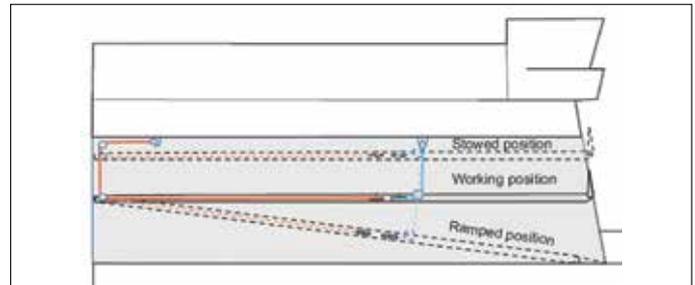
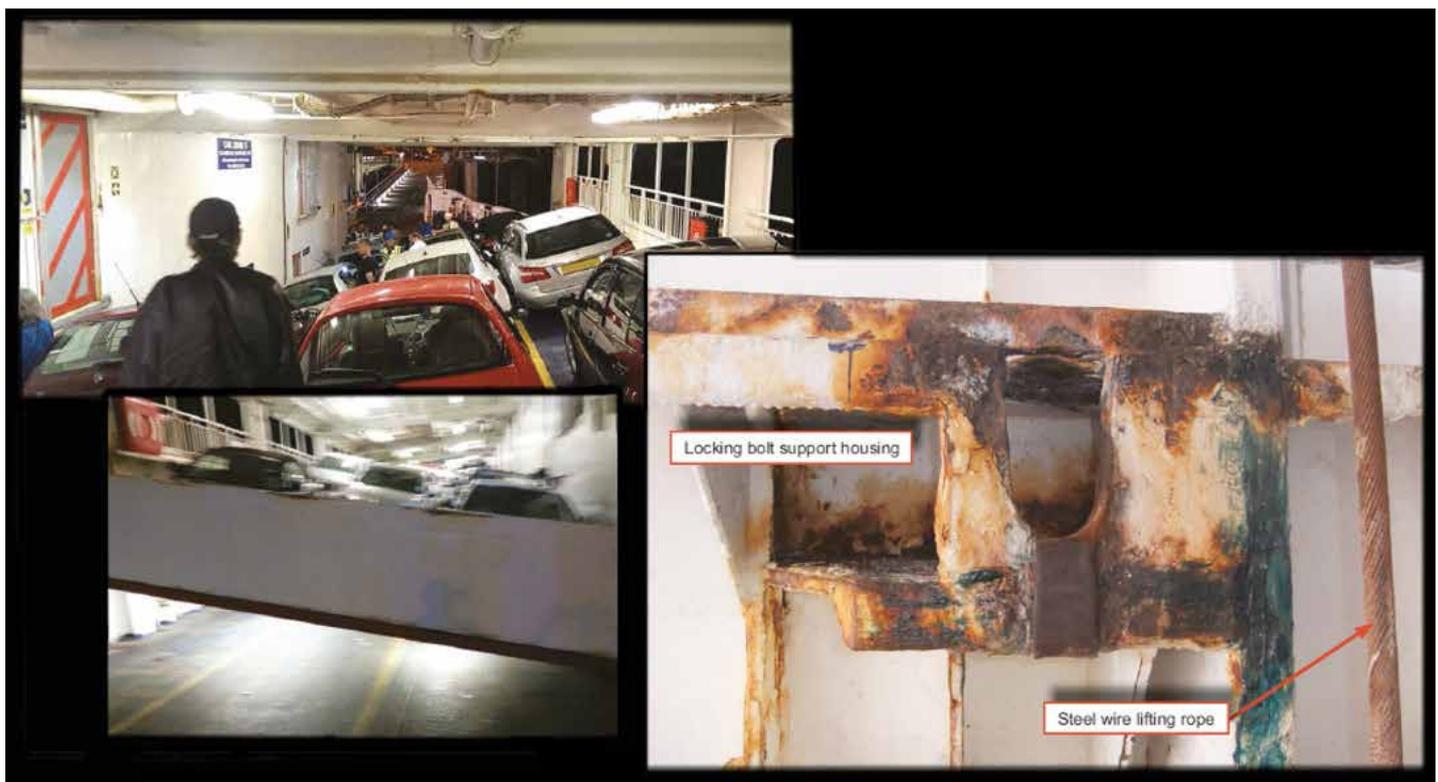
MARS 201650

The second mate checked that the starboard main deck was clear and then he began to lower the starboard forward mezzanine deck to its ramped position. As the forward end of the mezzanine deck descended, a loud bang was heard and the deck's forward inboard corner fell about

2 metres to the main deck below. The forward edge of the mezzanine deck came to rest at an angle of approximately 30° to the horizontal, with its outboard corner remaining in its suspended position.

- The ferry's starboard forward mezzanine deck collapsed because one of its steel wire lifting ropes parted under normal working conditions.
- The rope failed due to excessive internal and external mechanical wear.

- The ferry's mezzanine decks had not been maintained in accordance with the equipment manufacturer's instructions, allowing a dangerously unsafe condition to develop.

- The material condition of the collapsed deck's wire rope sheaves increased the stresses acting on the lifting wires and contributed to the rope failure.

- The ferry operator's deck greasing routines had fallen into abeyance and the steel wire lifting ropes had not been routinely dressed and lubricated for many years.

- The ferry operator's maintenance management system had weaknesses in key areas. In particular, maintenance roles and responsibilities were confused, record-keeping was inconsistent and time was not allocated for the conduct of some essential maintenance.
