Seaways

The International Journal of The Nautical Institute

Mariners' Alerting and Reporting Scheme

MARS Report No. 288 October 2016

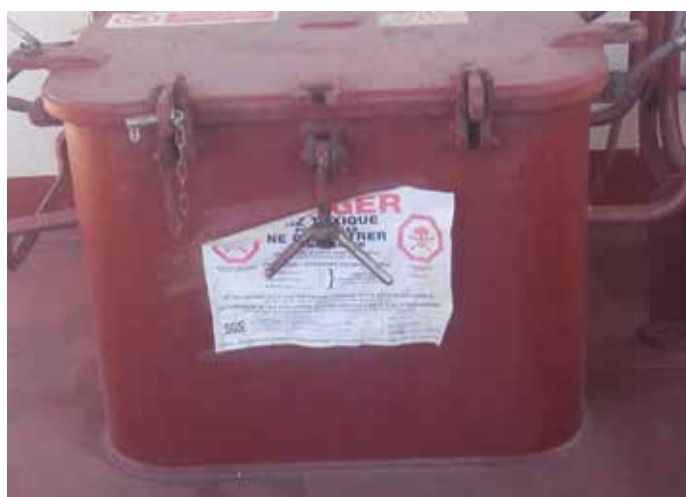
Fumigation fracas

→ A cargo of maize was loaded and fumigation initiated at the loading port. The fumigation was to continue in transit and warning signage was posted on the hold access hatches. The vessel then departed on a trans-oceanic voyage. Once at the arrival port the warning signs had become substantially detached from the coamings. According to the port reception officials, fumigation signage is often totally lacking.

Port reception officials at this port also informed MARS that although the Master should inform the Harbour Master or port safety authority in advance when they are carrying cargo with in-transit fumigation, this is unfortunately not always the case.

- Always ensure arrival port officials know in advance about in-transit fumigation.
- For the safety of crew, stevedores and port officials always ensure access to fumigated holds is restricted and fumigation signage is well displayed.

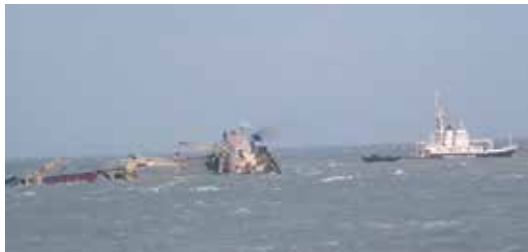
reason. The Master did not follow this instruction. About 25 minutes later the vessel hit an underwater object on her port bow. It was later determined that they had hit a known wreck, a vessel that had sunk two months earlier.

The emergency alarm was sounded and the Master ordered to abandon ship about five minutes later as the vessel began listing to port. Although all crew were eventually rescued by nearby SAR resources, things did not go smoothly during the abandon ship:

- The starboard-side lifeboat was launched and automatically released from the falls before crew could board. The boat drifted away crew-less. Nine of the crew then switched to the port-side lifeboat, successfully launching and boarding the craft.
- The two inflatable liferafts were also launched, but the nine remaining crew members could not embark due to failure of the embarkation ladder. They were later rescued by a ship in the vicinity.

Vessel listing during salvage attempt

The official investigation into the accident revealed the following contributory factors:

- The Master of the vessel did not ensure that all the latest navigational information and warnings had been considered in the voyage planning before sailing;
- The exchange of maritime safety information by means of VHF between ship and shore was not effectively carried out; the navigation officers of the vessel did not endeavour to clarify and heed the warning messages from shore;
- The bridge team members failed to communicate the navigation warnings and instructions received from shore to fellow members; and
- The navigation officers of the vessel did not maintain a proper look-out as they did not spot the wreck – which was marked by a red light and had a ship mast protruding 7m above the sea surface.

- Before leaving port ensure your charts are up to date for the required voyage.
- When passing the con to a relieving officer, even to the Master, inform them of all important issues concerning the navigation of the vessel.
- When undertaking your monthly abandon ship drills take them seriously, as one day you may need those same skills to save your life.

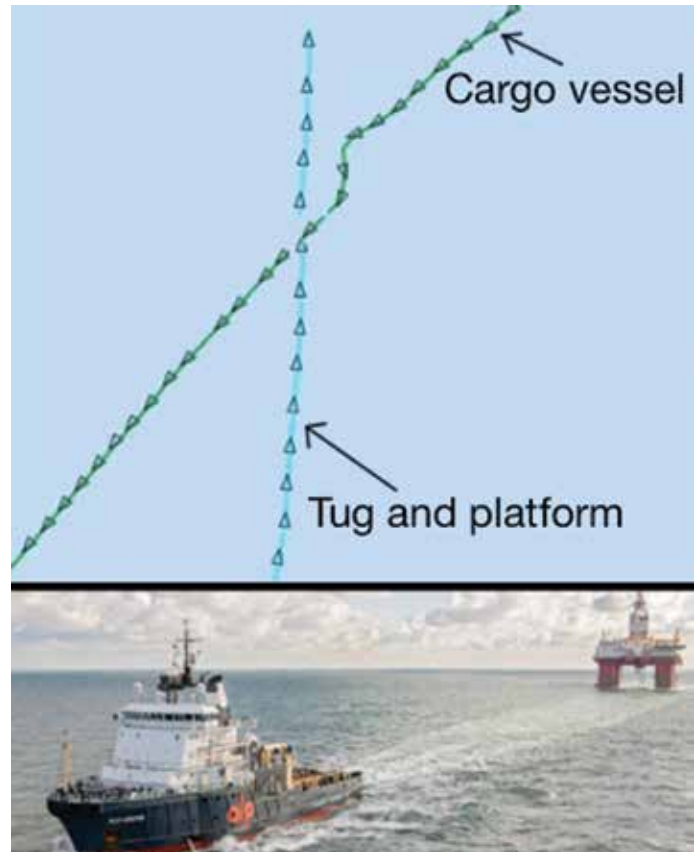
➔ A tug was towing an oil production platform on a line about 1,000m long in good visibility and sea conditions. A close quarters situation was developing with a cargo vessel to starboard. Given the tow, the tug was unable to manoeuvre. The OOW of the tug contacted the cargo vessel and requested the cargo vessel alter course to port to go around the stern of the rig. The OOW of the cargo vessel, who was the Master, signalled his agreement and began altering course to port, but very slowly.

A few minutes later, the tug OOW again contacted the Master of the cargo vessel and insisted they alter to port more quickly as the CPA between the rig and the cargo vessel was zero. After further communication the Master of the cargo vessel then realised he was about to pass between the tug and the towed platform, so he made a hard alteration to port and passed the platform's stern by about 260 metres.

An investigation by the cargo vessel's company was initiated because the tug company contacted the cargo vessel company about the close call. From the data on the voyage data recorder (VDR), it was found that the Master of the cargo vessel was navigating visually and had no indication of CPA whatsoever, as both radars were set on standby during the near miss situation. According to the VDR recording, the Master initially steered the cargo vessel towards the stern of the tug, probably unaware of the fact that a tow line lay between the tug and the oil platform.

It was later discovered that the vessel's three senior officers, Master, chief mate and chief engineer, had serious alcohol consumption problems. Junior crew were aware of these facts but they were afraid to report the senior officers to the company management. Given the sequence of events it is highly likely that the Master, acting as OOW, was under the influence of alcohol at the time.

- Irrespective of your rank, always take measures to inform management of alcohol abuse on your vessel – your life may depend on it.
- The company's safety management system should allow for a procedure to report any deficiency to company management, including drug and alcohol abuse by the crew and Master.

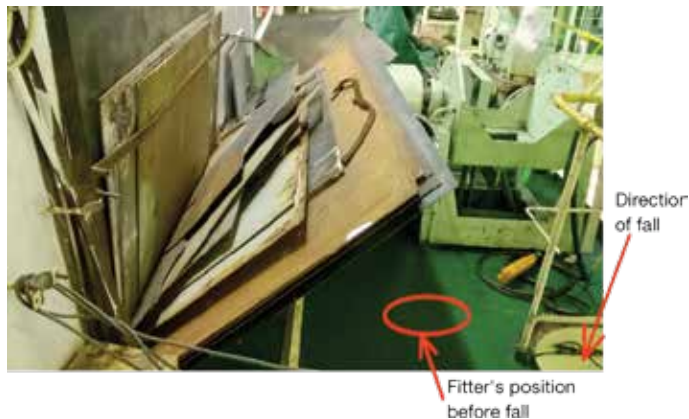
The fitter began the job by unscrewing the securing bolts of the angle bar at one end of the plates, then moved to the other end. The moment he removed the last screw of the securing angle bar, the steel plates shifted towards him. The fitter jumped back in a reflex reaction and hit the lower railing bar behind him. His impact on the railing caused it to bend and fail. As a consequence, the fitter fell to the engine room lower platform about 10m below. Although the victim was quickly transported to a local hospital he nonetheless succumbed to his injuries and was pronounced dead.

The railing that failed was the removable type which, when removed, allowed movement of larger parts lifted by the ER crane.

The company investigation found that although a toolbox meeting was supposedly held before the job being performed, the risk of shifting steel plates was not specifically mentioned during the meeting.

- Avoid the checkbox mentality when conducting a tool box meeting; simply telling everyone to do the job safely is not enough. These meetings are meant to discuss the inherent risks involved for the job under review and help crew mitigate those risks.
- Steel plate storage should incorporate protections against having the plates tip over, domino style.

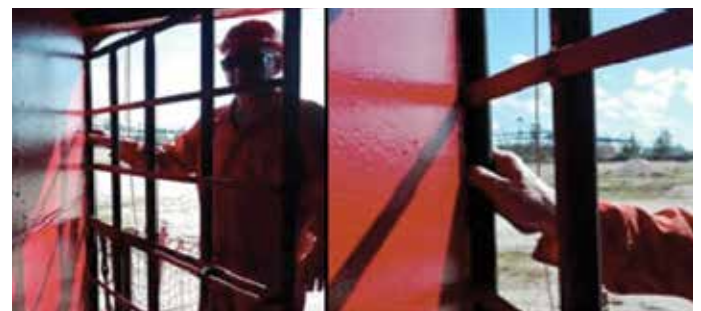
→ An additional security gate was being installed at the top of the gangway in way of the pilot boarding access. One crew member was holding the gate in position while a second crew member located the securing bolts for the new gate. The second crew member was unable to see the first, as the pilot door in the ship's side was blocking his field of view. To access one of the securing bolts, the second crew member closed the pilot door without warning, trapping the first crew member's finger between the gate and the pilot door.

As a consequence the victim lost the top of his right thumb above the first knuckle line. He was immediately taken to the ship's hospital and the Master informed.

- The work was viewed as an everyday task, with the consequence that the risk assessment was inadequate and vigilance was lowered. **Never assume any job is risk-free.**
- Lack of communication between the two crew involved in the task contributed to the accident. A good practice when working as a team is to verbalise your intentions before acting on them.
