Seaways

The International Journal of The Nautical Institute

Mariners' Alerting and Reporting Scheme

MARS Report No. 290 December 2016

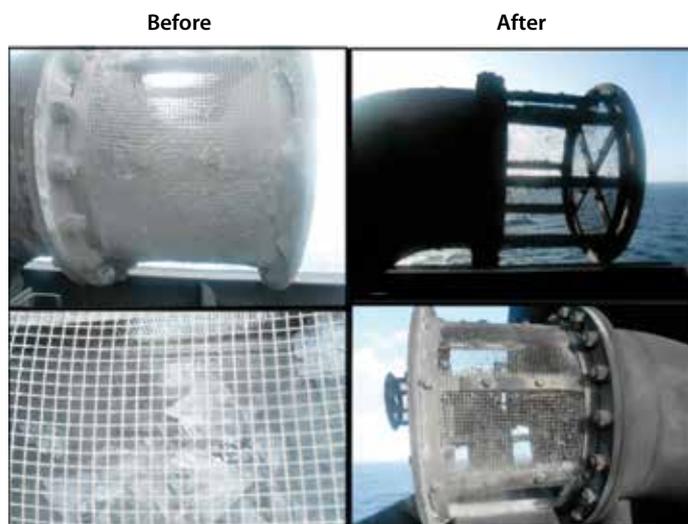
Among other things, the incinerator funnel flame screen was found to be completely clogged with unburnt paper and soot, which prevented proper exhaust flow (see photos below: before and after cleaning).

Feeding garbage into the incinerator when the primary chamber temperature is below 600°C can result in unburnt light materials blocking the flame screen at the funnel.

- Deviations from procedures can cause accidents. In this case, each deviation led further down the casualty path;
- Feeding material into the incinerator when the primary burner temperature is lower than 600°C can cause unburnt garbage to collect at the incinerator funnel flame screen.
- The funnel flame screen was allowed to become clogged, setting in motion the subsequent sequence of events.

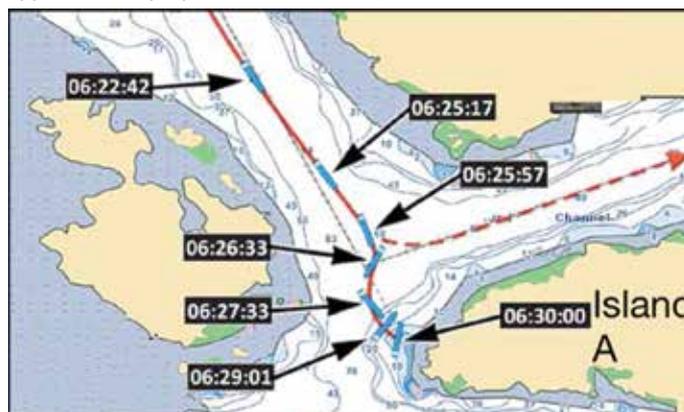
The OOW, who had the con for the first time in this area, requested that the Master take over before the large alteration to port at Island A (see below), approximately 0.7nm before the next course change waypoint. The Master took over the con and the OOW went to the chart table and began preparing the next chart. The helmsman was manually steering a course of about 140°G and the vessel was now proceeding at 16.7 knots. The Master was monitoring the vessel's progress on the starboard radar; he had set up a parallel index to determine when to commence the port turn. A parallel index line was also set up on a course of 071°T to maintain a distance of 0.22nm off the northernmost point of Island A.

At the planned wheel-over position, the Master ordered the helmsman to apply 10° port rudder to initiate the turn. The helmsman acknowledged the order by repeating it, but instead put the helm 10° to starboard. Within seconds, the Master ordered the helmsman to apply 15°. The helmsman looked at the rudder angle indicator and repeated the order, but put the helm to 15° to starboard. Then, the helmsman asked for clarification about the direction of the order. The Master ordered the helm be applied faster without indicating the direction. The helmsman then stated that the helm was at starboard 15°. The Master ordered the helm hard to port. The helmsman acknowledged by repeating the order and applying maximum port helm (35°). The vessel's speed was now about 15 knots.

contact west of Island A on a heading of 012°G. The engines and the bow thrusters were used to manoeuvre the vessel back into the channel, and the vessel continued its voyage while the crew sounded the tanks and checked for damage. A crack approximately 0.6m long was found in No. 3 port water ballast tank that was allowing water ingress.

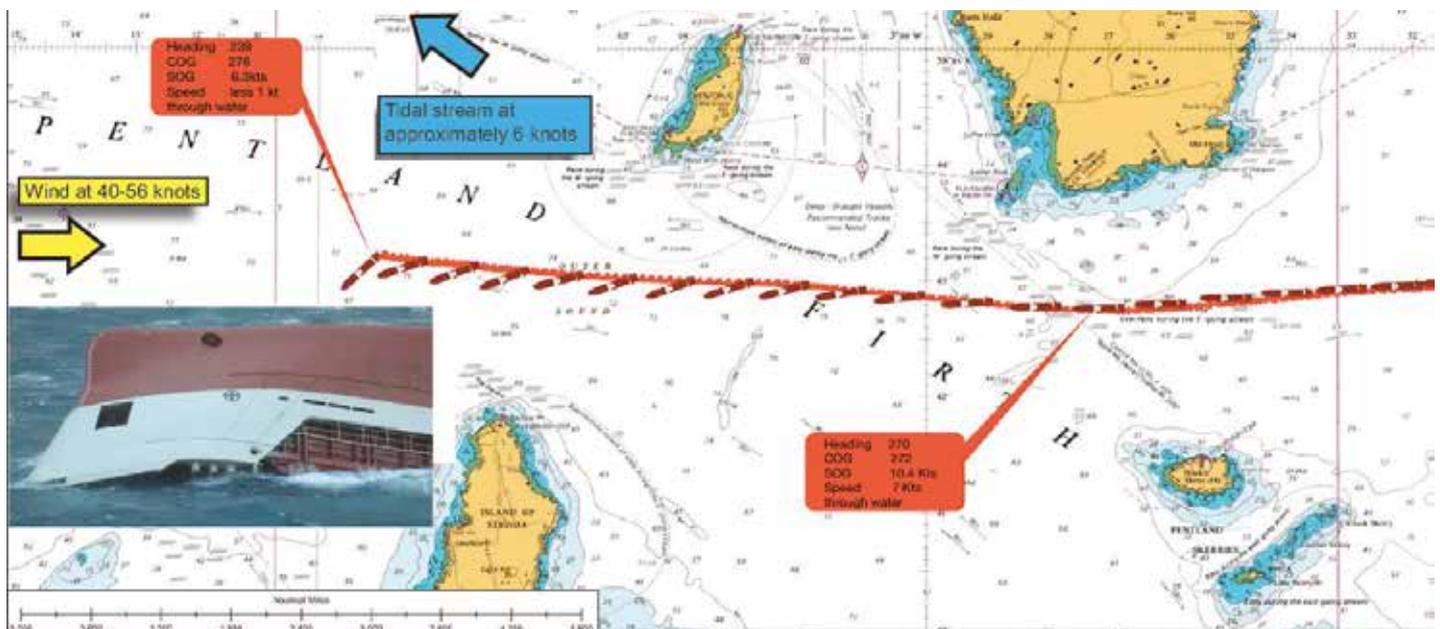
As the vessel entered Pentland Firth (figure below), it was on a heading of 270° (COG of 272°) and SOG of 10.6kt. Once inside the Pentland Firth, the vessel was sighted by the crew of a nearby ferry. The cement carrier appeared to be upright and making slow headway, pitching heavily into the large waves. Later that afternoon the vessel's AIS transmissions ceased. The data from the last received transmission showed a heading of 239°, a COG of 276° and SOG of 6.3kt. Such a SOG, however, would have meant a speed through the water of less than one knot, rendering the vessel unmanageable and at the mercy of the ferocious oncoming waves.

- The extraordinarily violent sea conditions were created by gale force winds opposing a strong ebb tidal stream. Such conditions were predictable and passage through the Pentland Firth should not have been attempted.

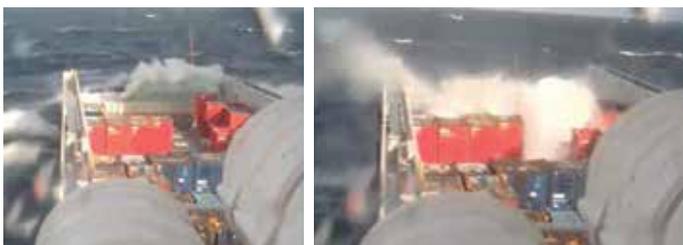
→ A platform supply vessel was carrying out deck cargo and fuel operations alongside an offshore platform. Winds were 25 knots and the swell 3m. With the starboard stern quarter of the vessel against the weather/sea, suddenly the stern was hit by one larger wave and water flooded the stern deck. Two unsecured small containers were shifted/capsized by the force of the water on deck.

- The risk of abnormal waves must be taken into consideration in the risk assessment and toolbox talk for work with the stern positioned against the weather.
- For this vessel and those of similar build trading in a harsh environment a higher aft bulwark should be fitted.

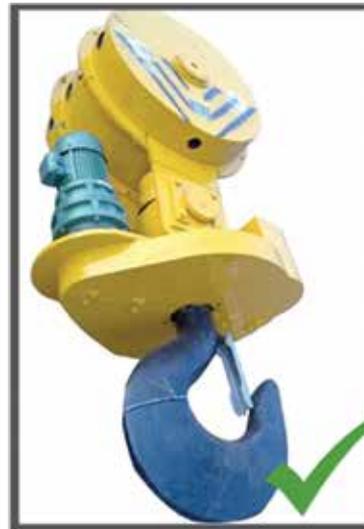
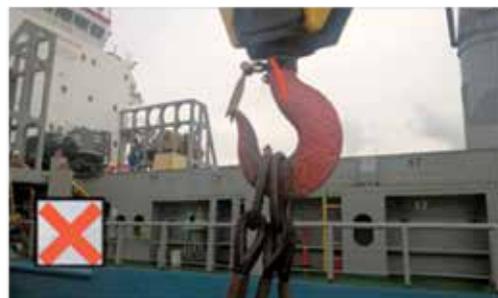
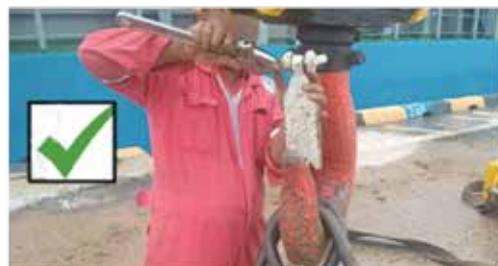
→ A port captain has reported several instances of poorly maintained, incorrectly installed or even missing safety latches on cargo hooks. Mariners should be advised that a cargo hook safety latch is a simple but critical safety measure that should always be in perfect order.

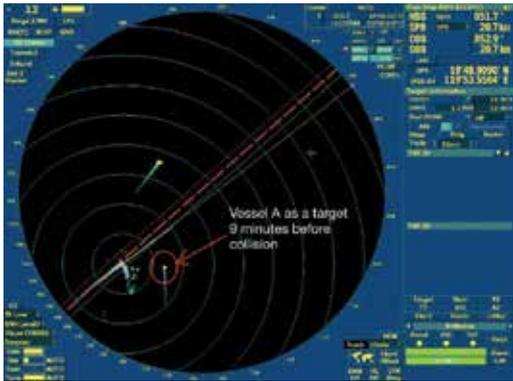
In the afternoon, the OOW was alone on the bridge and immersed in the task of planning the next voyage on paper charts. Several vessels were within visual and radar range, including Vessel A. At one point,

the OOW interrupted his chart work to make a minor course alteration of 3° to starboard on the autopilot. He then returned to his chart work, apparently unaware of vessel A approaching on his starboard side.
