Seaways

The International Journal of The Nautical Institute

MARS Report No. 291 January 2017

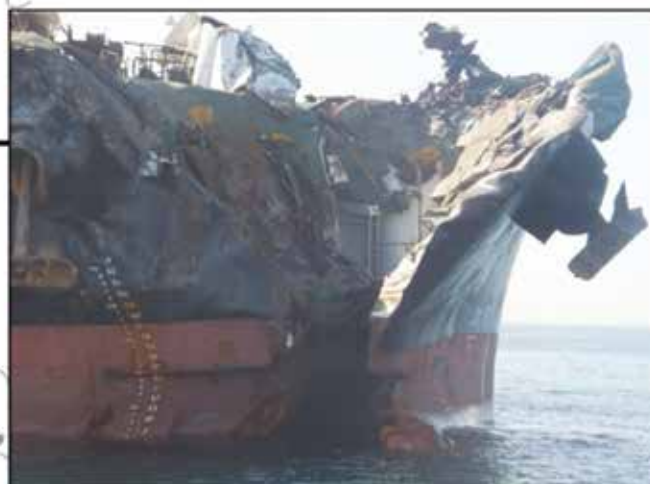
Tanker after collision

As the container vessel passed between the No. 1 buoys its speed was about 11kt. The tanker's Master saw the outbound container vessel pass between the No. 1 buoys and became concerned that the vessel had not altered to port as he had expected. He called VTS port control on the VHF radio to inquire. At this point, the pilot was still on the launch after having left the container ship. Shortly thereafter the two vessels, now both 4 cables from the entrance to the buoyed channel and near the centreline, collided bow to bow.

- The tanker Master's reliance on scanty VHF information and the failure of the container vessel's Master to keep a proper lookout and monitor the tanker's movement were pivotal to this accident.
- A lack of an agreed plan and absence of effective communication, co-ordination and monitoring were significant factors, which contributed to the flaws in both Master's situational awareness.
- On this occasion, the precautions of pilotage and port control, which should have been able to manage and de-conflict the vessels' movements, were ineffective.
- The pilot's failure to co-ordinate and communicate the passing arrangements for the two vessels was a significant omission; he was the assigned pilot for both ships. Although both Masters were aware of the other vessel, the plan for the meeting of the vessels remained ambiguous.

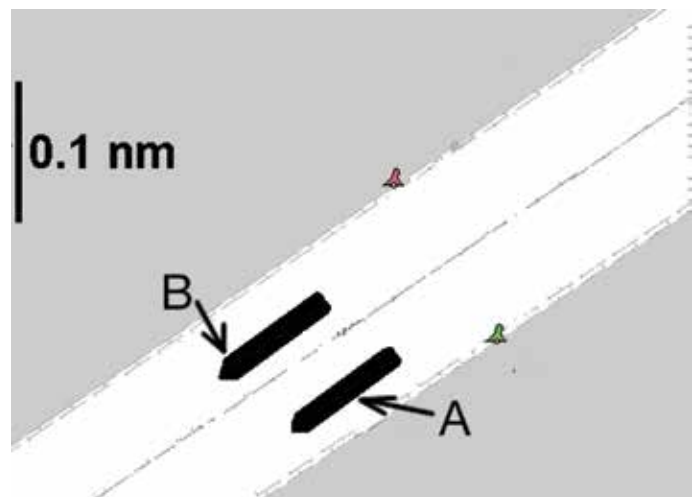
Ten minutes later, the helmsman on vessel A found it necessary to use a considerable amount of port helm (up to 23°) to maintain the desired heading of 235° Gyro (G). However, this information was not relayed to the pilot, nor did the pilot detect it from monitoring the rudder angle indicator. About one minute later, after passing a green channel buoy, the vessels were beginning to draw parallel to each other. They were now about 75 metres apart. Vessel B had reduced speed and was making 7.3kt, and vessel A was proceeding at 10.7kt.

- Neither pilot appreciated early enough the strength of the hydrodynamic forces at work, nor the need for early and decisive action to prevent the vessels from drawing together.
- Ineffective bridge resource management and poor communication between the vessels prevented both bridge teams from recognising the developing situation and taking timely action.

- When in the confines of a narrow channel, hydrodynamic forces between vessels are greater than when in open water due to the reduced flow capacity around the vessels and through the channel.

- When two ships pass or meet in the confines of a narrow channel, the squat experienced by each vessel increases by a considerable percentage.
- Hydrodynamic forces experienced by the vessels are proportional to the speed of the vessels through the water and inversely proportional to the distance between the vessels and the under-keel clearance of each vessel.

- The overtaking ship's resistance increases once past the overtaken ship, and the latter's resistance decreases. This can lead to a 'trapping situation' for the overtaking vessel.

- It is difficult to predict the onset and magnitude of hydrodynamic forces in the confines of a channel when manoeuvring large vessels.
- The hydrodynamic pressure zones around vessels can extend farther than the 100 metres commonly assumed.

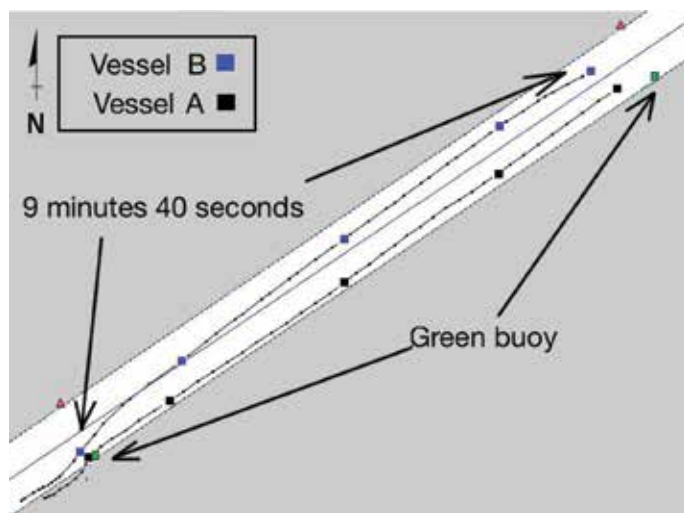
With the vessels closing, pilot B asked for full ahead, in an attempt to pull away. Notwithstanding this action, the two vessels collided, making parallel body contact about 9 minutes 40 seconds after the overtaking manoeuvre had begun.
