# Seaways

# Mariners' Alerting and Reporting Scheme

MARS Report No. 292 February 2017

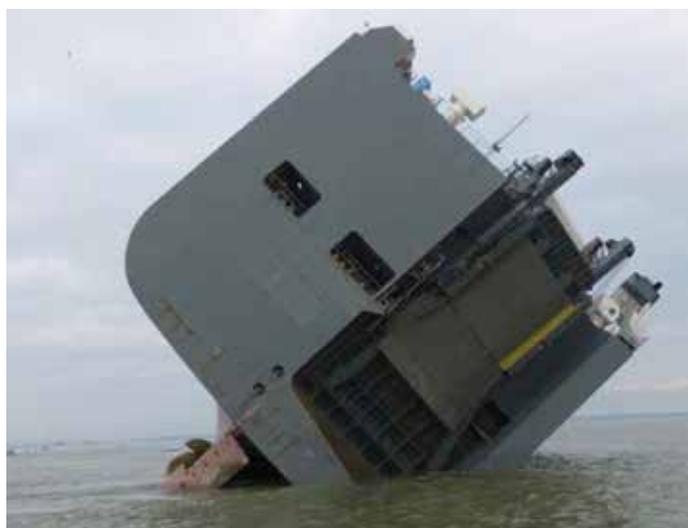
→ A car carrier sailed from port under the con of a pilot, with 1,633 cars and various heavy equipment loaded. The ship proceeded out, making good a speed of 10 kts when the pilot gave the first helm order to starboard. The turn was completed without incident, the ship heeling to port and returning upright as expected. A few minutes later, as the car carrier entered the main channel, the pilot requested that the ship's speed be increased.

Meanwhile, the chief officer was still undertaking final stability calculations in the cargo control room. He became concerned that the indicated metacentric height (GM) on the stability computer was less than his earlier departure stability calculation had predicted. He sent the deck cadet to take soundings of the three aft peak tanks in preparation for loading additional ballast water. The chief officer began setting up the ballast system as he anticipated that he would require additional ballast in the aft peak tanks.

As the vessel made the next turn, this time to port, it heeled progressively to starboard until its rudder and propeller were clear of the water. The vessel then suffered a blackout. Several cargo units and items of ship's equipment broke free from their lashings and shifted as the ship heeled. This resulted in a hole being punctured through the shell plating in way of the ship's gangway recess, allowing sea water to enter deck 6 when it became submerged.

Two tugs were tasked by vessel traffic services (VTS) to proceed towards the vessel and assist as required. Eventually the car carrier grounded. The inclinometer on the bridge was indicating a list of 40° to starboard.

A key finding of the official investigation is that a departure stability calculation had not been carried out on completion of cargo operations and before the car carrier sailed. Witness and anecdotal evidence suggests that this practice extends to the car carrier sector in general. The critical task of establishing whether the ship has a suitable margin of stability for the intended voyage before departure had been eroded on board. This unsafe practice had become the norm.

- The actual cargo weight and stowage were significantly different from the final cargo tally supplied to the ship.
- Cargo unit VCGs (vertical centres of gravity) were not considered when calculating the stability condition.
- The vessel's ballast tank gauges were broken. As a consequence, the quantities were estimated. These differed significantly from actual tank levels.

■ **Editor's note:** Master and crew were working in contradiction to the company SMS and good seamanship. Even a cursory safety audit by the company could have easily established this before the accident. Establishing procedures is critical but ensuring they are followed is equally important.

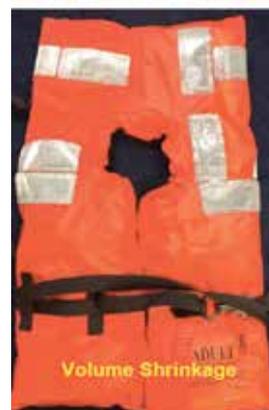
Degraded Dust-like Unicellular Foam

→ Recent inspections have found some vessels with inadequate lifejackets. The unicellular foam buoyant material within the nylon outer shell had degraded significantly over time, and in some instances was reduced to dust.

The lifejackets were properly stored, kept dry, and not under direct sunlight; however, the storage location was very hot at times. These particular lifejackets, manufactured in China, were the Type 1, 160RT model distributed by The Safeguard Corporation of Covington, Kentucky. They were approximately nine years old.

Lifejackets should be regularly inspected for indications of failure or degradation, specifically for:

- Compression: The lifejacket may be compressed from many years of stowage.
- Loss of resiliency: The lifejacket is excessively hard, stiff or its foam is brittle. Normally after compressing the lifejacket to about half its initial thickness, the foam should expand to its original dimension in a short period of time.

- Shrinkage: A physical reduction in size may be indicated by ‘wrinkling’ of the coating on vinyl dipped types or by a loose fitting shell on a fabric-covered lifejacket.

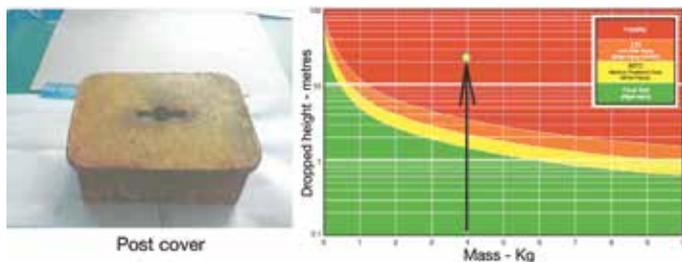
➔ A supply vessel was unloading a mud skiff and cargo to an offshore platform. During the hook up preparations a post cover was removed from its normal position and placed on the top of the mud skiff while lashings were fitted to the cargo. There was a change of shift on the supply vessel and a new deck crew continued the securing operations and the lift. The new crew did not notice the post cover, and it remained balanced on the mud skiff as the skiff was hoisted to the platform.

The occurrence was later reported by the crew of the offshore platform as a dangerous incident (potential dropped object). Weighing approximately 4kg the post cover, unsecured on the mud skiff being raised to the platform, was potentially a lethal hazard.

- No procedure was in place for managing the removal and replacement of post covers during cargo operations. As a consequence the post cover was forgotten on the mud skiff and, being unsecured, it became a hazard.
- Reporting incidents such as a potential dropped object, even as in this case where there was no adverse consequences, allows ship operators to improve their procedures and increase safety.

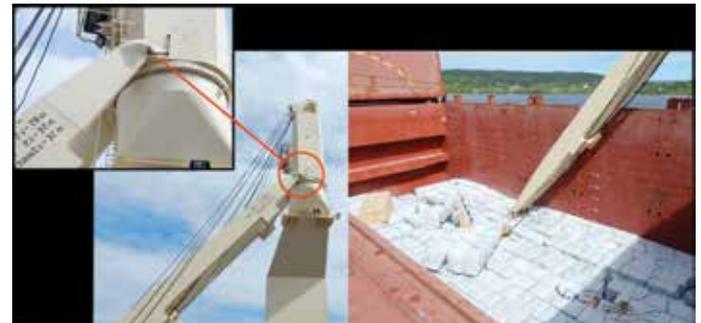
The ship’s crane had difficulties reaching certain zones of the cargo hold; this resulted in the crane arm being operated close to or even beyond its lower limit. When cargo handling had been ongoing for around a day and a half the topping cable released from the winch drum and the crane arm fell into the cargo hold, landing about half a metre from the stevedores. Fortunately, there were no physical injuries.

- The ship’s crane had been modified. An extra switch had been installed which, when activated, bypassed the crane’s limit switches for maximum lowering. It appears the modification had been made by a previous operator and crew. The reason for the modification could not be determined.

- Bypassing the limit switches allowed the crane boom to be lowered to a level which was too low for cargo handling, and to a point where there was not enough cable remaining on the winch drum to hold the combined weight of the crane boom and cargo load.
- The present crew, relatively new to the ship, had not discovered the bypass switch during the course of their own inspections.
- The crane operator did not perform a full operational check of the crane before the start of lifting manoeuvres. Such a check may well have helped in the discovery of the nonconforming bypass switch.

- Never bypass safety equipment such as limit switches.
- Always do full operational tests before using cargo handling equipment.
- Always use a signalman during cargo operations.

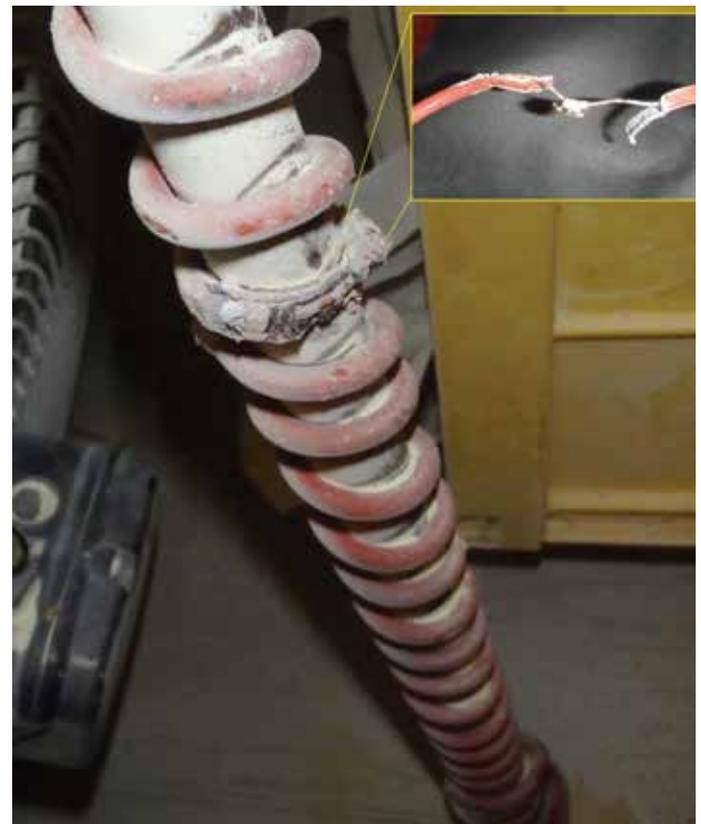
➔ A high temperature alarm sounded for the freezer. The chief engineer went to investigate. On opening the main door he could smell burning and he saw flames coming from the back of the freezer.

The investigation revealed that the heating element, which is coiled around the drain pipe, had become damaged over time and was touching nearby boxed stores. When the freezer went into defrost mode, which it does automatically twice a day, the heat ignited a box or the packaging that was in contact with the coiled element. The vessel was about 10 years old and the freezer defrost had been operating in this way since new.

- It appears that there had been no regular checks of the wiring. Such checks could have helped discover the damage the coil had experienced.
- Wires carrying electrical current should be protected against physical damage. In this case, boxes and stores were placed directly against the defrost heating element. Not only could this practice damage the wire, but once the wire is damaged, as in this case, it could initiate combustion with contacted boxes.

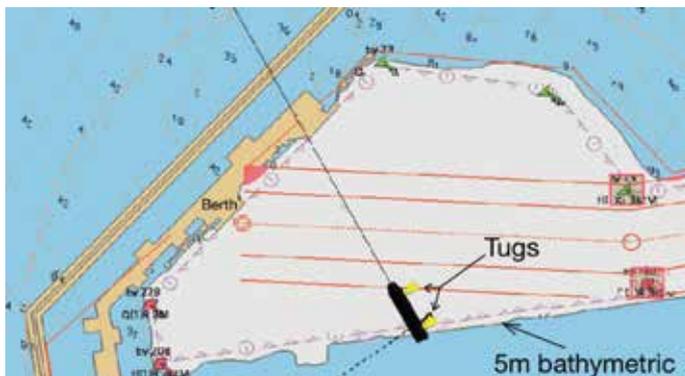
The pivoting manoeuvre was continued, as seen in the diagram, and although the stern swung through water shallower than the aft draft, no impact or vibrations were felt. Within a few minutes the vessel was secured alongside the berth.

Unknown to the Master, pilot and crew, the port side rudder had made contact with the bottom during the pivoting manoeuvre, causing the rudder stock to turn within the steering gear actuator by almost 25 degrees from its midship position. However, the rudder indicators were showing that the rudder was still amidships. This situation was only discovered upon departure when the steering was found to be unreliable and inexplicably unresponsive. The vessel quickly went to anchor and divers soon confirmed that the rudder was misaligned, although the rudder itself was physically undamaged.

- Before beginning a manoeuvre such as turning your vessel over 90° in a restricted waterway, ensure the vessel is appropriately positioned to safely accomplish this move. In this case, given the NE wind, the turn appears to have been initiated too close to the southern edge of the dredged area which left little margin for error while swinging to starboard.

- In this case, the rudder tests before departure did not reveal the misalignment that had occurred during the previous berthing.
- Even though contact with the bottom had been initially discounted due to the lack of vibrations or other indicators, the stern had swept through an area of less depth than the draft; contact should have been assumed and verified before departure.

- One of the key principles of BRM is the 'challenge'. In this case the Master 'informed' the pilot of the imminent danger, but appears not to have insisted that positive action be initiated to avoid the shallow area astern.

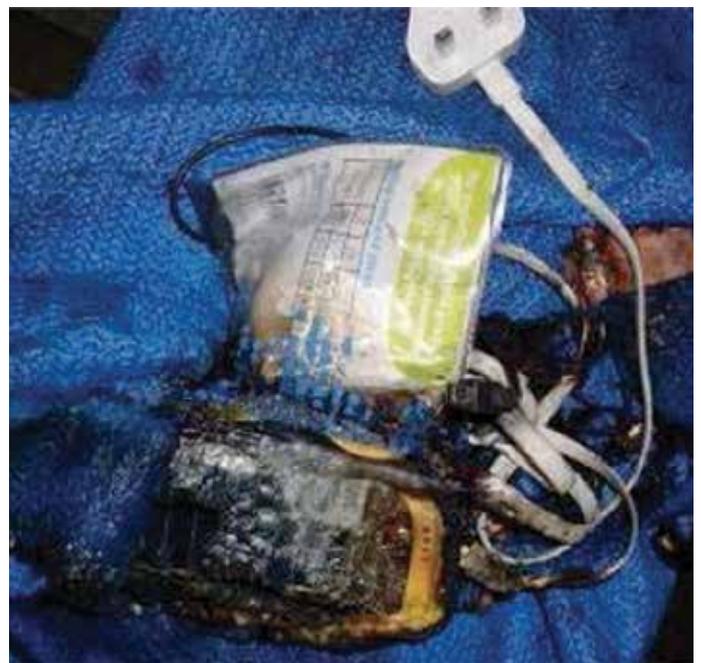
→ A small fire was discovered in a crew member's cabin and quickly extinguished. The crew member, who was not in his cabin at the time, had left a battery pack used for charging small appliances in the 'charging mode'. The investigation to date seems to indicate that the battery pack probably overheated causing the unit to melt. The battery pack under review appears to be an inexpensive, low quality unit.

- The use of non-original chargers for domestic appliances should be prohibited.
- The charging of power banks should be regarded with caution and risk assessments undertaken.
- All electrical equipment brought onboard a vessel should be checked and rated against the ships power supply by the engineering team.
- Never leave domestic electrical components charging or on standby unattended. If you leave the area switch everything off at the source or unplug it.

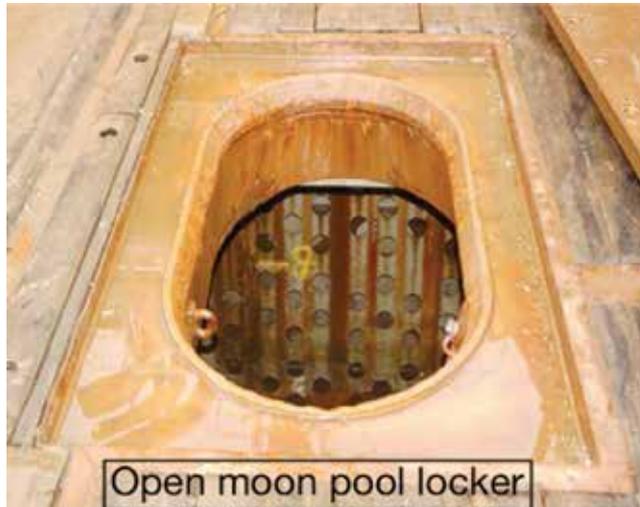
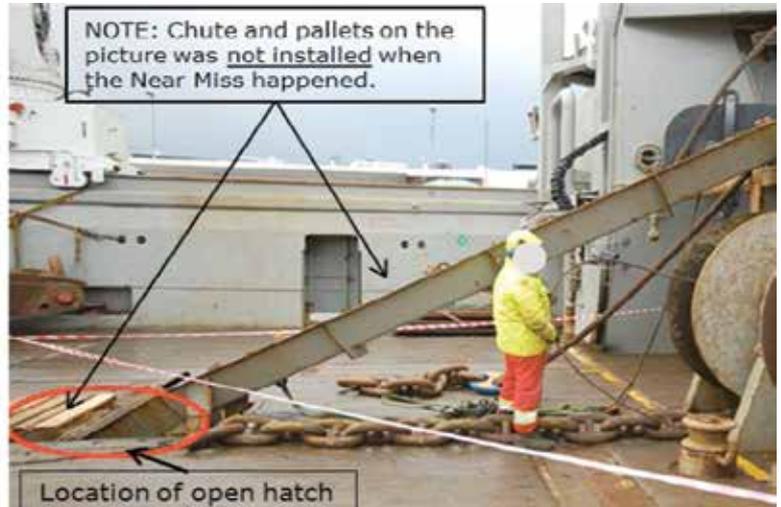
➔ Preparations were underway to load anchor chain into the moon pool locker, and the hatch cover had been temporarily removed prior to the installation of the chain guide (chute). The hatch had an opening of 155x85 cm and the locker was approximately 10 metres deep.

While attending to a related task on deck, a crew member stepped back and fell backwards into the open moon pool hatchway. As he fell

he was able to turn slightly to his right and grab the edge of the hatch opening with both hands. He then managed to get his right elbow over the edge of the hatchway and, shouting, attracted the attention of others. Crew members subsequently helped him to safety.

- Once opened, deck hatches and accessways should always be immediately cordoned off and indicated as a danger.
- Always do a risk assessment, even if it is just a mental check of dangers, prior to and during a task. Think of 'what could happen'.
