Seaways

The International Journal of The Nautical Institute

Mariners' Alerting and Reporting Scheme

MARS Report No. 294 April 2017

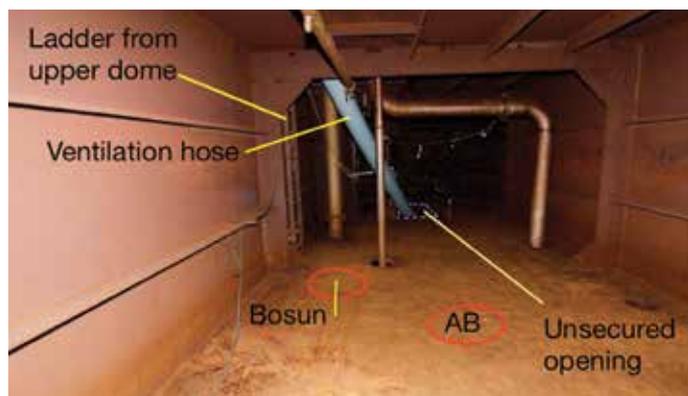
The OS followed a few minutes later carrying a hand-held torch. The bosun heard the OS as he started to climb down the ladder but after one or two minutes he realised the OS was not with them. He shone his light around the space to locate the OS but he was nowhere to be seen. The bosun then went over to the open hatch and looked into the tank. He then saw the OS lying immobile at the bottom of the tank 17 metres below.

Lower dome compartment

- Even if the paperwork is done, as in this case, the permits to enter tanks were completed, always ensure the required safety measures are actually in place before starting the work. Proper lighting and a barrier around the open maintenance hatch would have prevented the fatality.

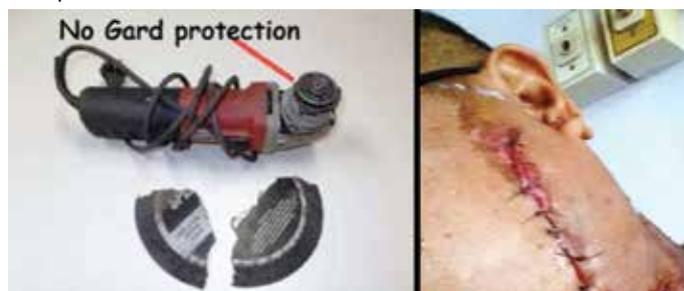
The grinding disk failed, and pieces of the disc went flying away at high speed. As there was no guard on the grinder and the engineer had no face protection some of the pieces hit the engineer in the face causing a large laceration. First aid assistance was quickly administered and shore assistance requested. The victim was evacuated to a nearby hospital and thereafter repatriated.

- In this case, there was a sense of urgency to get the job done in order to weigh anchor. Whenever you feel this sense of urgency in your work, slow down and ask yourself 'Am I doing this work as safely as possible?'
- Always ensure safety guards are in place for any machinery that requires it.

- Always wear appropriate personal protective equipment (PPE).
 - Always use the appropriate tool. In this case the angle of attack of the grinder was difficult to control due to the restricted space. Maybe a grinder was not the appropriate tool for the task?
- **Editor's note:** Electric grinders spin at very high speeds and grinding discs have been known to shatter while in use, causing serious injury to the face, as in this instance, or other parts of the body such as the hands. For other examples of this type of occurrence see past MARS reports 201624, 201243 and 200831. Past MARS reports can be found at <http://www.nautinst.org/en/forums/mars/search-all-mars-reports.cfm>

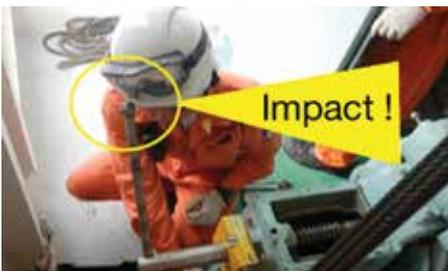
At about the same time, the elevator was activated by the other crew, causing the turning handle to quickly turn; it hit the engineer in his face and arm causing injuries.

- The engineer made an error; he had a lapse, forgetting to remove the turning handle before having the elevator motor energised via the breaker. Everyone makes errors but teamwork and procedures should eliminate single point failure and reduce the consequences of an error. For example, had the oiler specifically pointed out to the engineer that the turning handle was still in the gearbox, rather than just asking for confirmation that it was OK to turn on the breaker, the engineer would surely have removed it.
- Always follow procedures when undertaking specific jobs. In this case, allowing activation of the elevator while still in the elevator machinery room was most certainly against procedures.

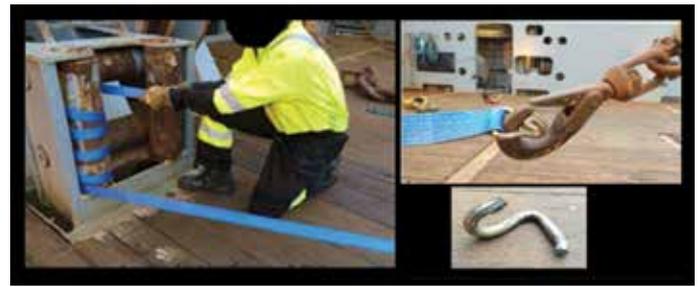
➔ During deck maintenance a roller on a winch fairlead was found to be seized. The crew decided to attempt to loosen the roller by using a pallet lifting strop, wrapped several times around the roller, and then fastened to the rail crane fitted on the vessel. When the crane driver applied tension the pallet strap hook broke. The resulting snap-back of the strop hit one of the crew in the back causing severe injuries.

The pallet strop hook was incorrectly secured to the crane hook, making it much weaker than the Safe Working Load (SWL) of the lifting strop itself.

- A critical examination of the hook-up before tension was applied would have revealed the hazard; the strop hook is not meant to have tension applied in that fashion. Always do a mental risk assessment when trying new work methods. Ask yourself 'What can happen here?'
- When tension is applied to a system, always stand well clear of the potential snap-back zone.

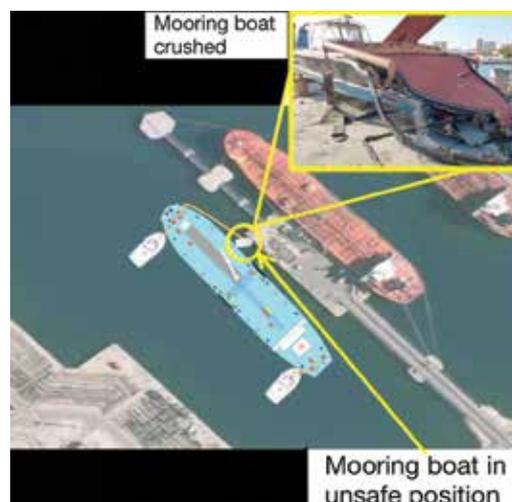
The Master became aware of the situation with the mooring boat and informed the pilot. The tug boats were ordered to hold the vessel off the jetty and the bow thruster was also engaged to push away from the berth. Unfortunately, these desperate measures were too late as the mooring boat was pinched between the vessel and the jetty. The mooring boat operator, who was alone on the boat, was safely evacuated but the mooring boat sank.

- The level of communication and coordination between the mooring boat and the pilot was inadequate.
- The mooring boat was operated by a single person (both operating the boat and handling the ropes) and this could have led to the loss of precious time in warning the pilot and vessel.

- While berthing, always keep a sharp eye on your surroundings to ensure an unimpeded and safe manoeuvre.
- As the crew of an assisted vessel, we are powerless to influence how assisting vessels are operated. Yet, if we remain vigilant and maintain a robust situational awareness serious consequences may be avoided.

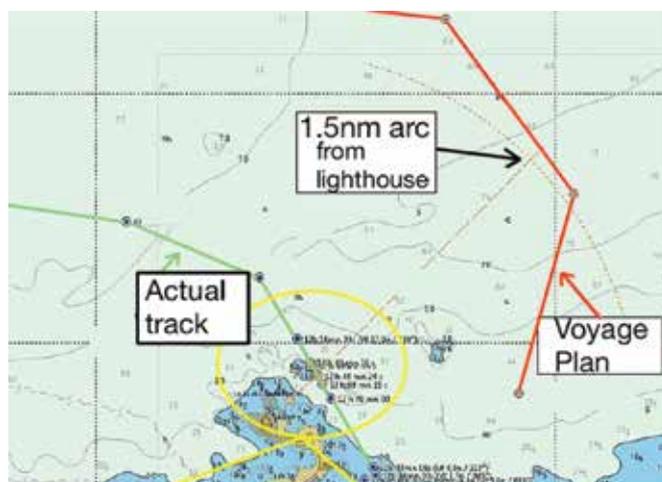
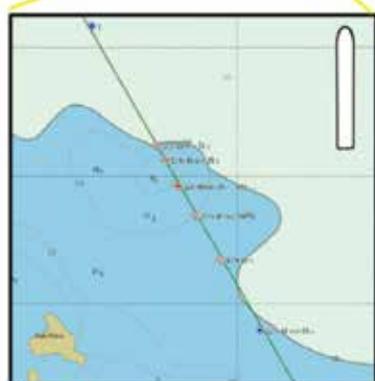
Vessel shape to scale

Once the pilot had disembarked, speed was increased but the heading was kept at 330°, bringing the vessel over the shoal, indicated as having a depth of 6.5m. The vessel was drawing 6.49m and was now making over 16 knots. Some vibrations were felt and, as the vessel continued its voyage, crew investigated but found no immediate evidence of water ingress.

The vessel made several more local voyages over multiple days with passengers and vehicles before an underwater inspection revealed bottom damage that was eventually linked to the earlier vibrations.

- As mentioned in past MARS reports 201610 and 201716, if you hear shuddering noises accompanied by vibrations throughout the ship, you should suspect you have touched bottom even if all else appears normal.
- Voyage plans are made to keep the vessel in safe water – follow your plan.
- Squat increases with vessel speed and can easily increase a vessel's draft by a metre or more. Check your vessel's squat characteristics.

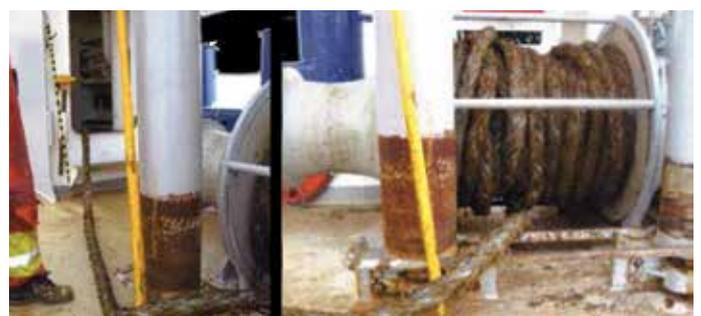
→ The deck crew were bringing mooring lines up on deck in preparation for port arrival. The operation included transferring a mooring line from the starboard locker storage spool to the aft deck winch. In order to expedite the work, a crew member held a crow bar in place to act as an improvised fairlead. This was intended to deviate the line around a pillar while the line was tugged directly from the storage spool to the deck winch under power.

During this operation the crow bar slipped; the deck crew member holding the crow bar caught his fingers between the bar and roller. Severe injuries to three of his fingers resulted.

- Improvised work methods are rarely safe.
- There should never be undue haste when undertaking a task. This leads to unsafe practices which can cause negative consequences.
- Normal operating procedure in this instance was to first remove the mooring line from the storage spool and then bring it onto the winch without having to angle around the pillar. This procedure was not written down, nor was it communicated to the new crew member undertaking the job.
