# Seaways

# Mariners' Alerting and Reporting Scheme

MARS Report No. 295 May 2017

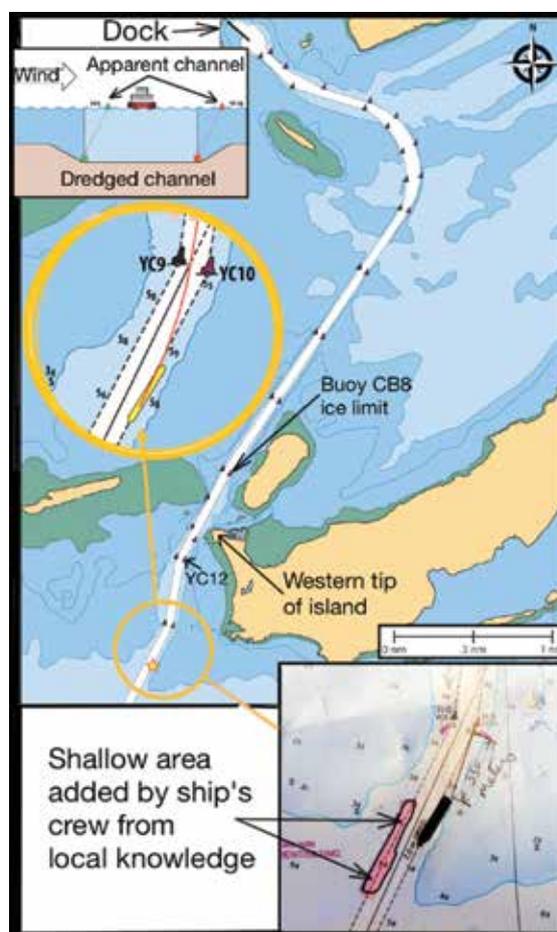
The Master ordered the helmsman to apply starboard helm and soon the bulk carrier's rate of turn began to increase. Approximately 15 seconds later, the vessel made contact with the bank southeast of the buoyed navigation channel at a speed of 7.5 knots. The rate of turn and the vessel's speed began to reduce and then the vessel grounded just outside the navigation channel about 1.5 ship lengths away from buoy YC10.

- The buoys were being set off their charted positions by the prevailing wind and current. By using these buoys as the primary method for navigating, the bridge team lost awareness of the vessel's actual position within the channel.

- The vessel was using an outdated electronic chart, which no longer displayed the channel or buoy positions accurately. Using this to verify the wheel-over position probably led the Master to initiate the turn later than intended.

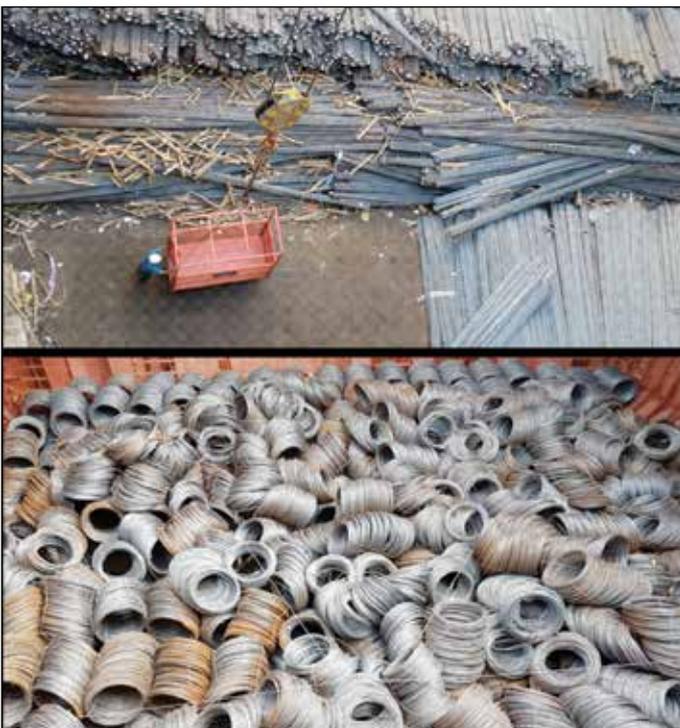
→ A port superintendent reports having witnessed many vessels arriving to discharge steel coils and bars with very poor stowage. No consideration has been given to the difficulty of slinging during discharge, as the gaps left between the cargo units are not sufficient.

While tight stowage is desirable for the voyage, it can present dangers to stevedores if cargo is not properly secured for the discharging operation using adequate dunnage and efficient chocking. This problem appears particularly acute when cargo is loaded by shore cranes and has to be discharged by the ship's cranes.

Also, discharging such cargo from under the coaming presents more problems; a very risky and accident prone procedure.

- Cargo should be loaded in such a way that it can be discharged safely with ship's cranes.
- Sufficient gaps should be arranged between cargo units so that slings can be safely and properly installed at the discharge port.

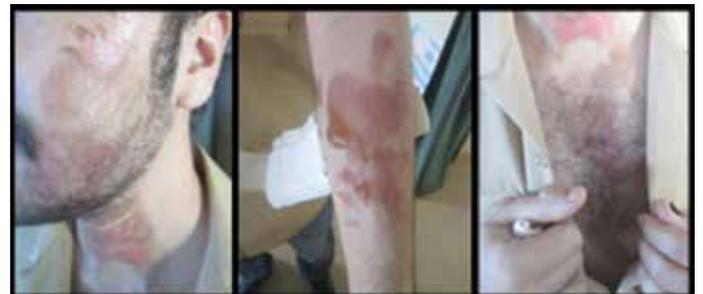
→ While at sea, it was discovered that the economiser circulation pumps were leaking. In order to rectify the problem the main engine was stopped. The economiser inlet and outlet valves and the boiler circulation inlet and outlet valves were closed, while the economiser drain valve was opened.

Once the economiser was empty, the economiser safety valve was dismantled, among others, and work started to correct the defect. After corrective action was taken, the boiler circulation pump was being re-installed when the engineer received hot water on his face, neck, chest and left arm. The boiler operates at 9-12 bar with water heated to 160-175 degrees Celsius.

- Always adopt a lock-out, tag-out procedure that will ensure risks are acceptable. In this case the barrier between the crew member and the hazard was not 100% secured.
- Every task that presents risks should be documented in a procedure.
- Always wear appropriate personal protective equipment (PPE) when undertaking a task.

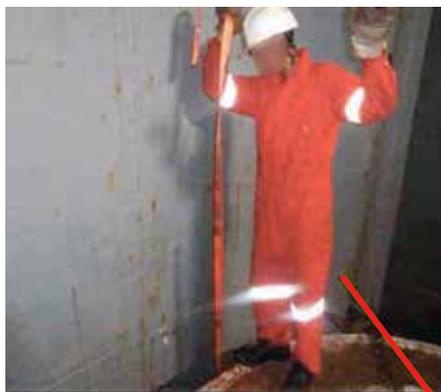
Simulation of CO just before fall

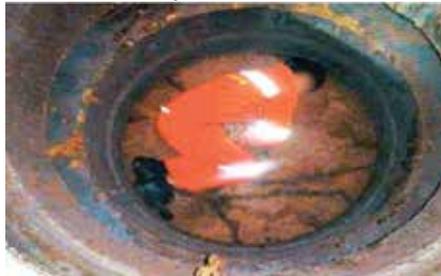
Simulation of CO after fall

- Standing on top of the crankshaft web was inherently unsafe and unnecessary.
- In the heat of the moment and with a 'can-do' attitude, the risks of standing on a load under tension were not recognised or intentionally flouted.
- When events start speeding up, step back and slow them down.

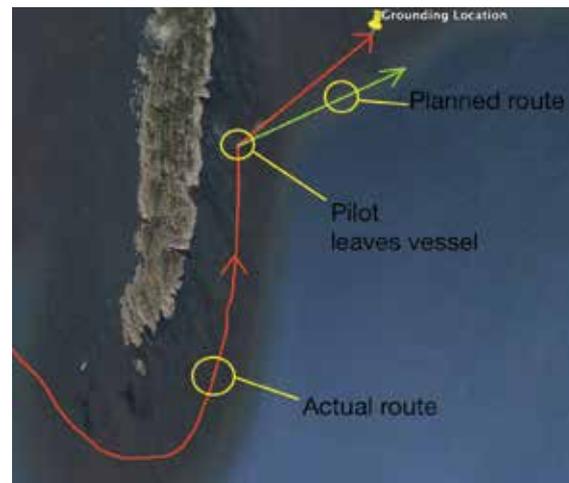
The vessel turned to a heading of 067° and then, some minutes later, grounded hard at a speed of nearly 10 knots on a known and charted reef.

The vessel suffered severe damage to the bottom of her hull and tank top, including her frame and bottom beams and girders. Damage was so severe that following re-floating and temporary reinforcement work in port lasting several weeks the vessel was considered a total loss; the vessel was towed to a nearby shipyard and scrapped.

- When navigating near land, reefs and other dangers, the top priority is knowing your position and your course made good versus the navigational dangers.
- If you are unsure of your position, slow down or stop.
