Seaways

Mariners' Alerting and Reporting Scheme

MARS Report No. 301 November 2017

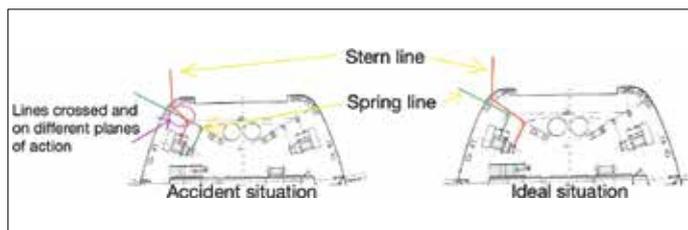
At some point in the manoeuvre the aft spring line came under extreme tension. The stern line absorbed some of the tension, which was transferred to the lower pedestal fairlead. Unexpectedly, the roller fairlead was launched from its pedestal, fatally injuring one of the shipyard personnel.

- The immediate cause of the accident was the failure of the two 10mm bolts holding the roller-keep in place, which sheared off under the tension generated by the mooring ropes.
- The berth configuration, which supported only half of the vessel, and the position of the fender contributed to a turning moment that could easily cause uneven tension on the fore and aft mooring ropes.
- The handling of mooring ropes was not discussed, nor were the dangers associated with mooring stations. None of the seven shipyard personnel present at the mooring stations on board the vessel had any training in mooring operations.
- The crew members at the aft mooring station did not have the necessary experience and knowledge to handle mooring ropes safely.

- Mooring a vessel involves great stresses. Always have experienced and sufficient crew to handle mooring lines.

- Never cross your mooring lines and never have them acting against each other in competing planes of action.
- Be aware of the forces acting on the mooring lines and stay clear of any areas of potential danger.

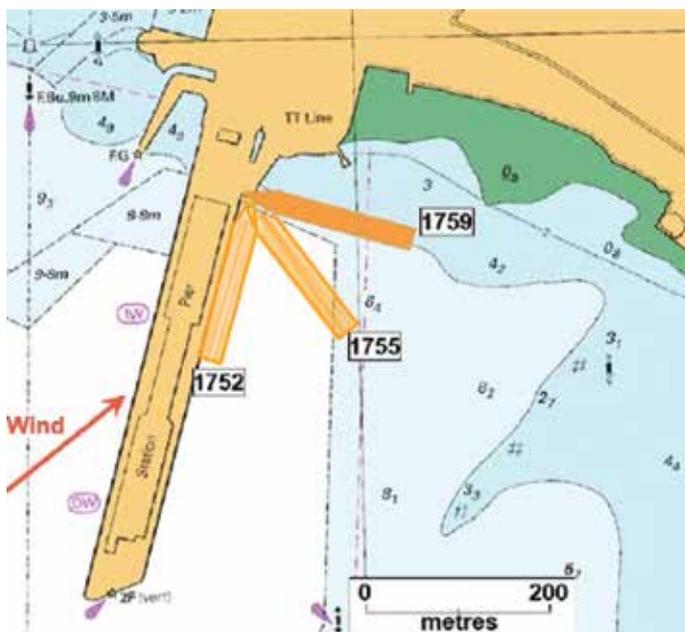
Within two minutes the south-westerly wind suddenly increased from about 25 knots to 60 knots. As the wind speed was peaking, the vessel's aft mooring lines parted in quick succession and its stern broke away from the wharf. As the stern swung away from the wharf the forward breast line came under tension and, along with one head line on the bight, held the vessel's bow.

failed, given their nominal breaking strength. Possible reasons for their failure, apart from any unknown defects, could have included:

- Unequal tension in the mooring lines (before the sudden increase in wind speed);
- Not all lines were held on winch brakes (some winches were on self-tension mode);
- Sudden dynamic forces (six-fold increase in wind loading);
- Dynamic loading (ship's momentum as it rapidly moved off the wharf).

It is possible that the breakaway might have been prevented had the precautions for adverse weather been more carefully considered. For example, had the breast lines been held on winch brakes, the increased static load capacity of the aft mooring line pattern may have prevented the first stern line parting. Similarly, had the ship's propulsion been ready for immediate use, the stern thruster (maximum 15T transverse thrust) could have been used to counteract some wind loading to prevent the first line parting.

- Since the wind force varies as the square of the wind speed, small increases in speed translate to large increases in force. In strong winds, gusting amplifies these forces significantly. Strong winds frequently contribute to breakaways;
- Check your mooring lines and ensure they are under equal load proportional to their breaking strength;
- At berth, putting mooring lines on winches and in self-tensioning mode is not best practice. Better to use the winch brake or on bitts as the securing method.

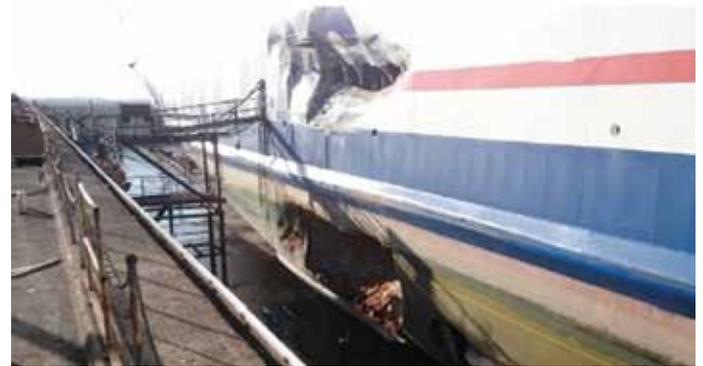
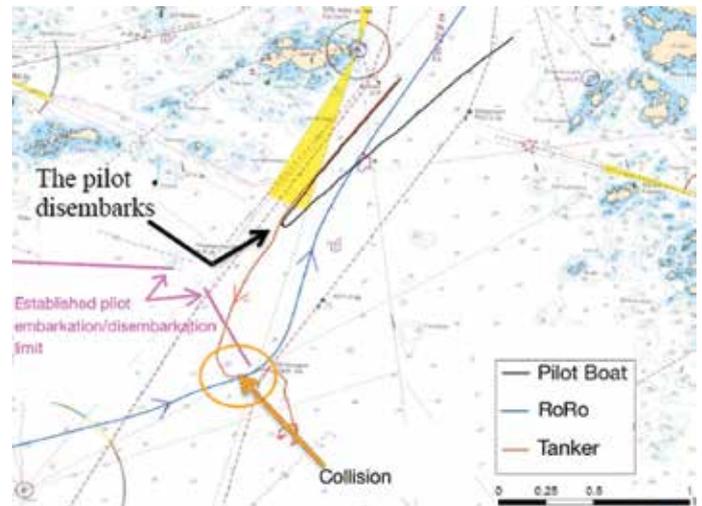
Damage to ro-ro ferry

that it had been agreed that they would pass starboard to starboard. However, on the inbound ro-ro, the OOW intended to have the vessels pass in the conventional port to port fashion. He requested this via VHF but received no response from the tanker. About 30 seconds before the collision Vessel Traffic Services (VTS) intervened to warn both vessels that they were running into danger but no response was received.

As the tanker was turning to port, in order to provide more space for what the Master believed would be a starboard to starboard meeting, it became apparent that the ships would collide. The Master of the tanker put the engine astern but a collision ensued nonetheless.

- Communication between vessel bridge teams must be sufficiently early, clear and unambiguous, especially when it involves a deviation from the collision regulations.
- A best practice is to repeat back the message that was sent to you and ask for the sender's confirmation.
- Multi-tasking is not safe; in this case the Master was the sole lookout and acting as navigator while the pilot left the vessel. His attention to the pilot transfer left his navigational situational awareness less than adequate.
- The official report states that the officers on both vessels were probably affected by fatigue. Fatigue is an insidious and often overlooked factor in accidents.
