Mariners' Alerting and Reporting Scheme

MARS Report No. 308 June 2018

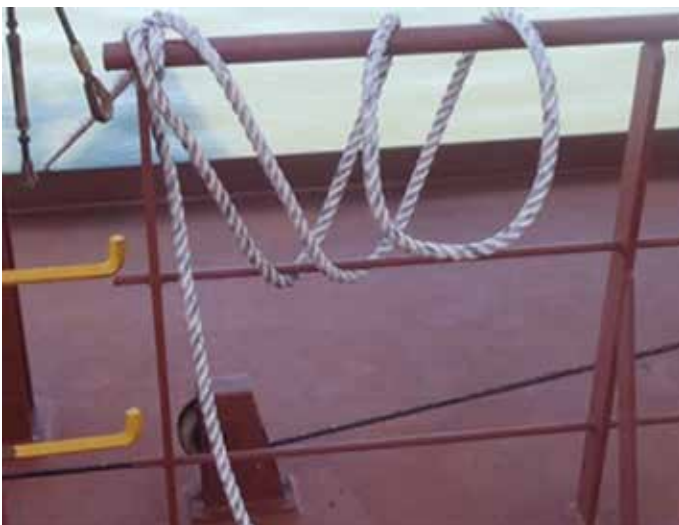
Unapproved secondary means of support tied to non-loading bearing part of accommodation ladder and vessel structure

- Connections to vessel's cranes or davits with insufficient safe working limit (SWL)
- Attachments to non-load-bearing parts of the accommodation ladder and vessel structure
- Inadequate tensile strength of ropes, wires, pulleys and fittings.

- If a secondary means of support is desired, a risk assessment should be undertaken on board in line with the vessel's safety management system.
- Procedures for the fitting, maintenance and operation of the secondary means of support arrangements should be included in safety management system procedures and crew should be inducted and trained in the use of these arrangements.
- Good seamanship and reasonable judgement is a standard in itself.

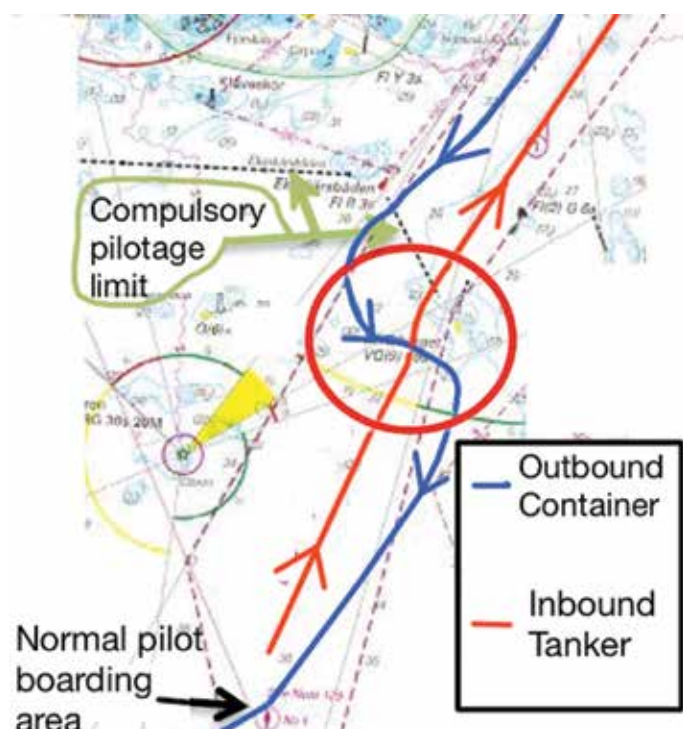
Radar recordings show that container vessel initially turned a little to starboard after the pilot had disembarked. According to the Master, he perceived the proximity situation with tanker as critical and decided to turn to port instead, increasing speed at the same time, choosing a starboard to starboard meeting instead of port to port because, in his opinion, the situation now called for this action.

- If you change the agreed plan, make sure you tell the other party. In this case the Master of the container vessel changed the plan without notice and only the vigilance and actions of the tanker Master averted disaster.

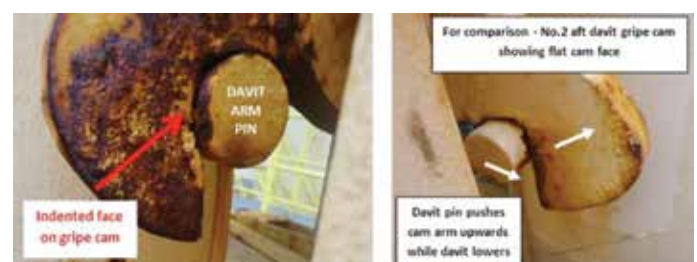
After investigation, it was found that an indentation had been worn on the face of the gripe cam due to oxidation and long, continuous contact from the davit pin. This resulted in the davit arm pin being engaged in the cam rather than moving the cam arm away as the davit was lowered. The cam consequently acted as a hook, preventing the davit arm from moving from the stowed position. The wear had not been identified during previous routine weekly lifeboat lowering exercises.

- Check, recheck and re-recheck your safety gear.
