Mariners' Alerting and Reporting Scheme

MARS Report No. 309 July 2018

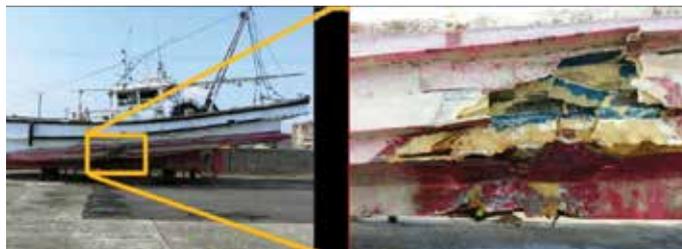
The investigation later determined that the target ship was a fishing vessel manned by a sole person, the skipper. He had not returned at the usual time and his family had informed the authorities that he was missing. A search was instigated and the fishing vessel was found capsized and damaged on the port side. The skipper was recovered from inside the vessel and was later declared deceased. A search was initiated for the other vessel implicated in the collision. After some investigation the small coastal container ship was identified.

- If you have the slightest doubt you may have collided with a small boat, stop immediately and investigate fully.
- At night, keep the bridge in 'blackout mode'. This is important for good night vision. Use red lights for the chart table and shield the light with curtains.
- Use your electronic navigation equipment to its utmost, but also your human power. The eyes of a dedicated lookout and the OOW are fine assets.
- When using the radar for collision avoidance, use relative mode instead of true to give a better visual representation of collision risks.

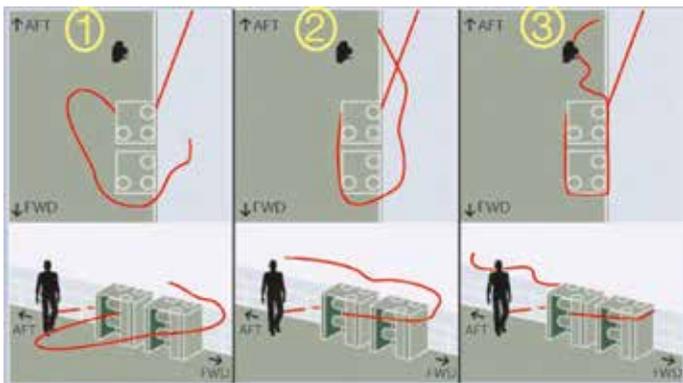
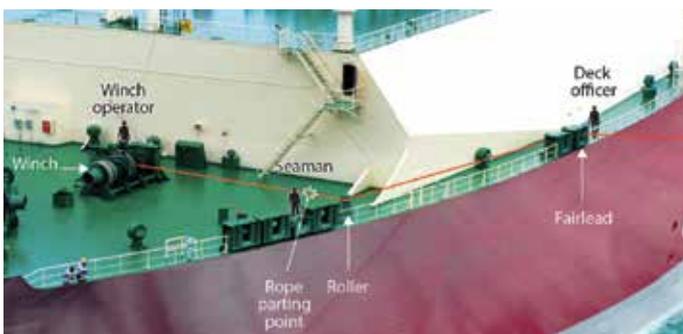
The mooring line parted inboard from a pedestal fairlead while under tension. The section of the line between the break and the port shoulder roller fairlead struck the deck officer on the head as it whipped back before going overboard through the fairlead. The deck officer was found lying unconscious forward of the roller fairlead. He had sustained multiple skull fractures.

- The residual strength of the mooring line was substantially reduced from original specifications. The tensile load on the mooring line when it parted was less than a quarter of its specified minimum breaking load and below its accepted working load limit.

- The predominant factor for the loss of residual strength was axial compression fatigue. However, axial compression fatigue had not previously been considered as a likely failure mode or significant cause of strength loss in HMPE rope by the manufacturer.
- The decision to attempt to reposition the vessel using the spring lines rather than recalling the tugs placed the mooring parties in an unnecessarily hazardous position, particularly given the strength and direction of the winds.

- Mooring line maintenance management and condition monitoring regimes must include clear and practical criteria for discarding compromised ropes.
- The condition of the load bearing core of jacketed ropes cannot be adequately assessed on board ship. Several of the rope discard criteria listed in the company's safety management manual, such as broken strands, abraded yarns and fused fibres, cannot be identified without destroying sections of the rope.
- The tensile strength of high modulus rope will diminish steadily over time regardless of how well it is maintained. For this reason, appropriate safety factors and anticipated life expectancies need to be applied, and parameters such as time, tension and temperature need to be closely monitored. Without these, the ropes will likely fail before being discarded.

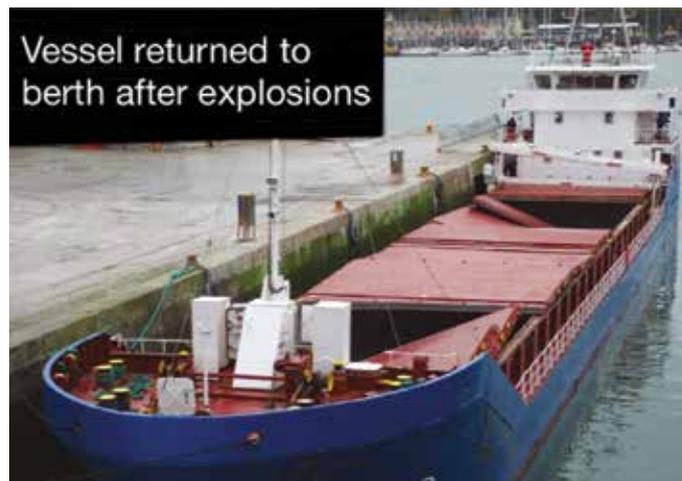
The victim was quickly evacuated by helicopter to a shore hospital. He had suffered first degree burns to his face and second degree burns to his body, hands and lower extremities. The vessel had suffered some minor damage. Five of the nine hatch covers had to be replaced, along with all of the hatch cleats and the cargo hold coaming bar among others.

The investigation found, among other things, that U-IBA, when exposed to water, generates a low rate of H₂, with a risk of explosive atmosphere formation. In this case, H₂ gas had probably migrated from the vessel's hold to the forecabin store and into the pump's start/stop panel, initiating the first explosion.

- If the bulk cargo is not listed in the IMSBC Code, do not load until approval for carriage is received from the competent authorities.
- Had the IMSBC Code requirements been followed it is likely this accident would not have happened, as the dangers would probably have been identified and procedures for safe carriage developed and implemented prior to loading.
- For purposes of transportation in bulk by sea, the release of any quantity of flammable gas should be considered dangerous.

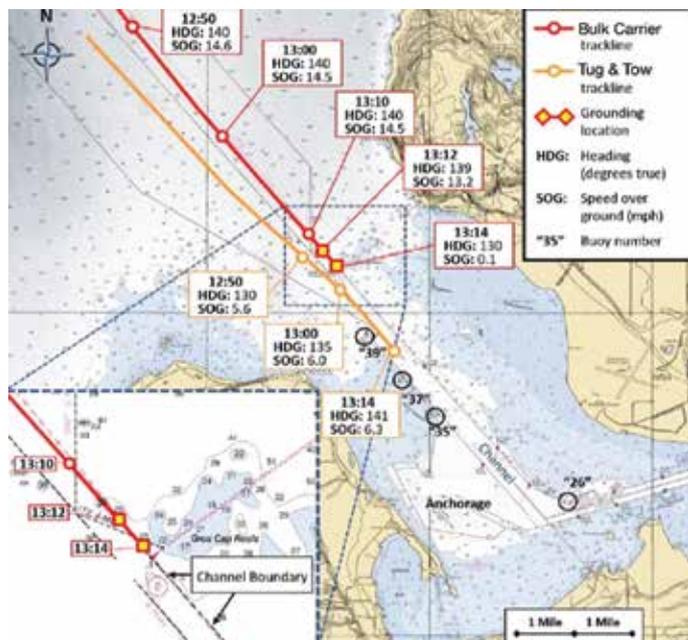
Immediately following the accident, the crew sounded the tanks. Multiple punctures and large fractures to the hull had been sustained. There was significant deflection of the steel deck in the forward end of the port side cargo belt tunnel and the cargo belt pulley system was misaligned. Damage cost in the order of USD 4.5 million and took over two months to repair.

- Use all available means at your disposal to navigate the vessel. In this case the electronic chart would have clearly shown the vessel was in danger of grounding.
- The bulk carrier's OOW must have felt some pressure to complete the overtaking manoeuvre as previously agreed, and therefore did not moderate the vessel's speed; a sharp port course alteration was coming up very near to where the overtaking would have been completed. Don't be afraid to change your plans, and when in doubt, slow down.

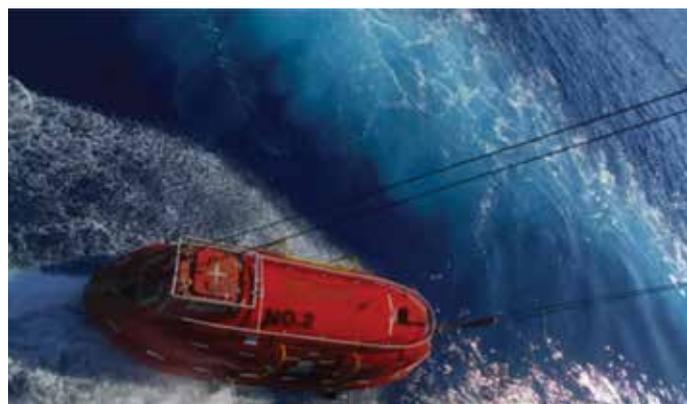
➔ The port life boat was to be lowered to deck level as a test, with the vessel underway at about five knots. As soon as the lashings were removed, the lifeboat started to lower itself to the sea of its own accord. Crew attempted to stop the descent by pulling down the brake arm to stop the lifeboat, but without effect. The lifeboat continued its course downward to the sea.

The bridge was informed and the vessel was stopped and turned to make a lee on the port side to protect the lifeboat. The company investigation found that the lowering arm, which had been dismantled for maintenance and then reassembled, had been improperly installed.

- Lifeboat launching apparatus is essential equipment. Maintenance should be undertaken or supervised only by competent personnel.
- Always slow the vessel to a near stop or wait until at anchor to test lifeboat lowering. If berthed, test the outboard lifeboat only.
