Mariners' Alerting and Reporting Scheme

MARS Report No. 310 August 2018

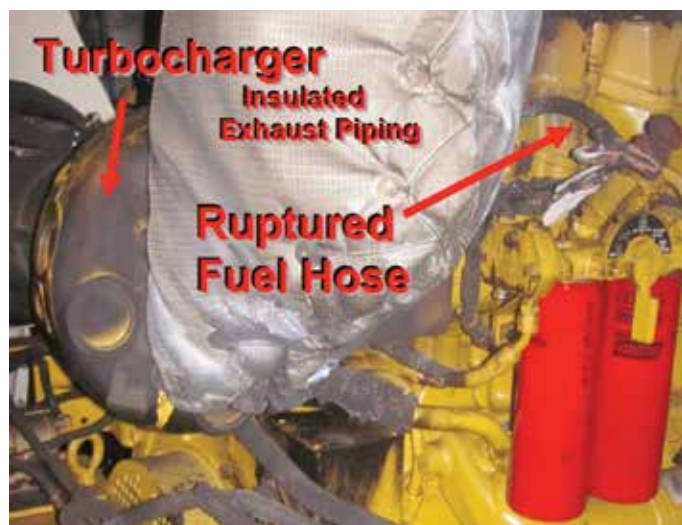
→ While underway a main engine low fuel pressure alarm sounded on the bridge. The crew member on watch entered the unmanned engine room and identified a high-pressure fuel leak spraying on the port engine's turbocharger. There was also a large quantity of diesel fuel in the bilge. The Master arrived on scene just as the fuel ignited and began a fire. He attempted to extinguish the fire using a portable fire extinguisher, but without success. He activated the general alarm, secured the hatches, had crew members secure the ventilation dampers and closed the remote fuel shut-off valves to the engine room. The fire then quickly self-extinguished.

The investigation identified the source of the fuel leak as a rupture on a flexible fuel hose connected to the fuel filter assembly. The fuel filter assembly and its components were installed relatively close to the

turbocharger on the inboard side of the engine. The heat radiating from the turbocharger components was very high and probably led to the degradation of the rubberised hoses nearby. However, the installation was in accordance with the manufacturer's marine engine manual.

- Closely inspect fuel and lubricating systems, from source tanks to system end points. Think about system vulnerabilities such as loose or missing pipe clamps and securing devices, wear or chafing from vibration that is affecting hoses, and pipes or tubes that may be poorly secured. Make sure that plastic piping is not close to hot spots.
- Ensure all insulation, blankets and lagging are maintained and kept tight. Look for areas where released fluids may make contact. Where spray shielding is used, check that it is kept in place; if it is not used, consider adding shielding.
- Minimise the use of non-metallic flexible hoses in systems carrying flammable liquids, particularly around engine areas where leakage or spray may reach hot spots capable of igniting the fluids. Consult with engine representatives if modifications are needed.

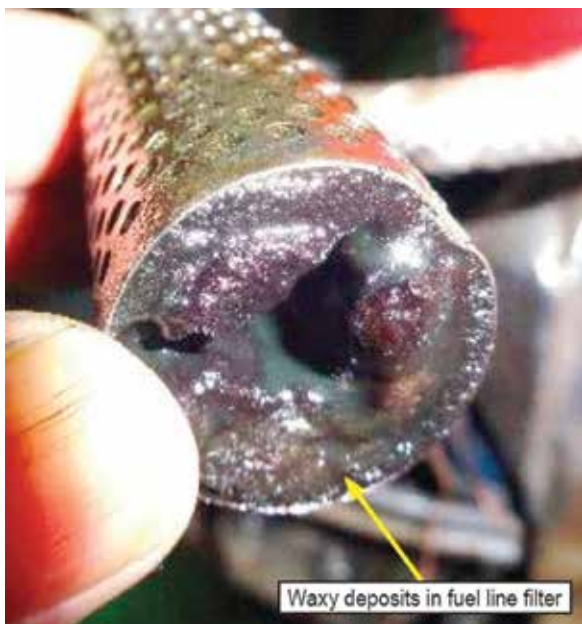
Examination of the boiler fuel system identified a build-up of waxy deposits in the supply filter, sufficient to restrict the fuel flow. Samples of the MGO being burnt at the time of the accident were sent to a laboratory for analysis. The tests found that the fuel had a cold filter plugging point (CFPP) of 14°C and a pour point (PP) of less than -9°C; it therefore required a minimum fuel operating temperature of 15°C. The ambient air temperature at the accident location was about 4°C, low enough for wax to form.

Since the more stringent sulphur emissions limit was introduced, there has been an increased incidence of boiler and marine diesel engine problems in colder waters, industry reports suggest. This has been attributed to the increased paraffin content found in some low-sulphur MGOs, which leads to the formation of waxy deposits or crystals as the fuel temperature falls. Restricted fuel flow due to wax deposits in filters and pipework can cause intermittent and incomplete combustion to the point of flame failure. This could have unintended consequences, as in this case.

- When purchasing low-sulphur MGO bunkers, give careful consideration to the ambient air and sea temperatures likely to be experienced during the voyage. The required cold flow characteristics of the fuel being supplied using cloud point (CP) and CFPP must be appropriate.
- If necessary, the CP and CFPP of the fuels carried on board can be tested through sample testing.

When operating in cold climates, the risk of waxy residue developing in the vessel's fuel lines can be controlled by:

- Closely monitoring the visual appearance of low-sulphur MGO bunkers for signs of wax precipitation
- Conducting regular fuel filter inspections and close monitoring of fuel system pressures.

- Maintaining the temperature of the low-sulphur MGO in the vessel's tanks and pipework above the CP and CFPP temperatures to avoid the possibility of filter blocking.

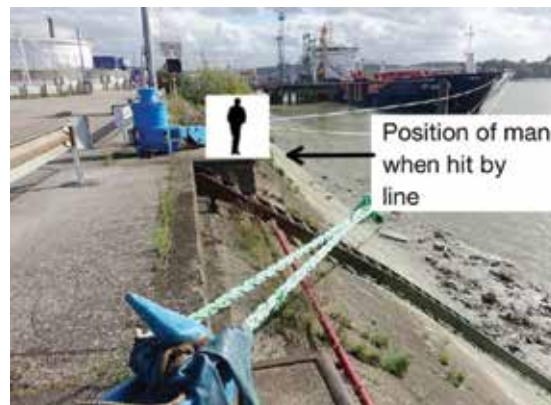
When enough line had been hauled ashore, the linesmen shifted the eye of the rope on the hook. The linesman was in the process of removing the layer on the drum when the slacked rope suddenly moved ahead on the left, hitting the linesman and throwing him down the embankment and into the water.

- When working with mooring lines, always be situationally aware of the forces and direction of tension that are in play – both on board and ashore.
- It is always good practice to keep linesmen in view while they are working your lines. If an accident happens to them, you are well placed to raise the alarm quickly.

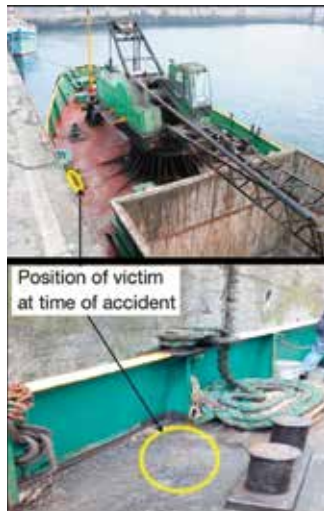
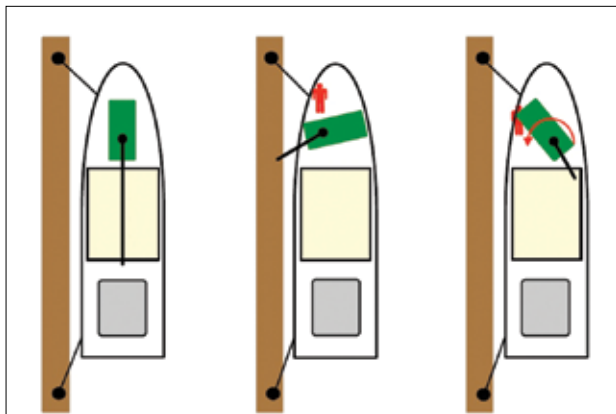
The crew member who was assembling the containers was in a vulnerable position on the port side, where the crane operator could not see him. He was trapped by the counterweight against the ship's bulwark. He collapsed and was quickly attended to but was later declared deceased.

- The victim was relatively inexperienced, and had probably not been made aware of the dangers of the foredeck while the crane was in operation
- The victim was not wearing hi-vis clothing nor a hard hat
- There were no barriers nor indications around the swing radius of the counterweight to warn persons of the danger.

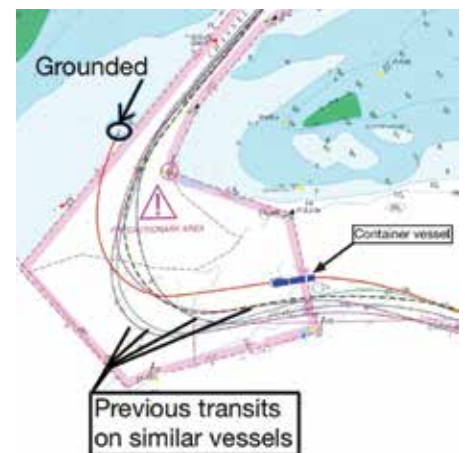
Soon after, the container vessel grounded with the engine at full ahead. The Master implemented the vessel's emergency procedures. The crew's initial inspections and tank soundings indicated that the vessel's hull had not been breached. Tugs quickly freed the vessel on the rising tide.

- The intended route through the precautionary area was not charted, and key decision points, wheel-over points and abort options were not identified.
- The absence of a charted pilotage plan meant that the Master, his bridge team and the assistant pilot were unable to monitor the lead pilot's actions and the vessel's progress during the execution of the turn in the precautionary area.
- The lack of a shared understanding of the pilot's intentions prevented the bridge team from providing the support to challenge or seek to clarify the pilot's actions.
- The bridge team became disengaged from the pilotage process and allowed the lead pilot to become an isolated decision-maker and a single point of failure.

- If you have concerns about the conduct of the vessel, discuss them with the entire bridge team.
- For critical turns or other manoeuvres, have key decision points established in advance. In this case, when compared with past trips, the vessel was obviously too far north as it entered the precautionary area and prior to making the starboard turn. This should have triggered an abort decision.
