Mariners' Alerting and Reporting Scheme

MARS Report No. 311 September 2018

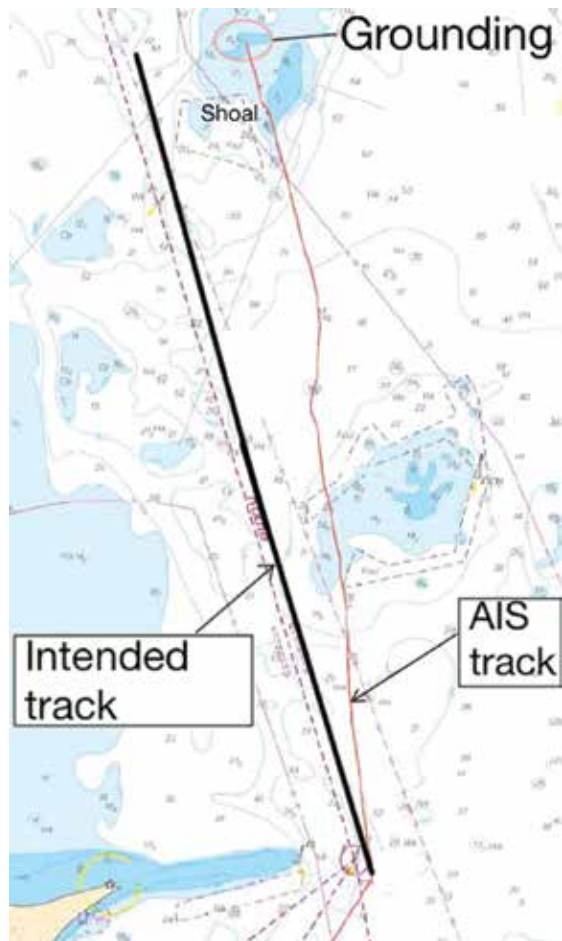
MARS 201853

Grounding on a charted shoal

→ A loaded bulk carrier was underway in coastal waters in good visibility. The bridge team was an OOW and a helmsman steering manually. According to the OOW, at one point a course alteration was undertaken to 340(G), although AIS recordings reveal the actual COG following the course change averaged 353(T). The vessel was not equipped with any sort of electronic chart nor an ECDIS and, according to crew, the radar was not helpful for position fixing due to clutter. The vessel's GPS was used as the primary position fixing tool.

After the course alteration, the OOW took a meal break and was replaced by another navigation officer. Having finished his meal, the OOW returned to the bridge and was informed by the other officer that no course changes had taken place and he had not put a position on the chart. About an hour and 50 minutes after having altered course the vessel ran aground on a charted shoal at a speed of about 12 knots. The vessel was severely damaged and needed lightering of fuel and cargo to be refloated.

- The official investigation found, among other issues, that;
- No position fix had been taken for almost two hours before the grounding.
 - The OOW was likely to have been fatigued and was attending to other duties while also navigating the vessel.

- As with other such groundings and collisions, a lack of attention to the primary duty of navigation was a main contributing factor.
- A radar can be adjusted for clutter and should be used as a primary fixing instrument or as a check on GPS fixes.

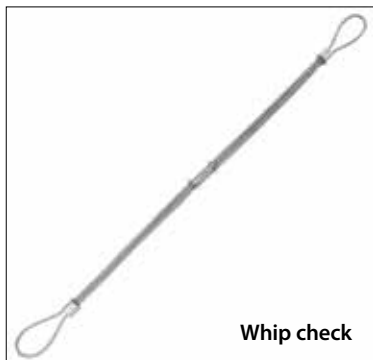
Whip check

→ A chemical tanker was underway and tank cleaning operations were being carried out with a mobile tank cleaning unit. A deck crew member was standing near the unit ready to close a valve during changeover from one cargo hold to another when the cleaning hose suddenly detached from its coupling. The loose hose hit the back of the deck crew's left leg. First aid was promptly administered and the victim was sent to rest.

The company's tank cleaning procedures and check list only described generic hazards arising from the use of mobile tank cleaning equipment. The specific risk of a sudden detachment of the tank-cleaning hose had not been clearly identified and assessed. The company investigation found that the type of hose used, with split type

coupling secured by bolts, was inadequate and that no whip check device was being used.

During the investigation on board it was also ascertained that a best practice is to reduce the working pressure of the hose to up to 1-2 bar before handling any valves. At the time of the event, the crew member manually operated the valve when the working pressure was at normal working pressure of 10 bar.

- Hazard identification and subsequent risk assessment are key to reducing accidents and incidents.
- A 'whip check' device is an effective risk mitigation tool for hose connections under pressure.

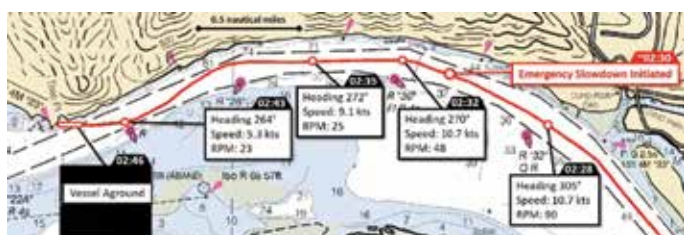
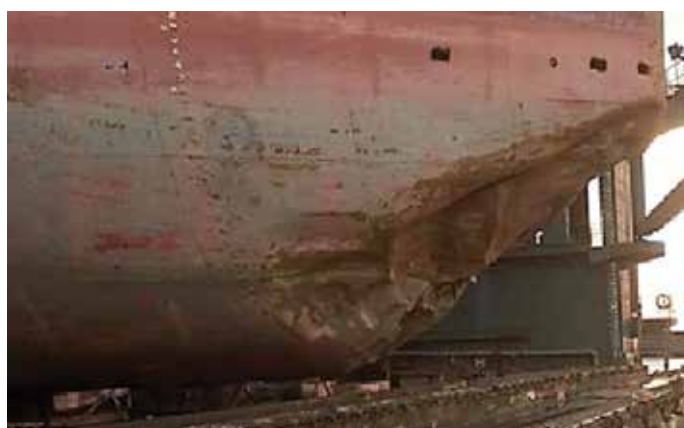
MARS 201856

➔ A loaded bulk carrier was outbound in a river channel, in darkness and under pilotage. An OOW, helmsman and Master were also on the bridge. The vessel was stemming a 1 knot flood tide and making way at near 11 knots. At one point the engine RPM decreased from 90 to 48 under an automatic programme. The pilot asked what was happening. The Master spoke to the engine room personnel and responded that there was an engine problem, but they were fixing it.

For the next 10 minutes the pilot tried to keep the vessel in the channel using the reduced RPM while the Master talked to the engine room personnel on the phone in his native language, which the pilot did not understand. At one point the Master asked the pilot if they should anchor. The pilot responded that the location was not good as the current was reversing direction due to the ebb tide.

The Master continued to talk with the engine room personnel, with the vessel now slowing to about 6 knots. With no answers to his questions about the main engine, the pilot ordered both anchors away and emergency full astern. The vessel drifted nonetheless and grounded on the channel side. Damage to the vessel was estimated at approximately \$4 million.

The investigation found that the engine failure was due to a cracked main engine cylinder cooling jacket that initiated an automatic reduction in engine speed.

- In restricted waters, quick decision-making is necessary if the main engine is at fault. In hindsight, a cracked cooling jacket could not be fixed in the time available; the pilot should have been informed immediately that the main engine was unavailable.
- If one must go aground, apart from letting go the anchors, look for a soft spot to put the bow.
- Check your Master-Pilot exchange checklist. If your vessel has main engine automatic speed reduction programs, include these on the information given to the pilot.

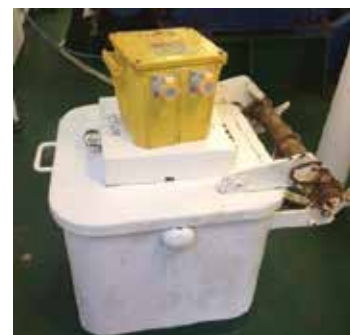
MARS 201857

➔ During a general walk around on a vessel a heavy electrical transformer was discovered on top of an emergency escape hatch. After investigation it was found that the transformer had been left by an outside contractor who had placed it on top of an escape hatch because the cable was too short to reach a power socket – even though the top of the hatch was marked 'Escape'.

The extra weight on top of the escape hatch would have made it extremely difficult if not impossible to open.

- Conduct a full and proper toolbox talk at the worksite; understand the scope of work and how the contractor intends to carry out the task, what tools they are going to use and any other requirements they may have.
- Conduct impromptu inspections of the worksite.
- Responsibility ultimately stops with you!

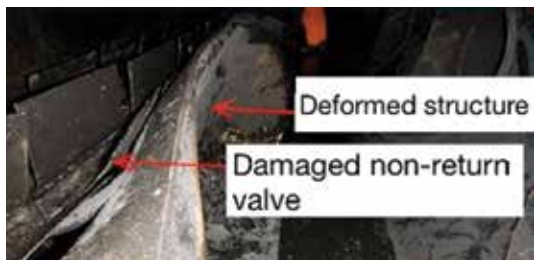
MARS 201858

➔ A cargo vessel was drifting, but preparations to start the engine and proceed for pilot pick-up were underway. Engine room crew proceeded to do an 'air blow' but soon afterwards smoke was seen coming from the indicator valve. They were then unable to start the main engine.

An investigation found that the scavenging space had been severely damaged by an explosion, especially the non-return valve manifold box. Further investigation found that ship's personnel had cleaned the scavenging space while the ship was drifting. It appears they had used flammable materials for the cleaning task. The cleaning materials vaporised forming a combustible atmosphere in the scavenging space. When the combustion wave in the cylinder propagated to the scavenging space, an explosion occurred.

- Never use flammable materials such as kerosene or gas oil to clean areas with high operating temperatures, eg the scavenging space.

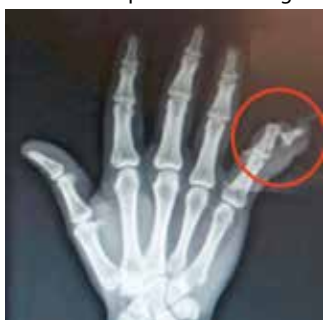
MARS 201859

→ While at anchor in fair weather some deck crew were performing maintenance on the mooring winches. A crew member had just greased one of the winches. He asked another crew member to start the winch and rotate it so he could wipe out the excess grease.

The assisting crew member started the winch, but almost immediately the greasing crew member cried out to him to stop the winch. His finger had been caught in the machinery and even though he had gloves on, his small finger was severely injured. After first aid was administered he was evacuated ashore where the tip of his small finger had to be amputated.

The company investigation found that in previous manoeuvres to remove excess grease a long flat paint brush had been used. In this incident the crew member used a small piece of cloth to wipe out the excess grease, bringing his hand close to a known hazard.

- Never cut corners for the sake of expediency – use the right tools for the job.
- Running risk assessments should become a matter of habit, but common sense should also be used in everything we do.

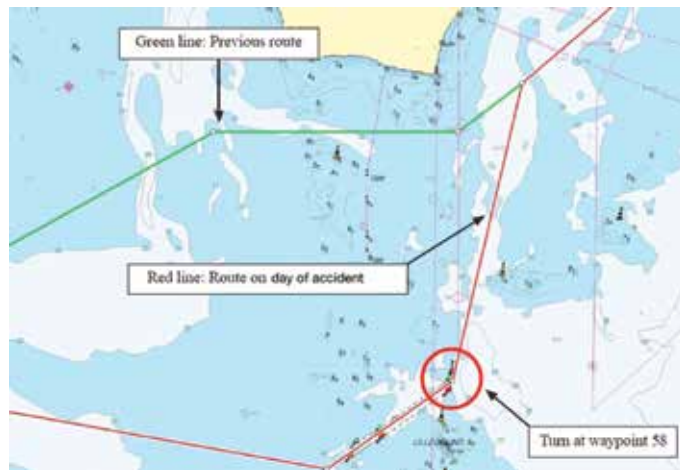
MARS 201860

→ A vessel was underway at about 16 knots in coastal waters and near darkness. The OOW was at the con with the Master present on the bridge and a helmsman at the wheel. The vessel was bound for a regular port of call but was using a different route from previous trips because of the vessel's draught.

At one point the OOW and the Master had a short discussion about the angle to the buoys at the entrance to the deepwater route, which was the next course change at waypoint 58. The channel was only approximately 0.2nm wide, with an area of shallow water north of the buoys. The angle of approach would make it difficult to execute a turn into the channel, from 192° to 237°.

They agreed to alter slightly to port to allow a larger turning circle, but the current and wind were affecting the ship in such a way that this slight alteration did not give the desired results. The vessel was still to the west of the planned route and coming close to a charted isolated danger near the buoys that marked the entrance to the deepwater

Suddenly, the ship started to vibrate violently, the speed dropped from 16 to 7 knots and the ship's heading changed from 195° to 204°. Within a minute, the vibrations stopped and the ship's speed increased. The crew quickly realised that the ship had touched the seabed. The bottom of the hull had been breached in several places along the starboard side damaging several fuel oil tanks. Some local coastlines were polluted as a result.

- Use all available means to navigate your ship.
- When in doubt, slow down.
- It proved to be difficult to make that course change at a speed of 16 knots, in near darkness and with a westerly current of approximately 1 to 1.4 knots. When passage plans are modified check for appropriateness of course changes and proximities to hazardous areas. In this case the angle of approach to the deepwater channel was inappropriate.

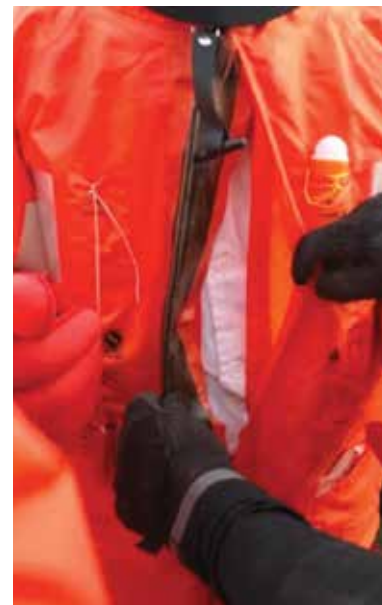
MARS 201861

→ During a recent inspection a significant flaw was discovered on approximately 87% of a vessel's immersion suits. The glue used to attach the main zipper to the body of the suit had failed. This defect will prevent the suit from achieving a watertight seal and will present serious risk to crew members in a survival situation.

- Regularly inspect immersion suits for this and all potential unsafe conditions. Do not wait to discover the problem during a real emergency.
- Any replacement immersion suits need to be approved by the vessel's flag state.
