Mariners' Alerting and Reporting Scheme

MARS Report No. 314 December 2018

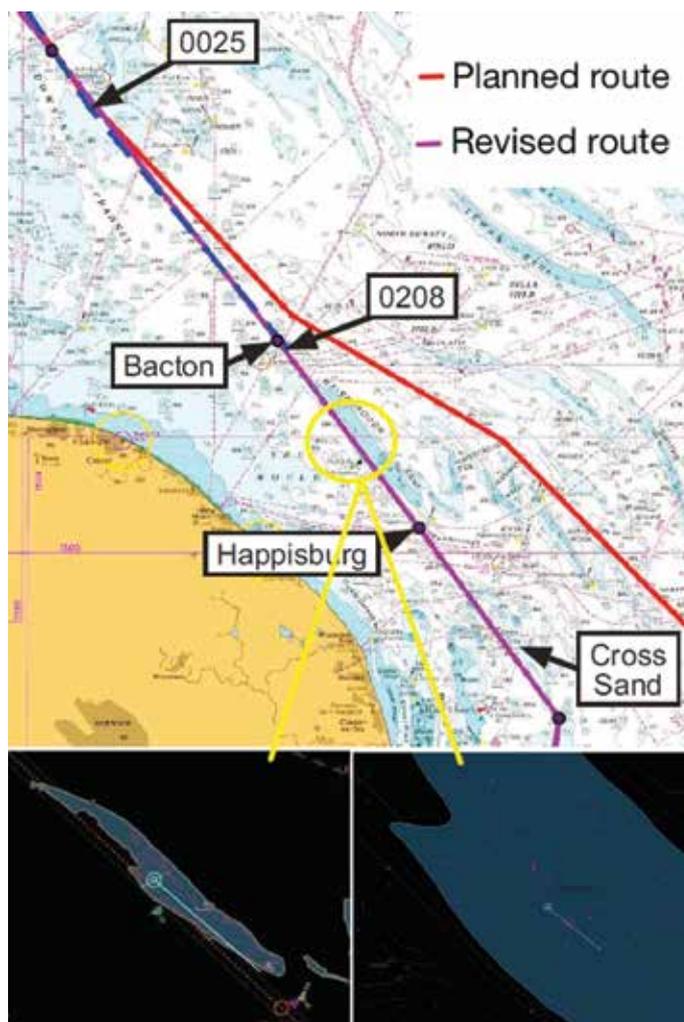
ECDIS 'standard' view

ECDIS 'all' view

- The OOW's visual check of the revised route did not identify that the track over Haisborough Sand was unsafe; it was neither planned nor checked on a chart of appropriate scale.
- The revision of the passage plan conflicted with the OOW's watchkeeping duties and the Master did not check and approve the revised route.
- The audible alarm and the guard zone had been disabled, removing the ECDIS barriers intended to alert bridge watchkeepers to imminent danger.
- The use of the 'standard' chart view limited the information displayed. Relying on visual checks when passage planning meant the process was prone to error.

- Changing a passage plan 'on the fly', in this case at night, while underway and without the Master's final check, introduces additional risks.
- Select the appropriate level of zoom and chart view when using ECDIS, especially when navigating coastal waters.

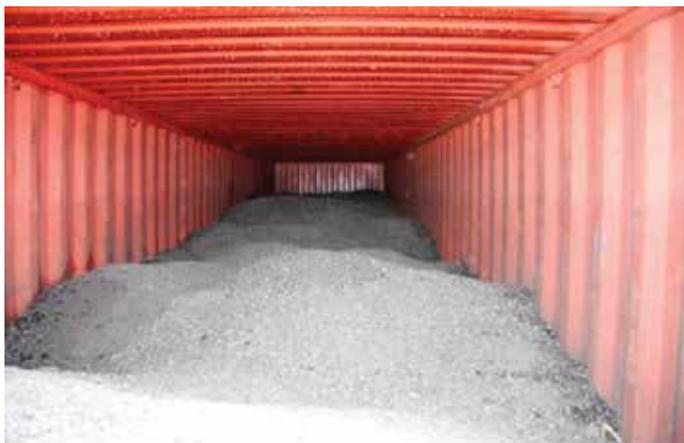
Charcoal as loaded in container

- It is not possible to fully determine the hazardous material properties of charcoal based on the UN N.4 test alone. This is at least true of charcoal that passes the preliminary test and is then transported in large packages or in bulk in large sea containers, for example.
- The UN N.4 test does not sufficiently address the dependency on the volume of the goods transported.
- In multiple instances, the cargo documents examined in connection with this case could not be definitely linked to the cargo transported – see Lessons Learned below.

- Check that the laboratory certificate is applicable to the customer...
- Check that the laboratory is accredited by the competent authority...
- Check that the manufacturer's name is shown on the laboratory certificate...
- The laboratory certificate must accompany the shipment. After the

containers have been stuffed, the container numbers are to be added to the certificate (hand written is acceptable) and placed on board the vessel...

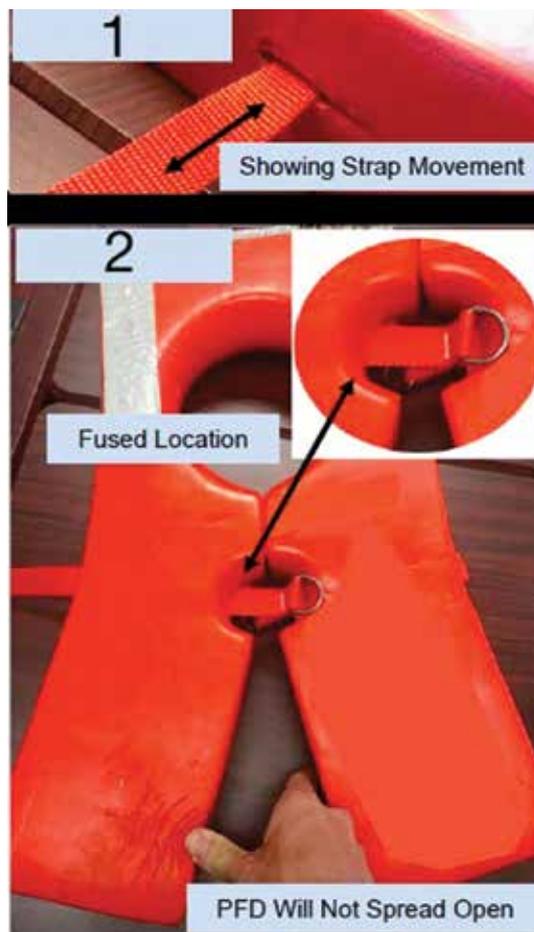
➔ During recent US Coast Guard inspections it was discovered that the securing strap of many lifejackets produced by a particular manufacturer were defective. The securing strap was fused at a point where it should have allowed sliding movement. As a result, a user would not be able to separate the halves of the personal flotation device (PFD) to allow proper donning of the vest.

Figure 1 shows a proper lifejacket while Figure 2 shows a defective example.

- Lifejackets are there to save your life – inspect them regularly and with diligence.

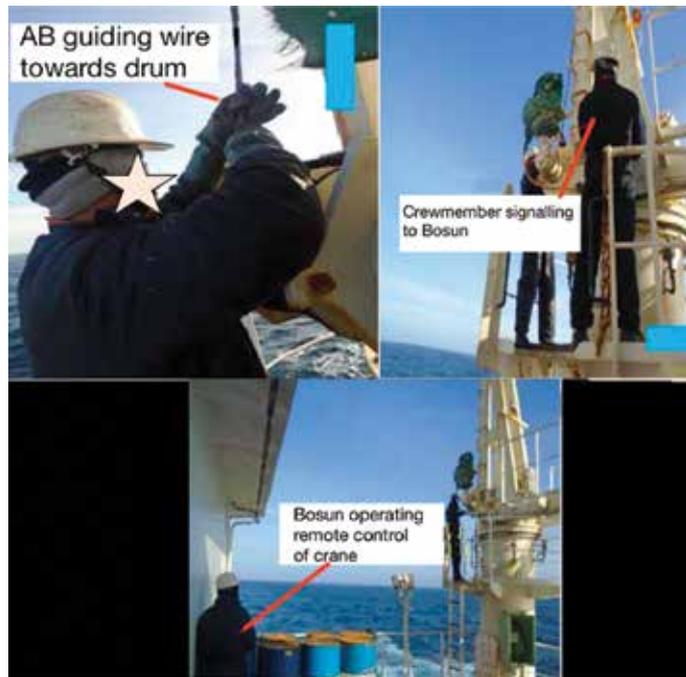
At one point, wire pinched the fingers of the crew member guiding it, causing him to cry out in pain.

The bosun reacted quickly but, out of confusion and panic, he operated the crane in the wrong direction, which resulted in the crew member's hand being further squeezed by the warping drum. First aid was immediately administered. Because of the severity of the injury, however, the victim had to be signed off from the vessel and sent ashore for further medical attention.

The company investigation found that the bosun, who had just joined the vessel, was not sufficiently familiar with the safe and smooth operation of the crane.

- A toolbox meeting (or Take-5 system) that exposes the job hazards and mitigation measures can help reduce accidents.
- Co-ordination and communication techniques should be agreed upon while performing any job that involves more than one person.
- Proper familiarisation should be given to any newly joined crew members. For example, the first few operations of the crane by a newly joined member of crew should be done under supervision of a qualified officer or other experienced crew member.
- Operating procedures and the instructions on the crane's key controls (with photographs) could be posted near the provision crane operating position for easy reference.

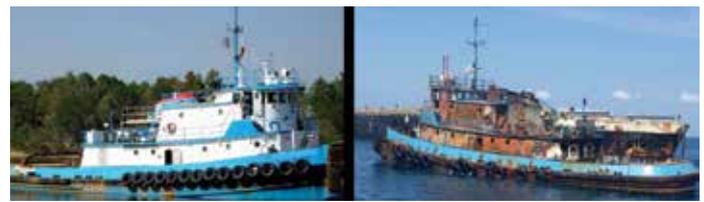
The probable cause of the fire was an ignition originating near an electrical fuse box in the upper engine room. Contributing to the intensity of the fire was the presence of combustible materials in the upper engine room, which included a drum of waste oil.

Before

After fire

- Engine room areas should be kept clean and free of unnecessary objects and stores, as these can act as fuel for any potential fire.

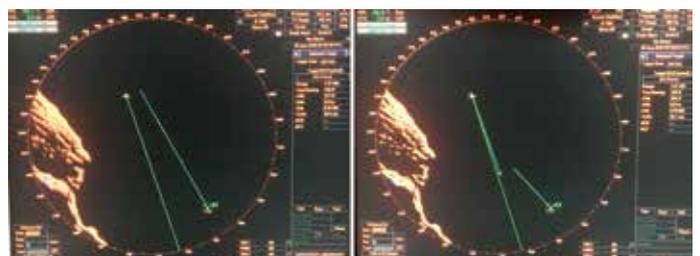
Although it is true that this lesson learned is not a 'finding' *per se* in the source report, MARS staff have more discretion than the accident investigators to direct readers' attention to what can be improved. The source report is nonetheless concerned with this issue; using relative mode gives an intuitively simple visual representation of collision risk. This is made abundantly clear by the photos below, which are for the same target at the same moment, with a CPA of 0.76nm.

Relative mode

True mode
