Safer Seas 2013

LESSONS LEARNED FROM MARINE
ACCIDENT INVESTIGATIONS

Office of Marine Safety Investigations

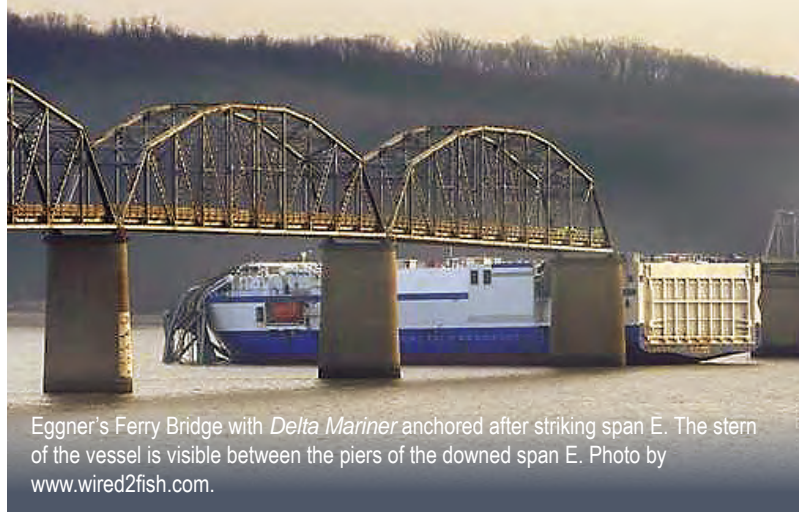
Eggner's Ferry Bridge with *Delta Mariner* anchored after striking span E. The stern of the vessel is visible between the piers of the downed span E. Photo by www.wired2fish.com.

At 2001 local time, the *Delta Mariner* allided with a bridge span that provided insufficient vertical clearance for the vessel's passage (the lowest of Eggner's Ferry Bridge's four navigable spans). The *Delta Mariner* was traveling at a speed of about 11.5 mph when it struck the bridge and tore away a 322 foot long span, including a portion of US Highway 68. Bridge debris lodged across the bow of the ship. The vessel sustained minor damage to its bow area, but its cargo was undamaged. Traffic was light on the bridge at the time of the accident, and vehicles traveling on the highway stopped before reaching the missing span. No injuries were reported on the vessel or on the highway, and no pollution was reported.

The National Transportation Safety Board determines that the probable cause of the allision of the *Delta Mariner* with Eggner's Ferry Bridge was the bridge team's exclusive reliance on the contract pilot's incorrect navigational direction as the vessel approached the bridge and their failure to use all available navigation tools to verify the safety of the vessel's course. Contributing to the accident was Foss Maritime Company's failure to exercise effective safety oversight of the *Delta Mariner*'s operations and the failure of the Kentucky Transportation Cabinet to effectively maintain bridge navigation lighting.

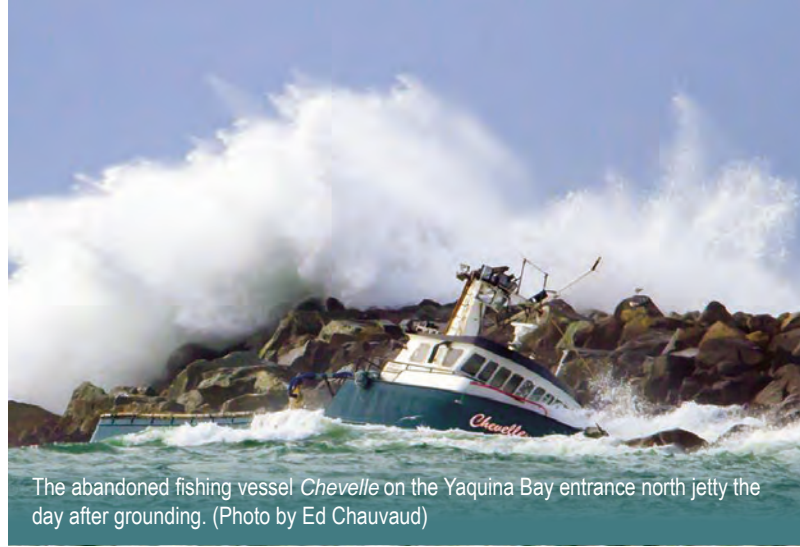
The abandoned fishing vessel *Chevelle* on the Yaquina Bay entrance north jetty the day after grounding. (Photo by Ed Chauvaud)

The National Transportation Safety Board determines that the probable cause of the grounding and subsequent loss of the *Chevelle* as it crossed the Yaquina Bay bar was the master’s loss of control of the fishing vessel after a series of breaking waves on the stern heeled the vessel to a severe degree from which it did not recover.

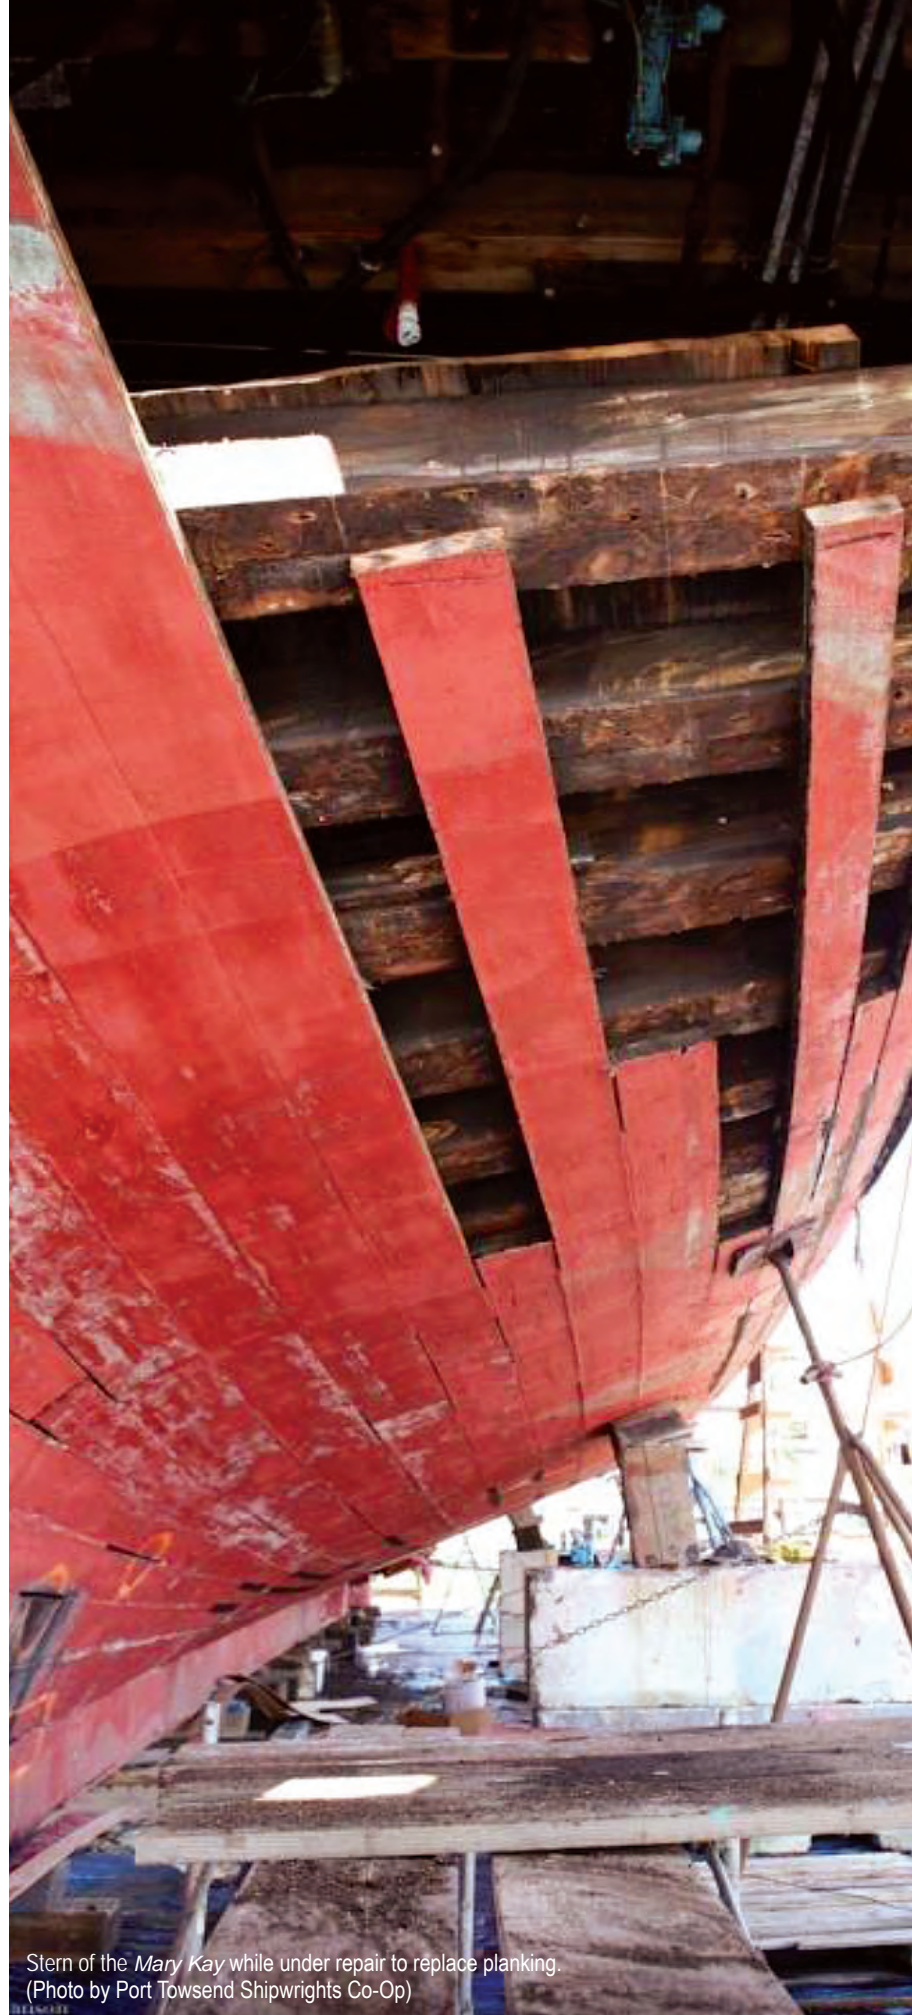
Stern of the *Mary Kay* while under repair to replace planking.
(Photo by Port Townsend Shipwrights Co-Op)

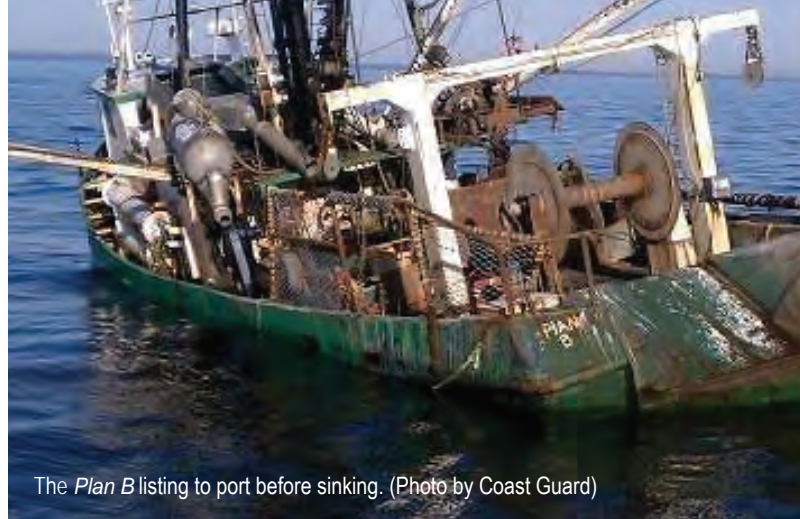
The *Plan B* listing to port before sinking. (Photo by Coast Guard)

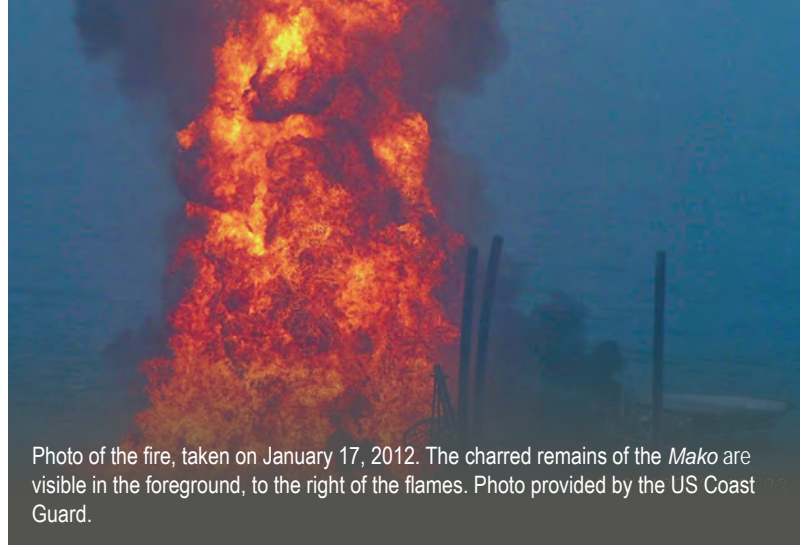
Photo of the fire, taken on January 17, 2012. The charred remains of the *Mako* are visible in the foreground, to the right of the flames. Photo provided by the US Coast Guard.

The National Transportation Safety Board determines that the probable cause of the fire on board and sinking of the liftboat *Mako* was a blowout of the wellhead under the adjacent jackup drilling rig *KS Endeavor*, which resulted in an uncontrollable gas fire that rapidly spread to the liftboat.

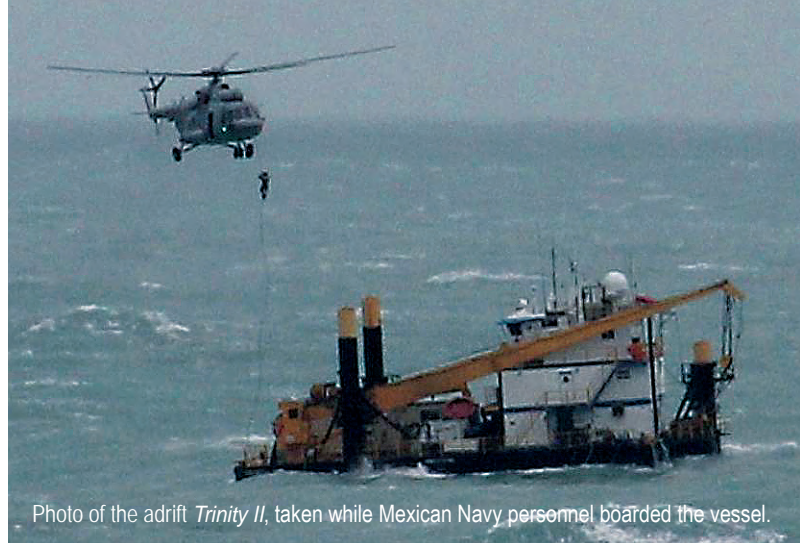
Photo of the adrift *Trinity II*, taken while Mexican Navy personnel boarded the vessel.

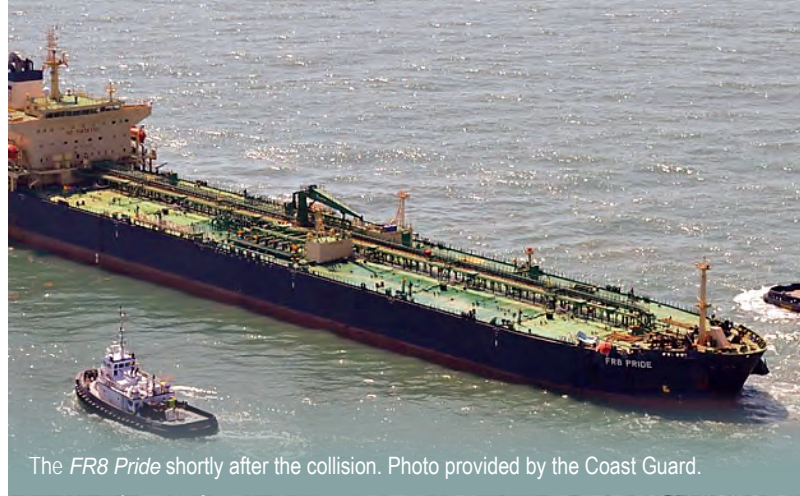
The *FR8 Pride* shortly after the collision. Photo provided by the Coast Guard.

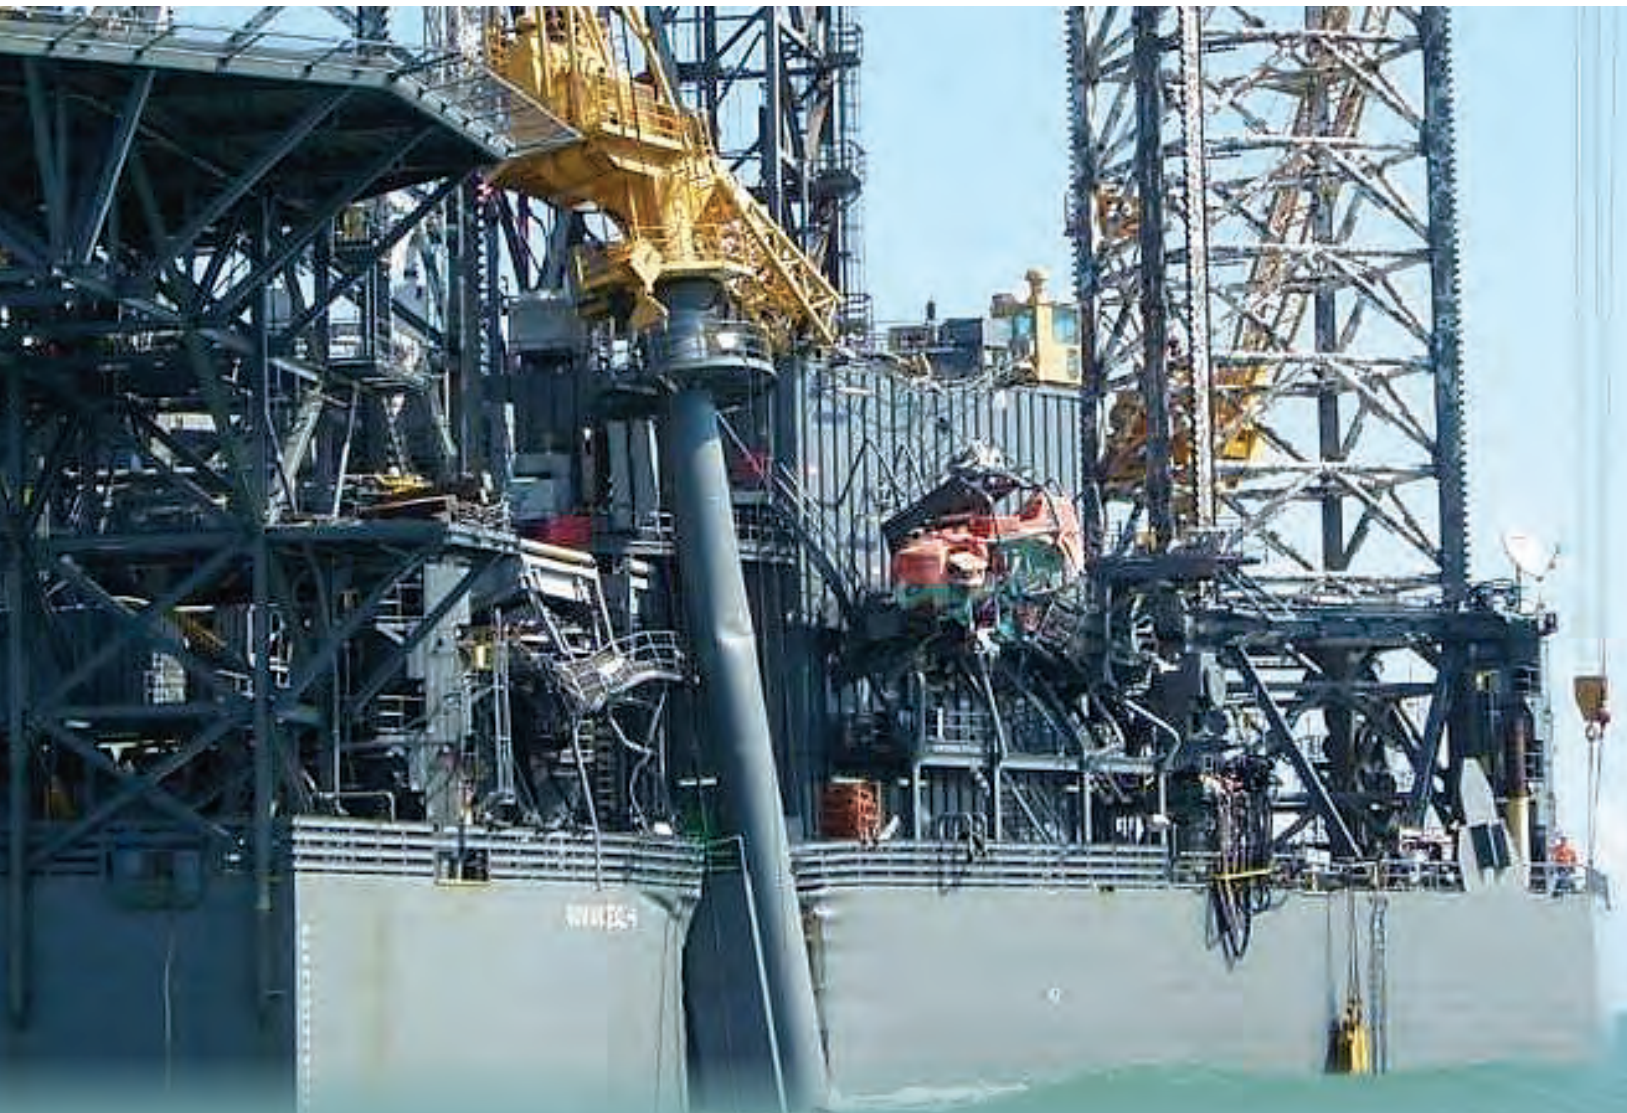
The National Transportation Safety Board determines that the probable cause of the collision of oil tanker *FR8 Pride* with MODU *Rowan EXL I* was the failure of the *FR8 Pride's* main propulsion engine, which resulted in reduced maneuverability of the ship.

The extensive damage to the port side of the *Rowan EXL I*, including its destroyed survival crafts (orange-colored) near the center of the photo. Photo provided by the Coast Guard.

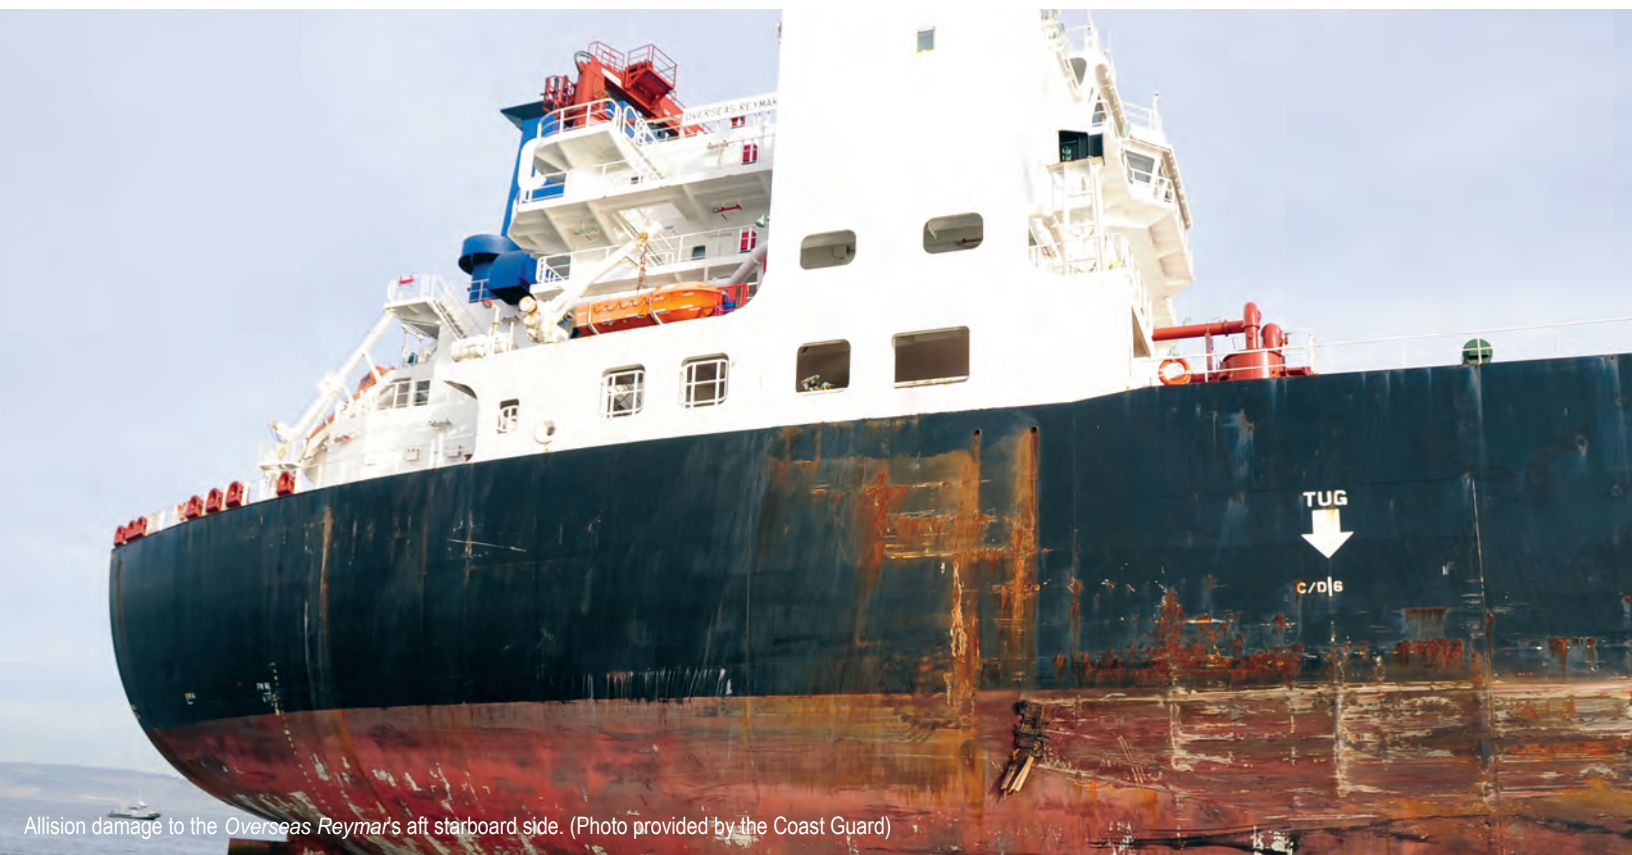
The National Transportation Safety Board determines that the probable cause of the *Overseas Reymar* allision with the San Francisco–Oakland Bay Bridge was the pilot's decision to alter course from the CD span to the DE span without sufficient time to avoid alliding with the bridge's Echo tower and the master's failure to properly oversee the pilot while engaging in a phone conversation during a critical point in the transit.

Allision damage to the *Overseas Reymar*'s aft starboard side. (Photo provided by the Coast Guard)

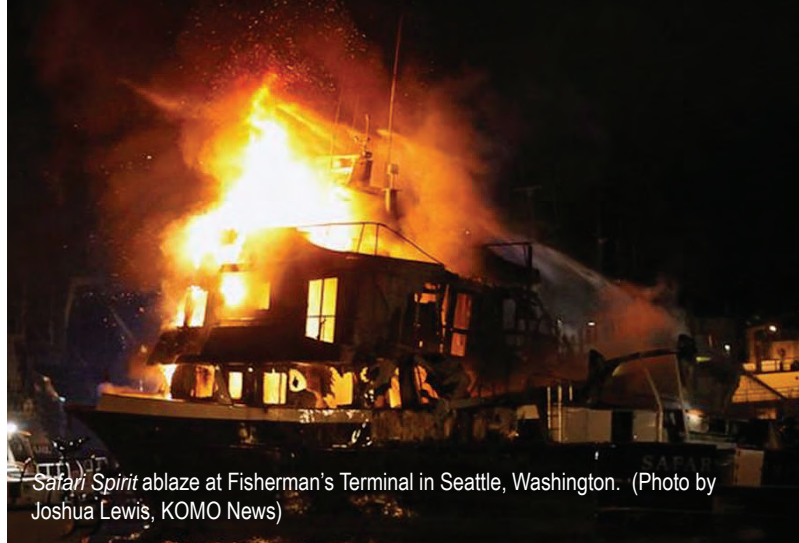
Safari Spirit ablaze at Fisherman's Terminal in Seattle, Washington. (Photo by Joshua Lewis, KOMO News)

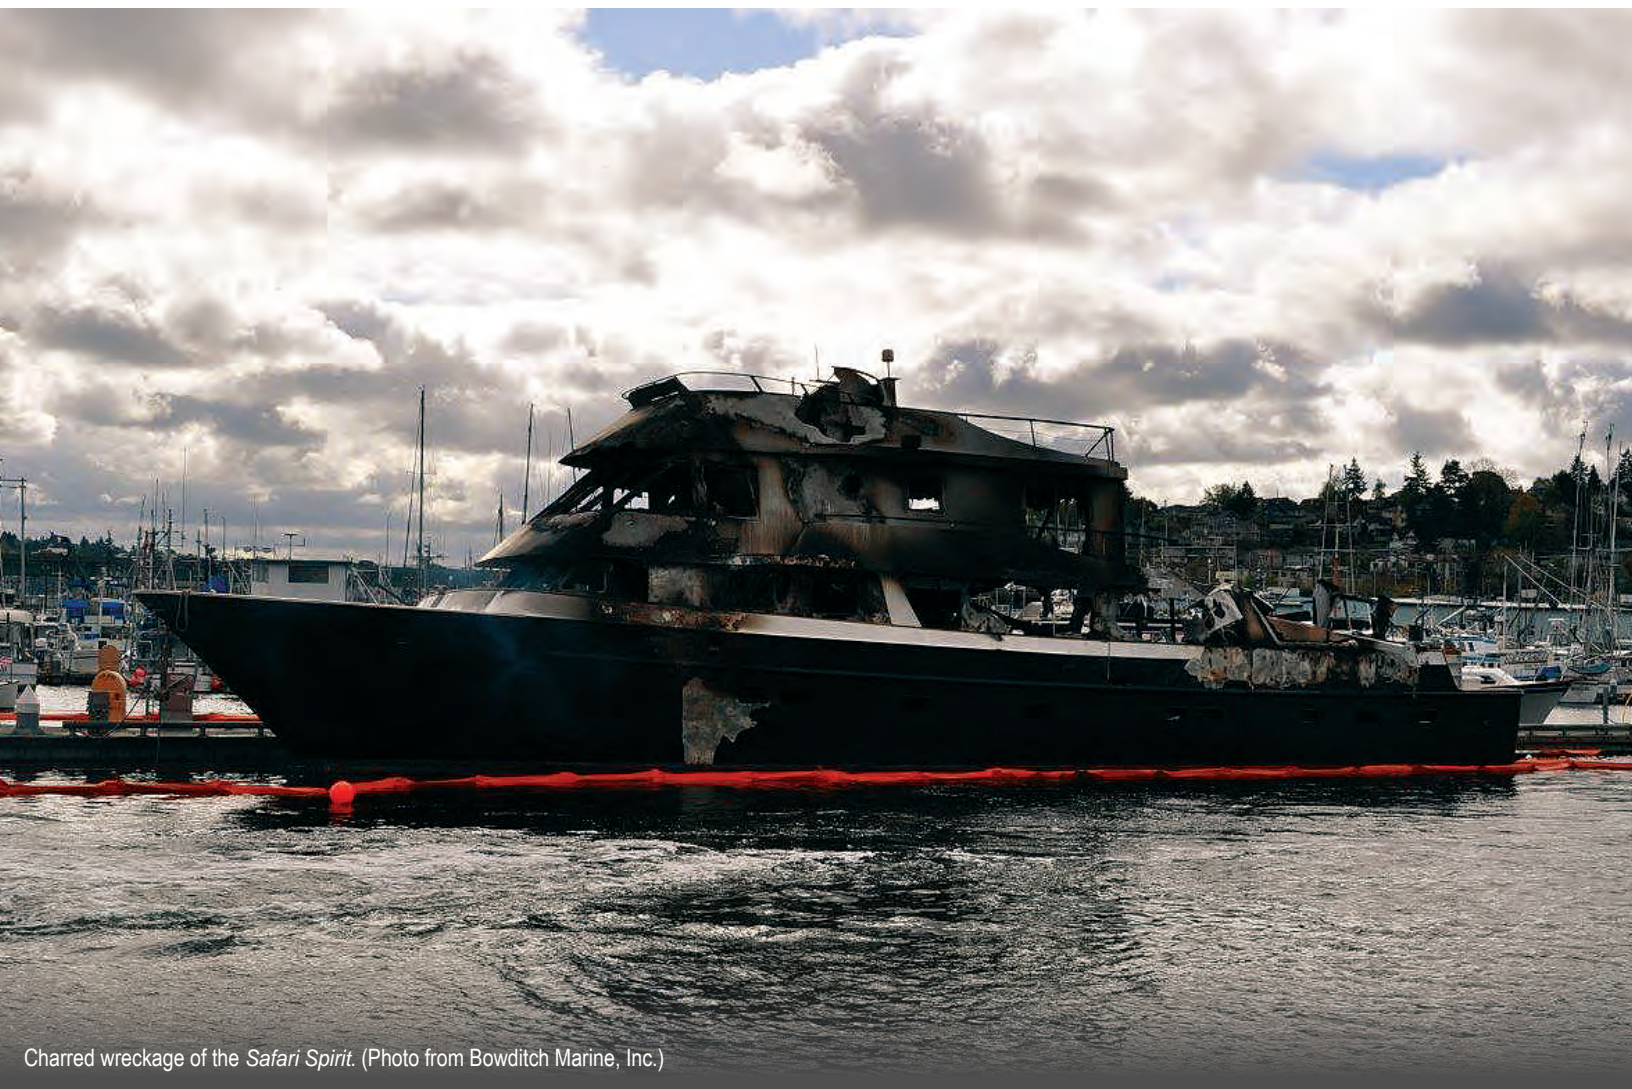
Self-heating is a process in which heat is created within a material through a biological or chemical process and without the application of an external heat source. If self-heating increases the temperature of the material above its ignition point with sufficient oxygen present, self-ignition can occur. Sufficient air must be present to sustain the combustion reaction, but not so much air that the heat is dissipated. Common examples of materials that can self-heat or self-ignite are linseed oil rags, coal dust, hay, wood chips, manure, and latex.

Charred wreckage of the *Safari Spirit*. (Photo from Bowditch Marine, Inc.)

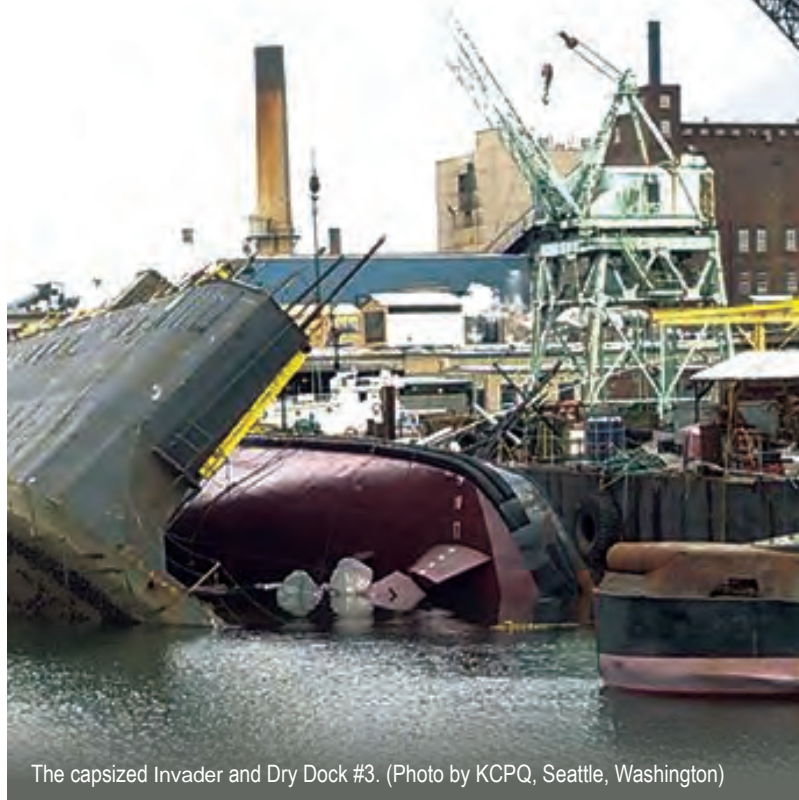
During the day on March 17, 2012, pumping activities had taken place on board Dry Dock #3. That evening, water leaked past the check valve of Tank #5 on the dry dock's starboard side; debris in the check valve prevented it from closing. In addition, the 4-inch discharge valve had been left open (even though the dock master told investigators it was customary to close the discharge valves after use), and this allowed ingress of water. The weight of the water gradually caused the dry dock to list to starboard. Further, the cover plates to the access manholes on Tanks #1 and #7 had been left open and unattended. As the dry dock

The capsized *Invader* and Dry Dock #3. (Photo by KCPQ, Seattle, Washington)

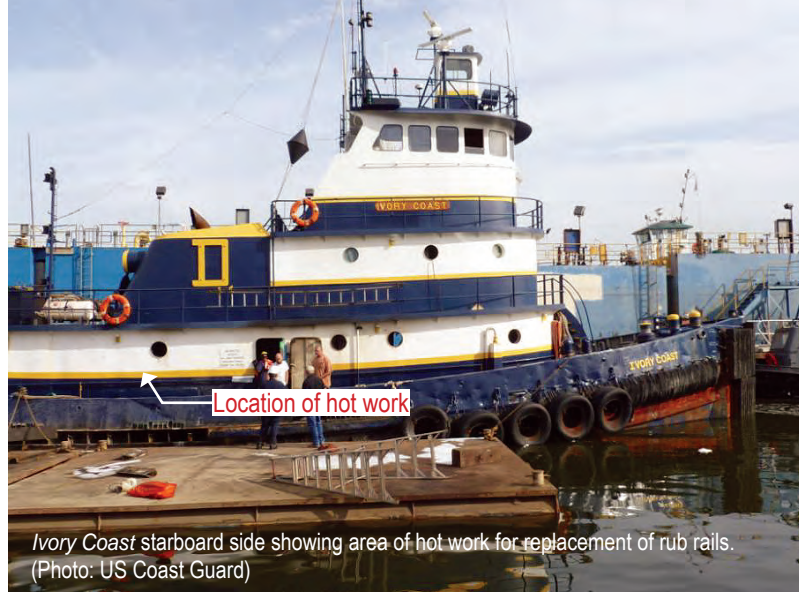
Ivory Coast starboard side showing area of hot work for replacement of rub rails. (Photo: US Coast Guard)
