TOP 10 CARGO VESSEL (SUBCHAPTER I) DEFICIENCIES

We conducted an analysis of all deficiencies recorded by CG Marine Inspectors while inspecting certificated commercial vessels (other than Offshore Supply Vessels) under Subchapter I. The purpose of this analysis was to identify the ten most common deficiencies to share with the owners/operators so they can take corrective actions onboard their vessels, ensure continual compliance with safety and environmental requirements, and so that problems can be rectified prior to scheduling the next Coast Guard examination.

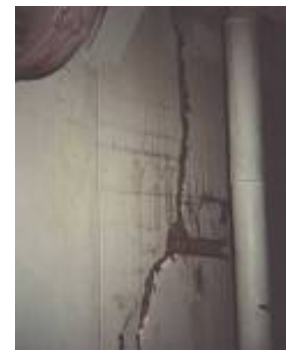
2. A. Hull Plating (46 CFR 126.140, USCG NVIC 7-68) While inspecting older vessels, inspectors will typically find breaches (holes and cracks) in the hull plating, as well as wastage of structural members. "Navigation and Vessel Inspection Circular No. 7-68" has provided the guidance for "Inspection and Repair of Steel Hulls" for four decades and is available on Homeport.USCG.mil. Where temporary repairs had previously been made, it is recommended that owners/operators make arrangements for permanent repairs before scheduling the examination. Occasionally, an inspector notices a temporary repair that had not been previously documented.

B. Deck Plating A common defect is cracked (hatch) corner brackets, which can easily be seen from below. Look for cracks in the vessel's winch foundations. Also look for obvious wastage of deck plating.

C. Ballast Tanks Some operators of ships that are constructed with upper and lower ballast tanks, are required to inspect their Lower Wing Ballast Tanks and notify the USCG District. These operators should have documentation available for the inspector.

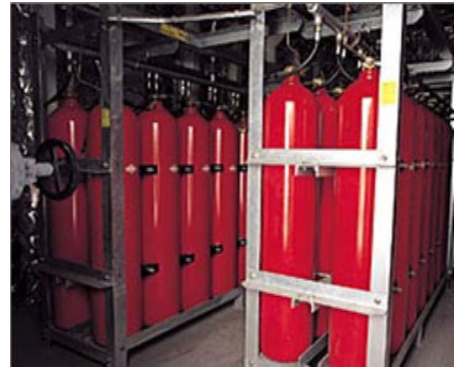
8. Fixed Carbon Dioxide (46 CFR 91.25-20 and 147.65) All piping controls, valves and alarms need to be checked for proper operation and 90% charge has to be verified. The pressure drop through cylinder connections may not exceed 150 psi per minute, over a two minute period, while subjected to the 1,000psi test pressure. Arrangements will usually have to be made for a contractor. Additionally, all carbon dioxide cylinders must be retested every 12 years. If cylinders ever have to be discharged at a time when it has been more than five years since they were pressure tested, they must be retested before recharging. Enclosure (1) to NVIC 6-72 lists the inspection requirements in one concise paragraph: "D.2.". The National Fire Protection Association provides the technical specifics for the inspection: "NFPA 12, Chapter 9.4.3".
