TOP 10 TOWING VESSEL DEFICIENCIES

We conducted an analysis of all deficiencies recorded by CG field personnel while inspecting, investigating or boarding “uninspected towing vessels” (UTV) that have been required to meet the provisions of Subchapter C. The purpose of this analysis was to identify the ten most common deficiencies to share with the owners/operators assist UTV owners/operators identify and correct common problems.

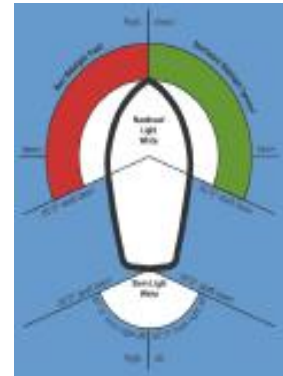
2. Running Lights (Masthead, Side and Stern) Inoperable or Defective (46 CFR 25.10-3) All vessels must have navigation lights in accordance with the International and Inland Navigation Rules. Many towing vessels are found to have inoperable stern, masthead, and sidelights. In some instances the installation of these lights was found to conflict with the International and Inland Navigation Rules, including the lack of “matte black” painting of the light screens. Vessel owners/operators should test their navigation lights prior to each voyage to ensure proper operation. Operators should inspect their running lights periodically, paying particular attention to the condition of the lenses, wattage and focal height of the light bulbs. The bulb’s filament must be at the same height as the middle portion of the lens. Household bulbs are not acceptable. Navigation Rule 24 provides the running light requirements for towing vessels and Rule 22 gives the ranges of visibility over which the lights must be visible.

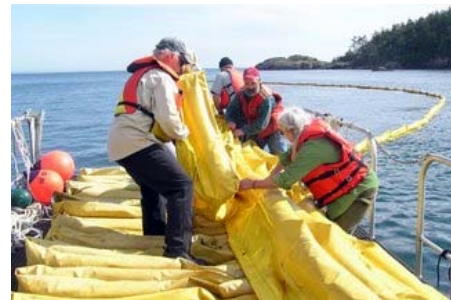
7. Vessel Response Plan (33 CFR 155.1040, 155.1060) With regard to towboats that push tank barges, the most common items that are either lacking from or not sufficiently addressed in the response plan are: (1) Certification that response resources are ensured under contract to respond, to the maximum extent possible, to a Worst Case Discharge; (2) Volume and type of oil that would be discharged in a Worst Case Discharge; (3) Responsibilities of the qualified individual for immediate communication with the NRC; (4) Vessel-specific information on the barges and the Captain of the Port Zone information for the areas in which the barges will be operated. Documentation of "Contract of other Approved Means of Spill Removal" must be on board. Response exercises and Qualified-Individual Notification exercises are required quarterly. Management Team exercises and Equipment Deployment exercises are required annually. Records of these exercises must be kept for three years. Owners/operators, who need to amend a Response Plan or submit a plan for approval, must use the "Homeport" web portal, <http://homeport.uscg.mil> - Log-in, click Help and navigate the "Homeport Plan Submitter".

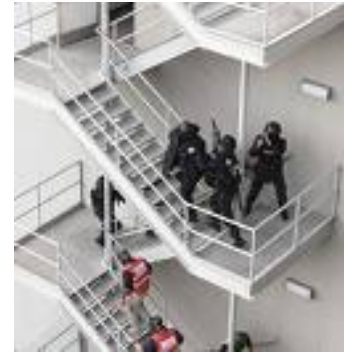
8. Vessel Security Plan (33 CFR 104, Subpart D) The Company Security Officer or the Vessel Security Officer must ensure that the Vessel Security Plan (VSP) is audited annually. The VSP must also be audited if the owner or operator of the vessel changes or if there has been any change in the operations of the vessel not addressed in the existing VSP (104.415). If the results of an audit indicate that the VSP must be amended, an amended VSP must be submitted to the Coast Guard's Marine Safety Center for review and approval (104.410). Plans may be submitted electronically through the Coast Guard's "Homeport" web portal after becoming a registered user. Vessel Security Officers must conduct at least one drill every three months while the vessel is in service. These drills must test individual elements of the VSP. Annual exercises are required to test communication & notification procedures and elements of resource availability, coordination and response (104.230). Records of drills, exercises and all other security activities must be kept for two years (104.235).
