Inaccuracies in Draught Surveys

Loss Prevention Bulletin

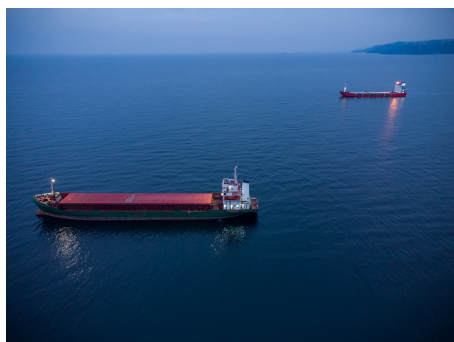
However, poorly painted, rusty, or draught marks covered with marine growth make reading the draught accurately problematic, therefore it must be ensured, so far as possible, that the draught marks are kept in a readable condition.

Darkness and shadows also make accurate reading difficult; therefore good lighting will be required at night. The turn of the hull around the stern leading to elongation of draught marks being viewed from an oblique angle, especially when this has to be done from an adjacent wharf at a higher level, can lead to difficulty in accurately determining the draught.

It is therefore advised to ensure that the inspection and maintenance of the draught marks be included in the planned maintenance system on a vessel.
