Loss Prevention 15 Dec, 2023

Djibouti - Port Authorities Crackdown on Air Pollution from Vessels

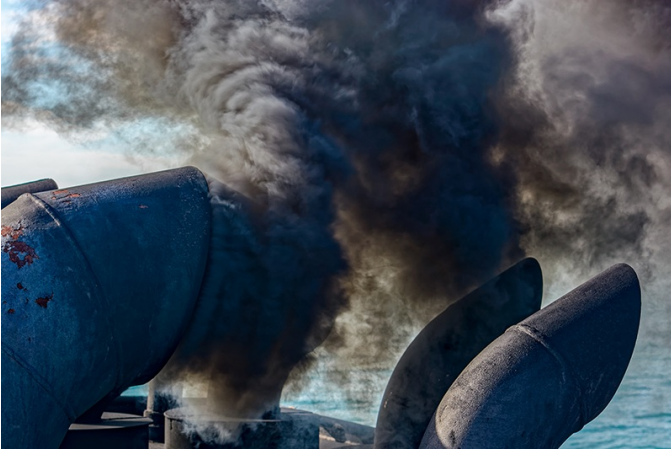
Excessive black smoke emanating from a vessel's exhaust system frequently indicates incomplete fuel combustion. Addressing and lessening this problem necessitates an understanding of various contributing factors. Vessels should consider the following key elements:

- Poorly maintained engines, malfunctioning injectors, and worn-out components can impede combustion efficiency, producing black smoke.
- Insufficient fuel atomisation during injection can produce larger droplets that do not combust completely, contributing to black smoke formation.

- Turbocharger issues, including malfunctioning components, excessive wear, clogged air filters, fouled blades and nozzle rings, can affect charge air pressure, impeding combustion and causing black smoke.

- Clogged fuel injectors disrupt the spray pattern, impacting fuel distribution in the combustion chamber and causing incomplete combustion.
- Fuel pump malfunctions can influence fuel delivery to the combustion chamber, affecting combustion and potentially causing black smoke emission.

Addressing these factors through regular maintenance, proper operational practices, and adherence to fuel quality standards can help minimise the risk of excessive black smoke emissions from a vessel's exhaust system, preventing possible exposure to fines by the authorities. Furthermore, it is advisable to refrain from using the vessel's incinerators during approach and in ports.
