## Loss Prevention Bulletin

# Inaccuracies in Draught Surveys

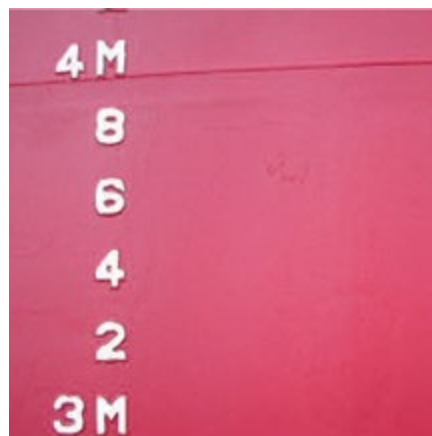
It is imperative that the draught marks are read as accurately as possible. Ideally this should be done from a boat so that the marks can be approached closely and read. However, poorly painted, rusty, or draught marks covered with marine growth make reading the draught accurately problematic, therefore it must be ensured, so far as possible, that the draught marks are kept in a readable condition. The presence of wind waves on the water surface will necessitate an estimation of the average draught by observation of the peaks and troughs of the waves against the hull. Darkness and shadows also make accurate reading difficult; therefore good lighting will be required at night. The turn of the hull around the stern leading to elongation of draught marks being viewed from an oblique angle, especially when this has to be done from an adjacent wharf at a higher level, can lead to difficulty in accurately determining the draught.

It is therefore advised to ensure that the inspection and maintenance of the draught marks be included in the planned maintenance system on a vessel.

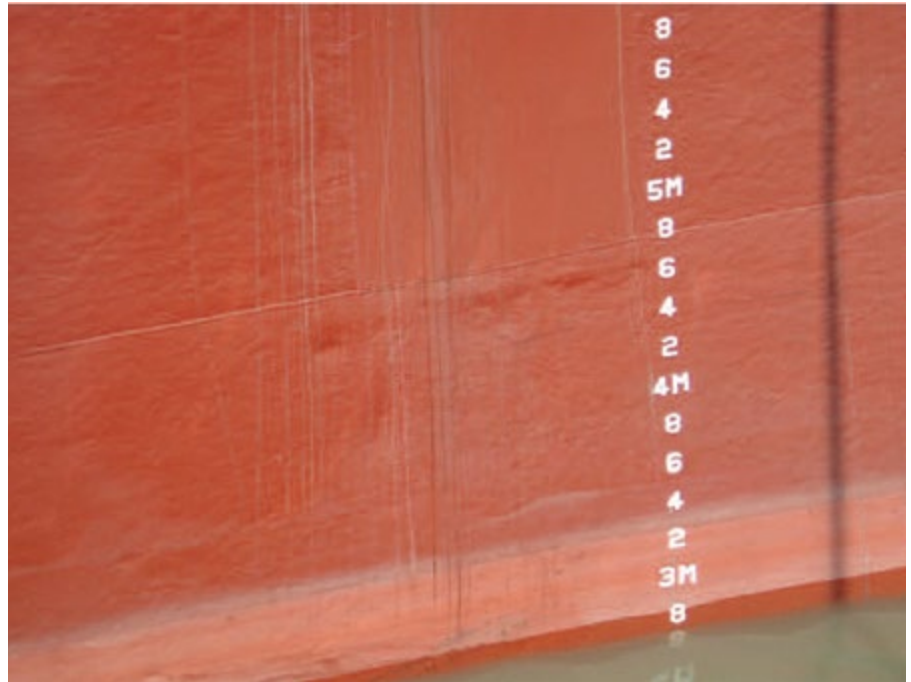
As most mariners know, squat is the bodily sinkage and trimming of a vessel making way with limited underkeel clearance. However, a vessel alongside a river berth may also be susceptible to squat, leading to inaccurate draught readings.

Squat will occur when there is limited space for the water to flow between the vessel and the river bed. In order for the river water to pass between the flat bottom and the river bed there will be an increase in velocity of the water flowing past the hull, and consequently a decrease in the water pressure. The decrease in pressure leads to the ship bodily sinking and also a change of trim. The magnitude of the bodily sinkage and change of trim is difficult to quantify, however, it will be a function of the underkeel clearance, speed of the water, the cross section of the hull in relation to the cross section of the river (blockage factor) and the shape of the hull (full form vessels are affected more). Generally full form vessels will trim by the head, and fine line vessels will trim by the stern. If a vessel is passing at the time that the draughts are being read, this may exacerbate the error due to the increased blockage of the river and consequently the vessel may trim and sink more than normal.
