### MARS 201218 Incinerator fire

### MARS 201219 Improper stowage of oversize steel structurals

### Fatality from parted mooring rope

### Faulty automatic electric kettle caught fire

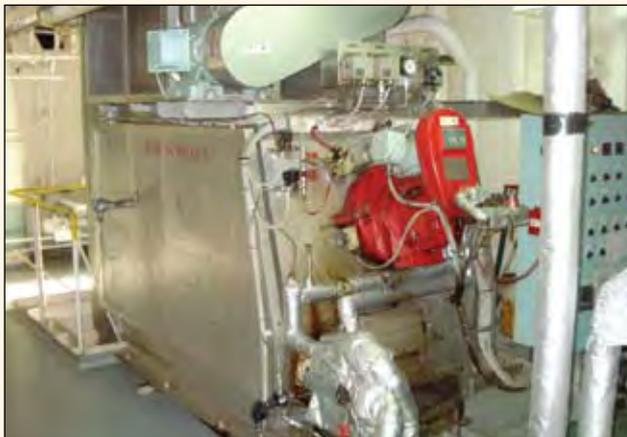
1. The atomiser unit's air nozzle holes were found to be choked with hard viscous sludge thereby restricting the flow of air into the incineration chamber. This condition seemed to have existed for some weeks prior to the incident;
2. Waste oil had failed to atomise properly and had collected and spread over the bottom of the combustion chamber and ignited, producing a large quantity of smoke;
3. The smoke activated the fire alarm, triggering the local fixed water mist fire extinguishing system.

▲ Exterior view of incinerator

Engineers' familiarisation form revised to include training and familiarisation in the use of the incinerator.

1. Discuss the incident at their next safety meeting;
2. Conduct onboard training on proper operation and maintenance of the incinerator, including emergency stop procedures, checks to be carried out prior to and during the use of the incinerator;
3. Ensure that the incinerator is cleaned and checked after every use;
4. Regularly test all safety devices on the incinerator as well as emergency stops.

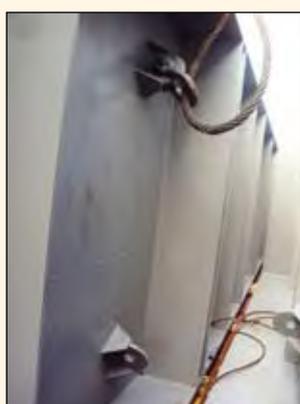
In my opinion, the shippers at the loading port had illogically stowed many lifts wrongly on the side and the ship's staff had not questioned the stowage nor considered the modalities at the discharge port. The manufacturers were also negligent in not marking the lifts to indicate correct lifting and stowage methods.

◀ Orientation of dedicated padeyes confirm that the lifts must be lifted and stowed only in the vertical orientation, i.e. on either the upper or lower flange

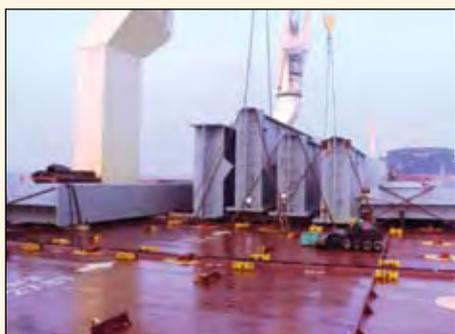
First lift being discharged by twin deck cranes. All the vertically oriented lifts were later turned on their sides by the road haulier on the shore

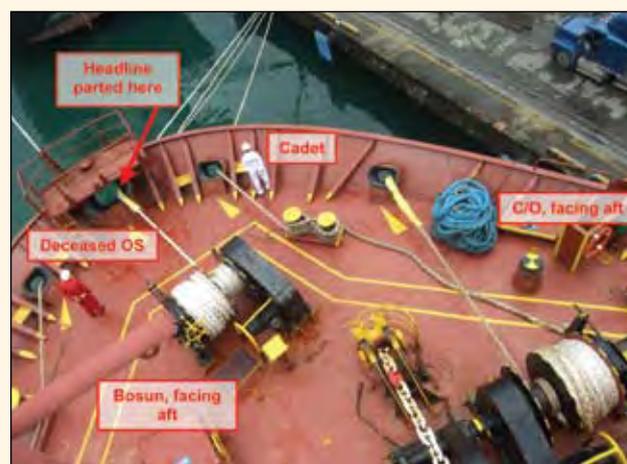
1. Failure on the part of the OS and other crew to recognise the danger of coming within snap-back zones of taut mooring lines;
2. Both the C/O's and the Bosun's attention were focused towards the stern and neither was aware of the excessive tension on the single headline;

3. Both the C/O and the Bosun were unaware of the OS's location as the former's line of sight was obstructed by the centre mooring winch and the latter was operating the winch controls in an aft-facing position;

▲ Reconstruction of accident site showing location of persons

1. Conduct a thorough risk assessment of mooring operations and a review of the mooring procedures being followed onboard;
2. Properly inspect all mooring ropes to identify and replace damaged ropes in line with company procedures and ensure a detailed record of inspections and condition is maintained;
3. Conduct training for all crew on identifying and understanding the dangers associated with snap-back zones;
4. Ensure that no modifications are made to the layout of mooring arrangements and associated equipment without completing a risk assessment and obtaining the requisite approvals.

1. Ensure the effectiveness of control measures put in place following this accident and review them regularly;
2. Ensure that a sufficient number of experienced crew is available at each mooring station.

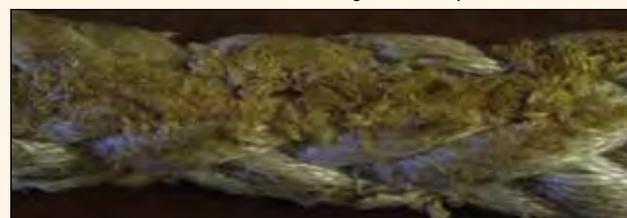
The parted mooring rope was an 8-strand polypropylene rope, 72 mm in diameter and the test certificate stated its minimum breaking strength of 101.6 tonnes when new. The rope had been in use for a year and its condition was assessed as 'satisfactory' when last inspected a month earlier. Following the accident, a representative sample of the rope outboard of the failure zone was analysed and it was concluded that:

1. The representative sample had suffered a large reduction in strength;
2. The main cause of this strength loss was external abrasion damage;
3. The abrasion damage had slowly become cumulative before the failure incident;
4. Internal abrasion damage also contributed to the failure, but to a lesser degree;
5. The pre-existing external abrasion damage on the failure zone was worse than the representative sample, causing the rope to fail at that point;
6. Thermal degradation had also possibly contributed to the rope's failure.

6. In the absence of roller fairleads, all mooring ropes had to be led through Panama fairleads or chocks. The high frequency of port calls caused significant external abrasion damage;

▲ Evidence of abrasion damage near the failure zone

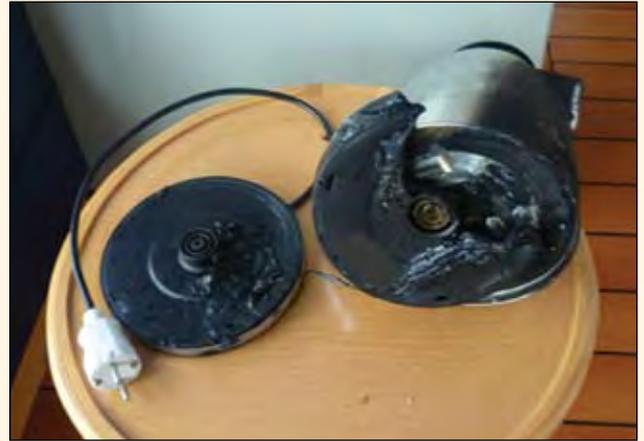
The electric kettles being used on board typically consisted of a cordless stainless steel jug fitted with a plastic base that contained the electric heating element. Power was supplied via a male-female central connector mounted on the base unit, also made of plastic. Following a mid-afternoon coffee break, the crew had left the messroom and had failed to notice that the water in the kettle was still boiling and the automatic thermostat switch had not operated and cut off the power supply to the heating coil. Some minutes later, all the water had evaporated and without any more heat load, the temperature rose high enough for the plastic base and kettle bottom to melt and ultimately catch fire. The strong smell of burning plastic drew the attention of a passing crewmember, who, after seeing the fire and smoke at the base of the electric kettle, quickly disconnected the power cord from the supply socket and transferred the burning kettle and base unit into the adjacent galley sink and turned on the water, successfully extinguishing the fire.

1. Automatic thermostatic switch malfunction;
2. Negligence on the part of the crew in not observing that

the kettle was still boiling when they left the messroom at the end of the coffee break.

▲ View of fire-damaged kettle and base unit

1. All existing kettles permanently removed from use and replaced with new ones;
2. Prominent notices displayed near all electrical appliances requiring the disconnection of power cord from electrical supply outlet when not in use;
3. An incident report was sent to the office to be shared with the rest of the fleet;
4. Incident discussed at the next onboard safety meeting.
