MARS 201222

Multiple injuries from falling hatch lid

MARS 201223

Oil cargo spill from tank washing line drain cock

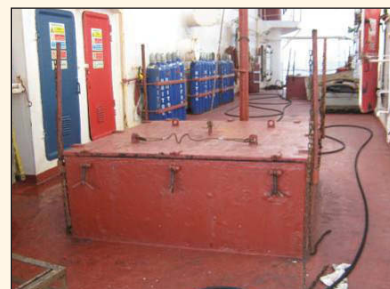
A disused washing machine was being lifted out of the engine room through the hatchway located on the main deck. The hatchway had a portable lid which was designed to be lifted and stowed clear by means of a portable davit fitted on one side of the coaming. However, the crew assigned to this task decided to partially tilt the lid open and temporarily hold it at that angle by using a wire rope sling and chain block attached to the davit. The Junior Engineer (J/E) was on the main deck observing the operation. As the lift was being prepared, the engine room alarm sounded. The J/E leaned over the open hatchway trunk to look into the engine room with his right hand resting on the coaming edge and his left hand taking the support of the partially open lid. Suddenly, the hauling chain of the block parted and the lid fell down, striking a glancing blow to his head and trapping his right hand. He sustained a deep cut on his scalp (not wearing helmet) and multiple compound fractures to his right hand. He was given first aid onboard and repatriated urgently for extensive restorative surgery ashore. It is likely that he may have permanent deformity and disability in his right hand.

1. Improper and very unsafe method of opening and holding hatch lid;
2. No risk assessment or tool box talk was conducted before commencing the task;
3. The lifting arrangement and points of attachment were not assessed for condition, stresses and adequate capacity;
4. None of the crew present recognised the obvious dangers arising from the wrong working practices employed.

◀ View of hatchway showing portable lid and base of lifting davit

1. Casualty administered first aid onboard and later repatriated for emergency medical treatment;
2. Defective chain block permanently removed from use;
3. Hatch lid modified to incorporate safer lifting and permanent fail-proof securing arrangements;
4. Incident discussed onboard at safety meetings held on all company vessels, with instructions to ensure that:
 - Prior carrying out any task, a proper risk assessment is conducted and recorded;

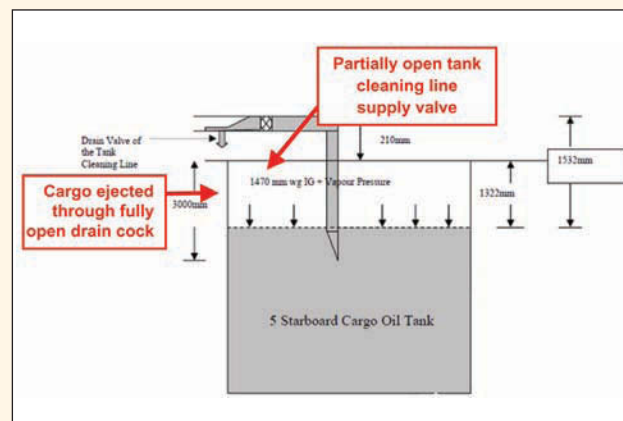
4. With the near-full loaded condition, the tank cleaning machines were submerged in the cargo. The increase in vapour pressure inside the tank due to cargo sloshing resulted in the cargo being pushed up into the tank cleaning line. The cargo then passed through the partially opened tank cleaning valve and fully opened drain valve on to the deck, resulting in the oil cargo spilling on deck;

▲ Diagram showing the circumstances that caused the backflow and escape of cargo from tank cleaning line

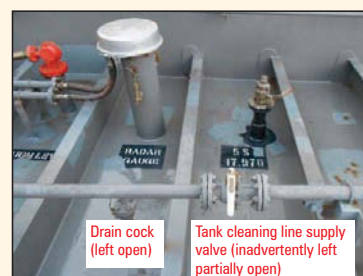
Chief Officer (C/O) on bridge watch noticed a small pool of oil cargo moving with the roll on the main deck starboard side, between the deck longitudinal and ship's side. The Master was immediately called and the oil spill emergency response plan was activated. Upon the Master's arrival on the bridge, the C/O proceeded to the main deck. Meanwhile, the crew had plugged all the scuppers on the main deck. The crew found that cargo was coming out through the open drain cock on the tank cleaning line branch to 5 Starboard Cargo Oil Tank (COT). This valve was immediately shut, and the deck team then discovered that the supply valve for 5S Tank Cleaning machine was also partially open. The supply valve was then also closed tight. Although no oil or sheen was visible in the ship's wake, it is possible that some oil could have escaped to the sea during the hours of darkness.

▲ Deck fittings at spill site

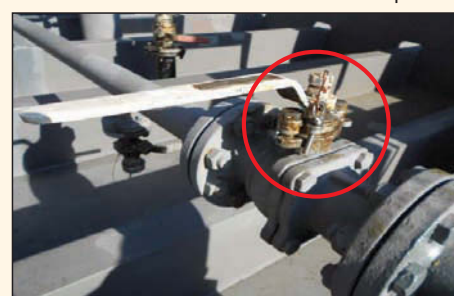
◀ Corrective action – protruding valve activating handle secured shut with locking pin

1. A safety meeting was conducted by the marine superintendent at the next port and the incident was discussed in detail;
2. Crew re-trained on proper post tank-cleaning/pre-loading procedures;
3. Pre-loading check list has been amended to include the closing of all tank cleaning line valves, drain cocks/caps;
4. Missing locking pins on all valve handles have been renewed;
5. Placards have been posted near all tank cleaning and line drain valves to ensure they are closed prior to any cargo operation;
6. Chief Officer's standing instructions have been amended to ensure that all drain valves are positively shut after tank cleaning operations;
7. Incident made part of pre-boarding briefing for all officers.

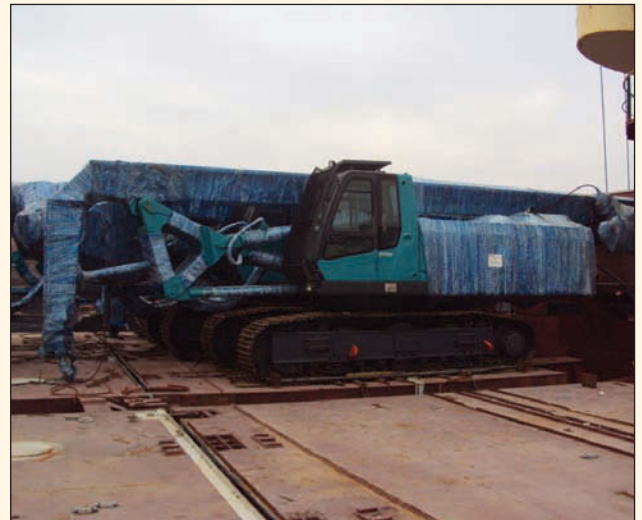
A heavy lift vessel arrived to discharge a consignment of project cargo at our terminal. The manifest included some units of a maximum weight of about 50 tonnes. However, many of them had both a paper sticker with shipping marks showing the gross weight written by hand (some overwritten with a figure different from the weight declared in the manifest), and a metal plate prominently affixed with punched numbers showing a figure far in excess of

▲ Typical deck cargo unit displaying both metal plate and paper label showing different weights

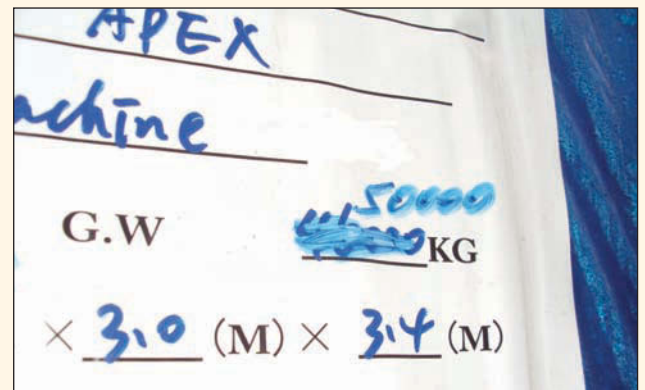
▲ Typical label bearing overwritten weight information
