# Seaways

# Mariners' Alerting and Reporting Scheme

MARS Report No. 240 October 2012

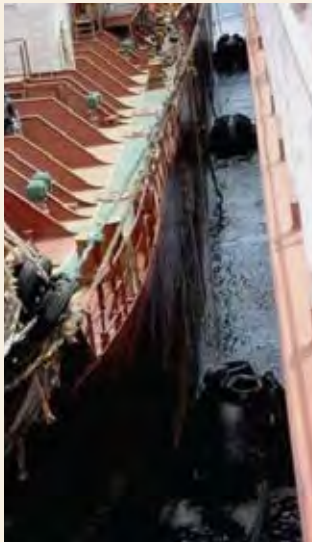
- 1 Substandard conditions: Inadequate equipment. Subsequent expert opinion confirmed that, considering the size of the bunker tanker, the fenders were too small and there were not enough of them, especially for STS operations in open anchorages;

Large bunker vessel on left rigged with three undersized fenders

- 1 Procedures in the SMS revised to:
  - i. Enhance the safety and efficiency of STS and bunkering operations;
  - ii. Improve risk assessment techniques for bunker transfer from bunker barges and bunker tankers at anchorages;
  - iii. Provide guidelines for better mooring planning and execution;
  - iv. Recommend means for more efficient communications between vessels.
- 2 A fleet bulletin was circulated to share the lessons learnt from the incident;
- 3 Incident to be included in officers' pre-boarding familiarisation;

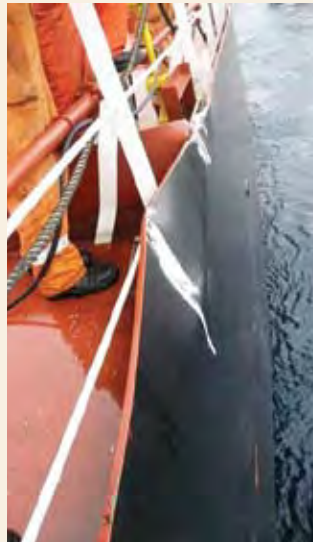
The next morning, following a review of the mooring manoeuvre and evaluation of the prevailing and expected sea conditions, it was decided to proceed with the fuel transfer operation. Unfortunately, due to the bunker vessel's slight residual headway, once again her sternlines tightened and drew her stern in towards the tanker, and both vessels sustained more contact damage in the stern regions. In this incident also, the bunker vessel was cast off and ordered to move away.

View of contact damage near the tanker's stern

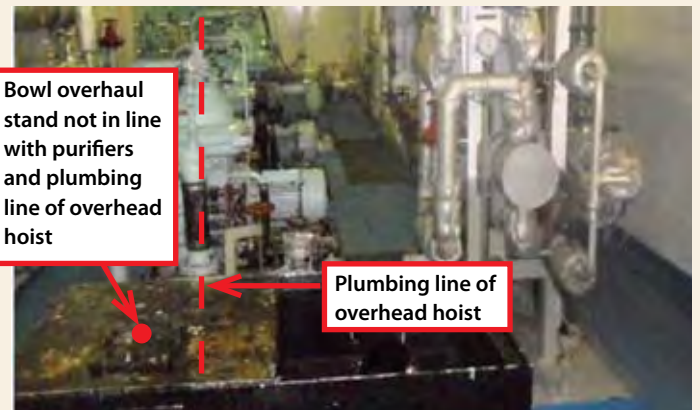
1 The overhead rail of the travelling chain hoist was not vertically above the bowl overhauling stand, requiring the user to pull on the suspended bowl assembly and guide it into the stand manually. This increased the risk of injury to fingers;

Stand for the overhaul of purifiers not in line with the purifiers and plumbing line of hoist. The fourth engineer was pulling on the suspended bowl assembly and attempting to lower it on the overhauling stand (indicated by the red dot) when the accident occurred

- 5 Although the stand had been wrongly positioned ever since the vessel was commissioned, no modification request was raised by ship's staff;
- 6 None of the crew assigned to the task recognised the obvious danger arising from the wrong working practice employed – i.e. positioning a large, heavy object by hand whilst it is being lowered;

- 1 After the accident, the overhauling stand was properly aligned to be in line with the chain hoist and purifiers;
- 2 Fleet circular issued instructing all vessels to discuss the incident at the next safety meeting;
- 3 Officers ashore will be briefed on this incident by:
  - i. Seminars conducted by the DPA;
  - ii. During pre-joining briefing with the superintendents;
  - iii. New officers joining the company will be briefed in detail during their familiarisation training in the office;
- 4 The knowledge, understanding and proper implementation of safe working practices will be verified during internal audits and other visits on board by the superintendents.

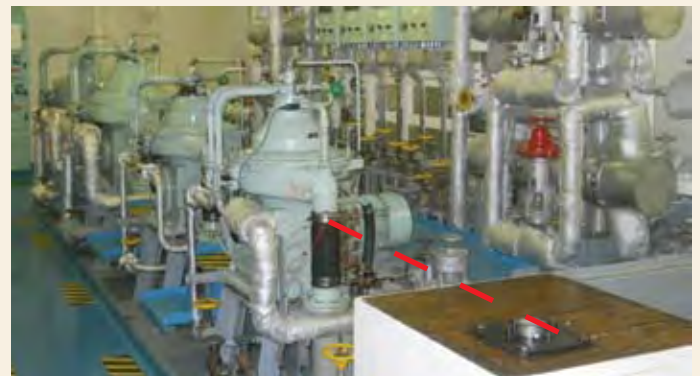
Purifier room on the sister ship – note the correct positioning of the overhauling stand – exactly in line with the row of purifiers and plumbing line of overhead chain hoist

- 7 There appeared to be a training gap on board – no senior engineer or rating had coached the young fourth engineer on safe working practices;
- 8 The same arrangements in the purifier room of a sister vessel were correct in all respects with the hoist plumbing the purifiers and the overhauling stand.

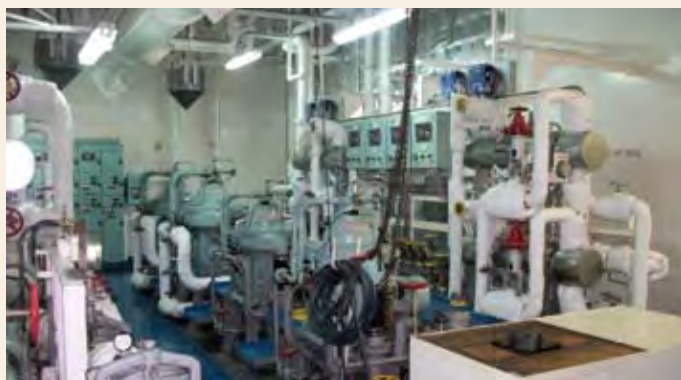
Corrective action #1 implemented – with the purifier overhauling stand positioned correctly

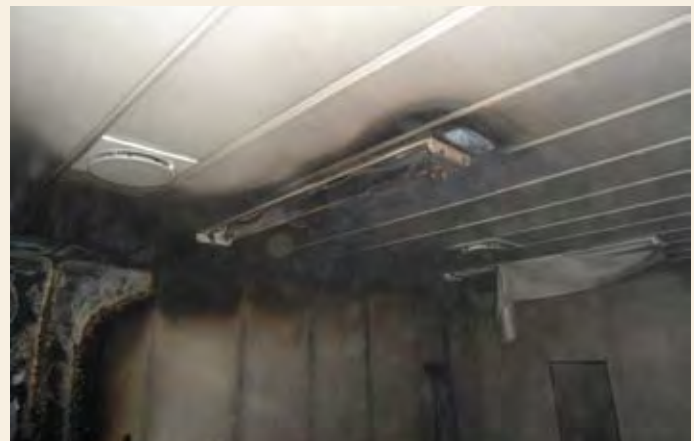
- 1 The crew had not used the gymnasium for three days prior to the incident, but the lights were left on;
- 2 It is suspected that a defective electrolytic capacitor of a panel ceiling light had overheated, and the escaping hot electrolyte and molten plastic sheath fell on and ignited a plastic mat lying on the deck directly below it;
- 3 The Chief Engineer reported that he had already detected poor quality capacitors from the same manufacturer in the past, but he had not reported this matter to the company. A check revealed a further eleven capacitors which showed evidence of overheating and ejection of electrolyte.

View of damaged deckhead panelling and the light fixture that is thought to have started the fire

- 1 All capacitors of the same brand were removed from light fittings on board;
- 2 Crewmembers were reminded that the prompt reporting of even relatively insignificant faults or abnormalities can prevent accidents and generally improve health and safety;
- 3 Lights in unoccupied spaces and compartments not forming part of machinery spaces, accesses and/or working areas should be switched off when not required;
- 4 A safety alert was sent to all vessels with instructions to discuss the incident at the next safety meeting and to implement the above practices.

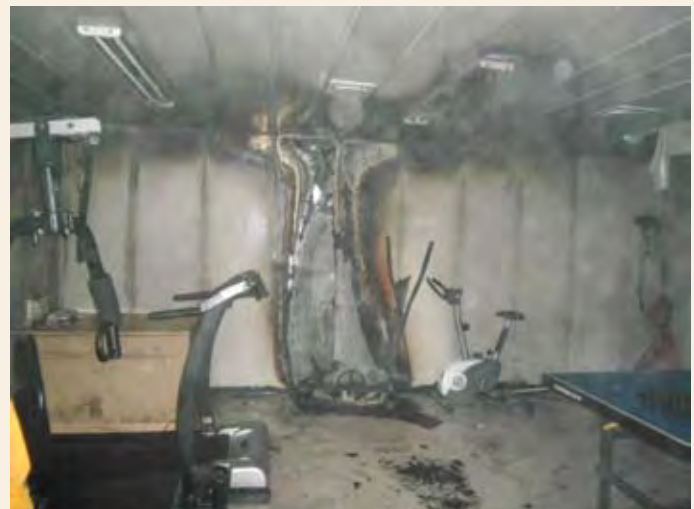
→ A fire occurred in a container ship's gymnasium. The crew responded properly to the event and quickly extinguished it. As a result of the fire, there was considerable smoke and fire damage to the bulkheads, ceiling and some sports equipment.

View of fire-damaged bulkhead, deck and deckhead

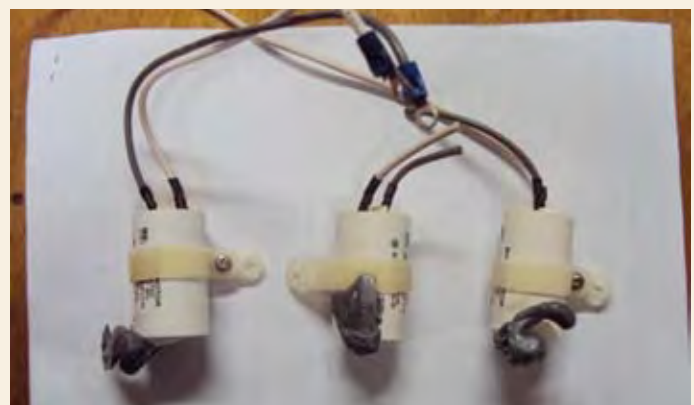
Other capacitors that have overheated with expelled electrolyte
