Seaways

Mariners' Alerting and Reporting Scheme

MARS Report No. 247 May 2013

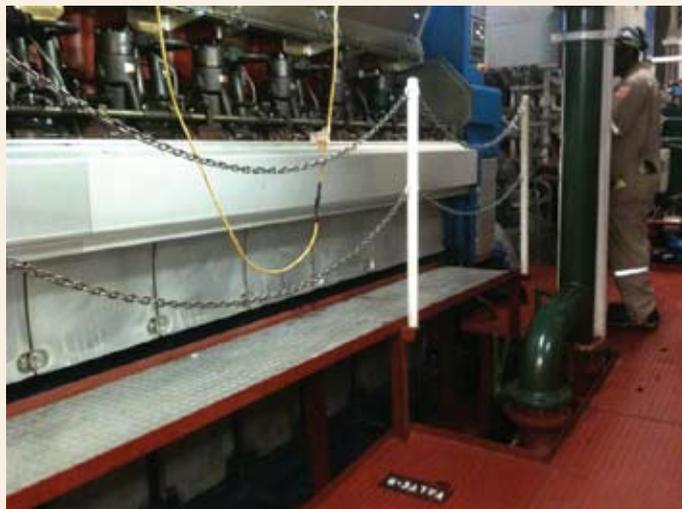
→ The engineering crew was engaged in maintaining the starboard main engine from an adjacent work platform. A Job Safety Analysis (JSA) had been completed for this particular maintenance work. To better access parts and tools required to complete the work, the safety chains and stanchions were removed from the perimeter of the raised work platform, running along the engine side about half a metre above the deck plating. As the work was nearing completion, the Assistant Engineer, while facing the engine, hastily stepped back from the work platform and down to retrieve a part from the floor plates. In doing so, he inadvertently placed his left foot on the vertical flange of the angle iron frames holding the chequered plates. With almost his entire body weight resting on the heel of his left boot, which was supported on the edge of the angle iron, his footing slipped and his ankle rolled inward resulting in torn ligaments and a Lost Time Incident (LTI).

Inboard Starboard Engine showing raised working platform and safety stanchions and chains

- 1 Engineering Supervisor and Master reviewed vessel-specific JSAs and identified areas which required further dissemination – including the removal of safety barriers;
- 2 A special safety meeting was held aboard the vessel to discuss the incident;
- 3 Operations Department distributed a Fleet Safety stand-down order, reviewing the circumstances and requesting feedback from the fleet;
- 4 Subsequent to this report, a more detailed account with root causes and lessons learned was distributed. This incident was also reviewed in detail during weekly fleet teleconferences.

- 1 A thorough risk assessment exercise meant to identify additional hazards related to safety barriers, particularly in the engine room, was commenced on all vessels;
- 2 Engineering Department is also reviewing platform design for modification, including steps or removable tool stations for periodic maintenance.

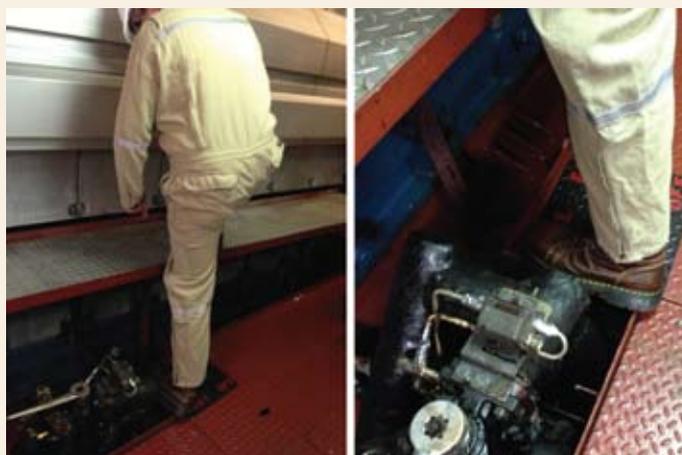
- 1 Inadequate work direction/preparation/JSA. The full implications of removing the safety chains and stanchions were not fully discussed / considered;
- 2 The JSA and risk assessment conducted did not adequately identify slips, trips and fall hazards.

Re-enactment of mis-step and unstable footing

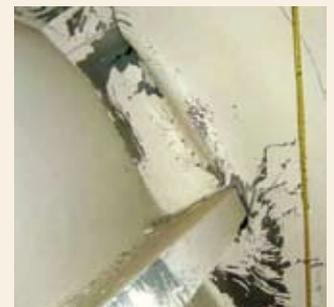
The duty AB reached the poop deck and noted an unnamed barge moving away from the ship. He reported that he couldn't see any visible damage to ship side from the poop deck or within the steering gear flat. The engineer OOW reported that the stringer plating under the second platform in engine room, on stbd side was deformed/ buckled including attached brackets, but the ship side was intact and there was no water ingress.

The ship manager arranged for a Class Surveyor to attend the ship and carry out a survey, and a Condition of Class was imposed requiring permanent repairs to be carried out.
