Seaways

The International Journal of The Nautical Institute

Mariners' Alerting and Reporting Scheme

MARS Report No. 248 June 2013

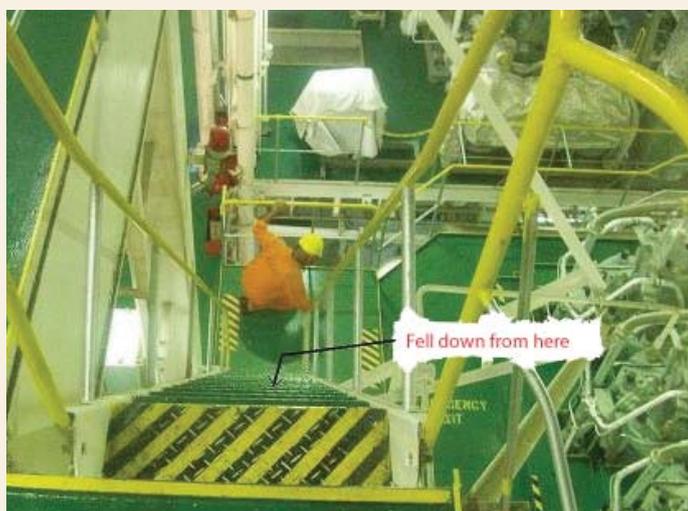
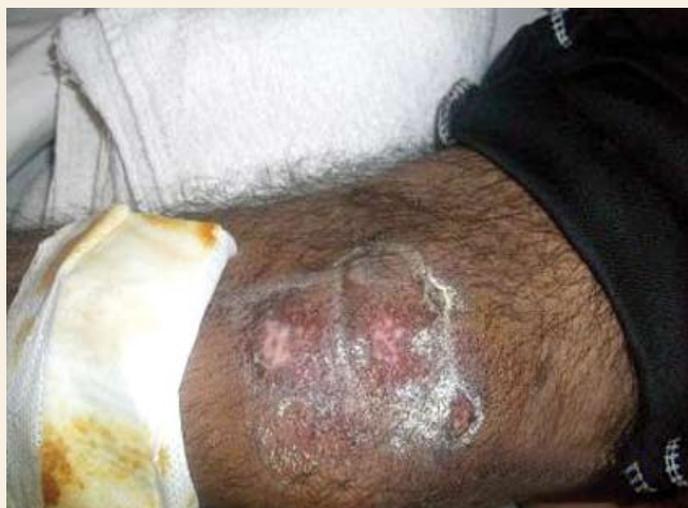
➔ While at anchor the engineer on watch (EOW) advised the motorman to remain in the engine control room while he went to replenish the compressor oil. Shortly thereafter the motorman heard a shout from the EOW. The motorman rushed to see what had happened and found the EOW lying at the bottom of the steps in great pain. He immediately went to the control room and raised the alarm.

The ship's investigation found that the EOW had descended the ladder with one hand on the railing and other hand clutching a one gallon can containing compressor oil. As he descended the ladder his

foot slipped on the fourth step. The EOW tried to hold on to the railing with his free hand but was unable to control his fall and ended up tumbling 15 steps down to the next deck. The victim was wearing a safety helmet which probably helped prevent a head injury.

After the incident, all crew were assembled and the importance of properly using ladders and stairways was reiterated by the Master. They were reminded that whenever going up or down a ladder, both hands are to be used to hold the railing. Any items to be transferred should be carried in a bag that allows both hands to grasp the rails or lowered using a bag/bucket and line.

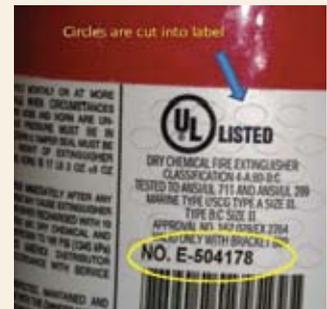
The labels on counterfeit extinguishers may be printed simplistically. Labels on genuine approved extinguishers will include a security imprint/texture behind the UL LISTED logo. Genuine Amerex Corporation extinguishers will have a pattern of scored 'circles'; (see below) and genuine Buckeye Fire Equipment extinguishers will have the letter S scored into the label.

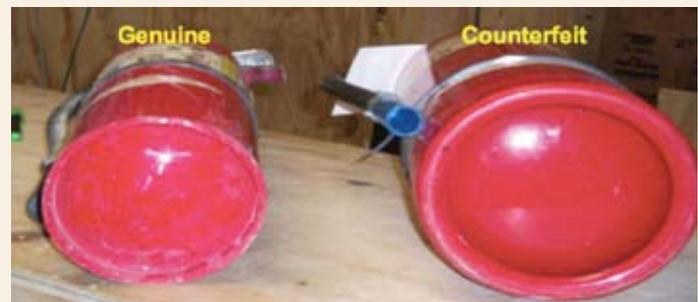
The bottoms of the counterfeits have a rounded curved-in lip as shown on the right side of the image below. The bottom of a genuine Amerex extinguisher is shown on the left side of the image. Genuine Buckeye extinguishers will have a date stamped on the bottom.

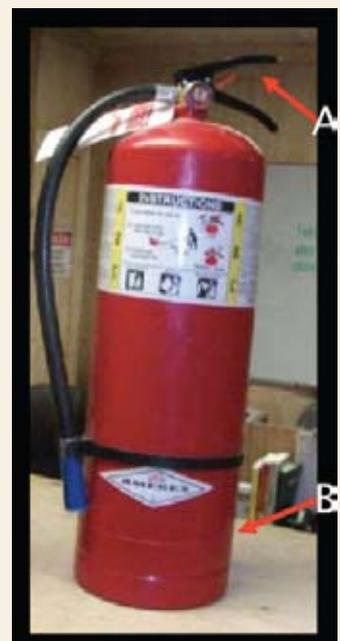
The counterfeit extinguishers have been reported to have black or red plastic handles (see A below). Genuine approved dry-chemical B-II extinguishers typically have handles that are constructed of silver-coloured aluminum (although there are some with plastic handles). Pressure gauges on the counterfeit units may be the wrong colour. The gauges on genuine approved Buckeye dry-chemical extinguishers will have a red background. Counterfeit extinguishers may have welded seams on the sides of the cylinders (see B, right).
