The International Journal of The Nautical Institute

MARS Report No. 249 July 2013

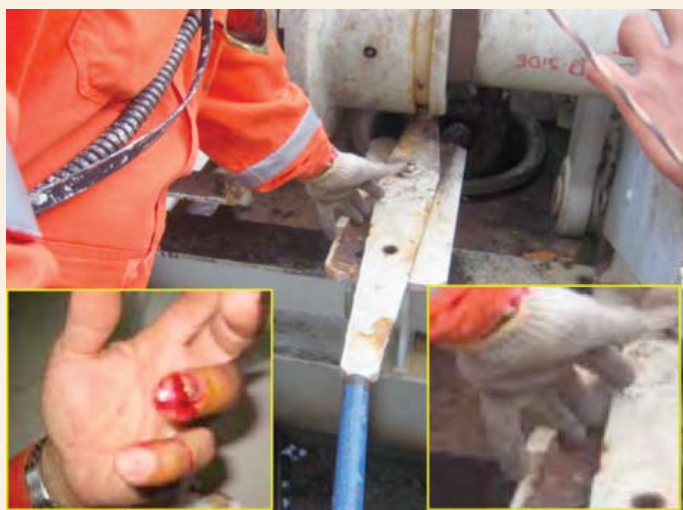
→ While the vessel was in dock, the bosun and an assistant carried out adjustment work on the windlass. After completing the job they intended to disengage the clutch by shifting the clutch lever. The bosun removed the stopper pin for the lever and instructed his assistant to shift the lever, which the assistant did (after first confirming all was clear and getting a confirmation back). However, the bosun's finger was still positioned between the edge of the clutch lever and the stopper plate. As the assistant swung the clutch lever the bosun's finger was crushed as the lever approached its end position. The victim sustained several superficial lacerations, a distal edge nail laceration and a fractured finger joint. He was treated with sutures and application of a prosthetic nail after surgical nail-bed repair.

The accident occurred at the end of a hard day's work so fatigue may have played a part. Neither the bosun nor his assistant were aware the bosun's fingers were in harm's way.

More importantly, had the bosun or his assistant accomplished this task alone, no injury could have occurred. If the same person first removes the pin and then throws the clutch lever their fingers cannot be in harm's way. Of course, hindsight is 20/20 but this nonetheless highlights the advantages of carefully evaluating each task to be accomplished before acting.

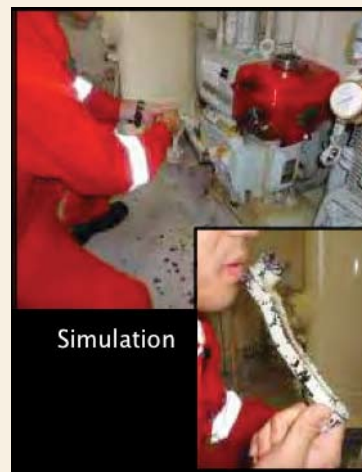
→ An engineer was carrying out routine inspection and maintenance on the emergency air compressor including a start test. When starting the compressor by manually cranking, the engineer failed to remove the handle before the engine reached its self-ignition RPM speed. As a result, the handle was thrown off the crank engagement nub when the compressor began turning over on its own, hitting him in the face. The engineer suffered two chipped teeth and lacerations of his lip.

The vessel's investigation determined that the engineer was not fatigued at the time of the task. Additionally, he had carried out the same starting operation a number of times in the past.

- Suitable caution notice should be displayed near the unit to remind the operator of the danger.
- The operator should receive specific training and be made aware of this danger when joining the vessel and before he/she carries out this test for the first time.
- The operator should be positioned suitably and firmly and pay full attention at the time of crank-starting the compressor.

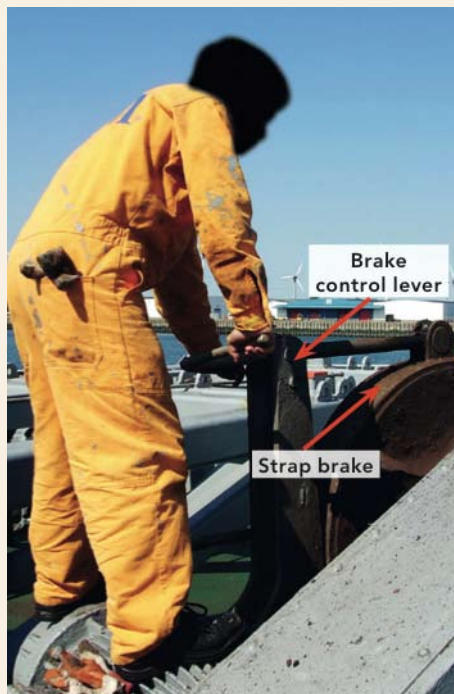
suddenly failed. Since the electrical systems on board the vessel were linked to the main engine via the shaft generator, the electricity failed as well and for a short period of time the vessel suffered a blackout. During the blackout, the rudder unexpectedly turned to port, causing the vessel to deviate sharply from its course and toward the tug and tow. In order to prevent a collision, the captain, on VHF radio, ordered the anchor let go. As there were crew on deck at the time, the anchor was let go very quickly after the order – within 15 seconds. At the time the anchor was let go the cargo vessel still had a speed over ground (SOG) of 7.5 knots.

Despite the attempts by the AB to secure the winch brake, the anchor chain continued to run out. The last length of chain had broken loose from the chain locker, and the AB was hit and fatally injured by the bitter end.

Simulation of A/B attempting to secure the brake as the chain ran out

The use of the anchor to slow down the ship in an emergency: IACS stipulates that an anchor must be constructed in such a way that it is suitable to anchor a ship temporarily in 'moderate' ambient conditions. The anchor gear is not designed to stop a ship. Anchoring at high speed is an extremely risky operation that may result in fatal injuries to crew members and serious damage to the ship. Such a manoeuvre should only be considered in an extreme emergency. The captain, in consultation with the bridge team, should assess whether the potential benefits of such a manoeuvre outweighs the substantial risks for the crew and ship.

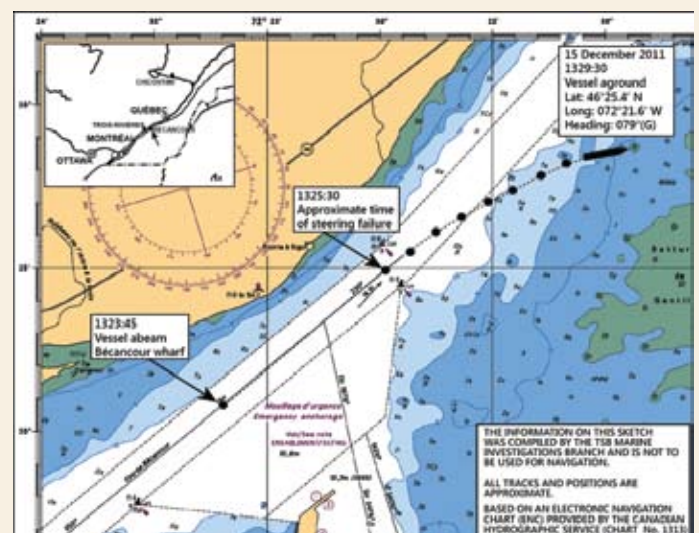
The Master arrived on the bridge just as the vessel was leaving the buoyed channel. He went directly to the steering stand and transferred the steering system actuator switch from the port system to starboard system. This action restored control to the steering but it was too late. The vessel ran aground at an estimated speed of 8 knots over the ground.

follow-up (NFU). The helm order data signal to the steering gear telemotors is provided by two potentiometers that are mechanically linked to the helm wheel and electrically linked to each telemotor: one potentiometer per telemotor. It was later discovered that the port system helm follow-up potentiometer had failed, rendering the FFU useless until the starboard system was belatedly selected by the Master.

- 1 Without the regular replacement of potentiometers, there is an increased risk that they will fail in service.
- 2 Crew may be unfamiliar with the steering control methods of the non-follow-up mode or switching steering systems in cases of steering failure if this information is not incorporated into technical manuals, familiarisation, and drills, or adequately described and posted near the steering stand.

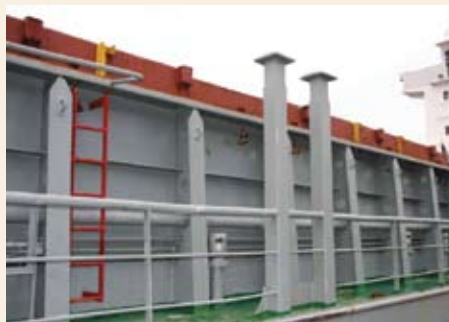
➔ During operations, an O/S climbed onto the 2.2 metre hatch coaming and used the guard rail for foot support. Presumably, as there were no direct witnesses, he lost his footing and/or handhold, fell backward

onto the deck and struck the guard rail with his head causing fatal injuries. He was wearing size 10 mixed fabric (cotton/rubber) gloves and a protective helmet. An examination of the work rest schedule of the victim did not reveal fatigue as a factor.

Scene of the accident (simulation)
