# Seaways

The International Journal of The Nautical Institute

# Mariners' Alerting and Reporting Scheme

MARS Report No. 250 August 2013

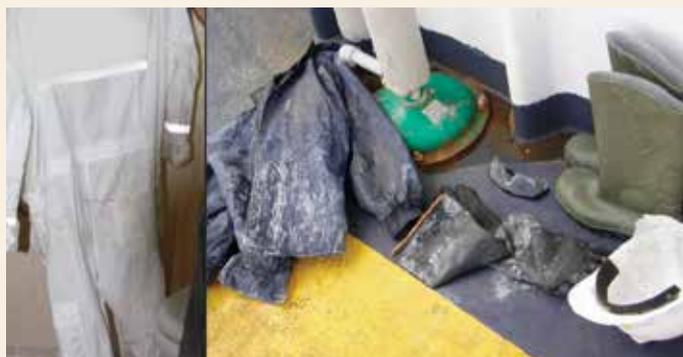
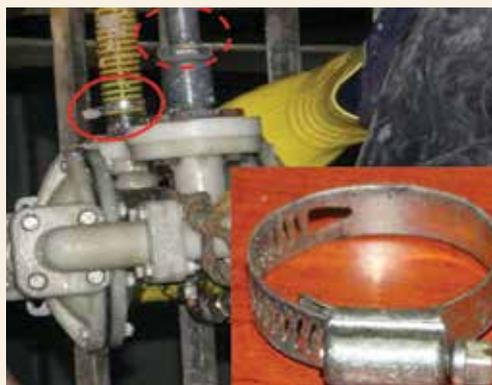
Portable pump with pressure side (red dotted line), suction side (red continuous line) and hose clamp used to attach hoses to pump.

The bosun stood at the coaming of the entry hatch to the tank to keep an eye on the work. The Master was also nearby. While the caustic soda was being pumped out, the hose parted from the pressure side of the pump (red dotted circle in photo), spattering one crew member with the caustic solution. A small quantity of the product also entered his eyes. The victim was immediately taken to his cabin where his eyes were continually rinsed with water until the arrival of rescue services. The victim was transported to the hospital and treated as an in-patient for ten days.

- Given that contact with only a 5% sodium hydroxide solution can cause extremely severe chemical burns, the protective equipment used was inadequate for the planned manoeuvre using a 50% solution. The IBC Code states that protective clothing made of chemical-resistant material as well as tightly fitting eye goggles and/or face shields are needed for caustic soda. The cotton overalls and eye goggles used, which were open at the sides, did not meet these requirements.

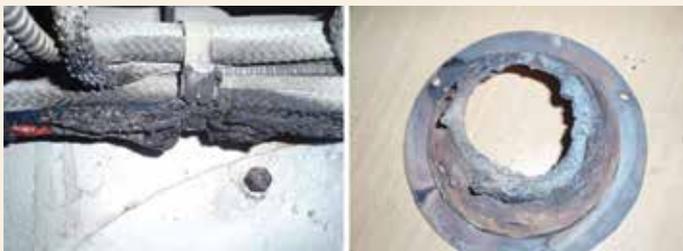
➔ While at sea a fire occurred on the waste oil incinerator. The local fire alarm for the incinerator area was activated and the appropriate fire extinguishing mist system for the incinerator was triggered. Ship's staff immediately closed-up to the incinerator but found that fire was already extinguished with only slight smoke remaining. The incinerator had been in use even though one of the two fuel line solenoid valves had been damaged and was awaiting spare parts. The fire damage included electric cables, burner protector, door switch and fuel solenoid valves.

- The crew did not follow procedures to clean the burner before use. Uncleaned carbon deposits and the eventual failure of the second solenoid valve led to the fire.
- A non-routine risk assessment was not conducted when the first solenoid valve failed, hence no additional controls were placed on the use of the incinerator for operation with only one solenoid valve.

- A company wide generic risk assessment for the normal operation of the incinerator to be established.
- Vessels to create a comprehensive risk assessment with additional controls when using defective equipment which must be approved by the company.
- Urgent spares to be supplied as soon as practically possible as detailed in the company SMS. Vessels to follow up with office for their delivery.
- Incinerator operating procedures to be updated.
- Vessels to notify the company of their requirements for shore discharge of waste oil when incinerator is defective and cannot be used.
- The critical incinerator parts to be identified on all company's vessels and one set to be kept on board as spare.

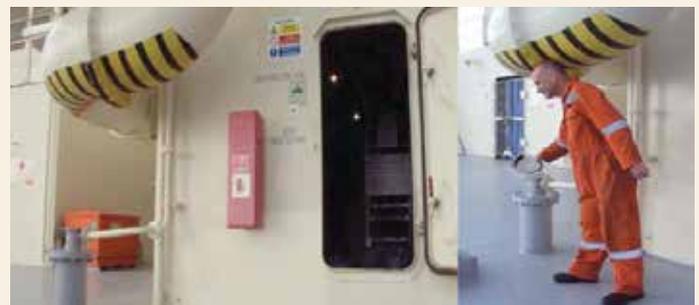
➔ An oiler was proceeding to the engine room via the engine casing entrance. After leaving the paint locker he hit his forehead on the inert gas (IG) main line directly above and to the side of the paint locker entrance. The oiler suffered a cut to the forehead.

- 1 The crew member was not wearing correct PPE for the task.
- 2 The crew member was preoccupied with the task at hand.
- 3 The IG main line had been previously identified as a hazard, and was already marked with 'tiger stripes'. Nonetheless, due to regular passing of the pipe without incident crewmembers had become complacent about the danger.

- 1 A company wide review of trip and bump hazards on vessels and a reassessment of whether current warning/identification measures are sufficient, or if additional measures are required.
- 2 In this case it has been identified that 'tiger stripes' on the piping alone were an insufficient visual warning. Tiger stripes have now been painted on the deck and a soft protective covering placed around the flange.

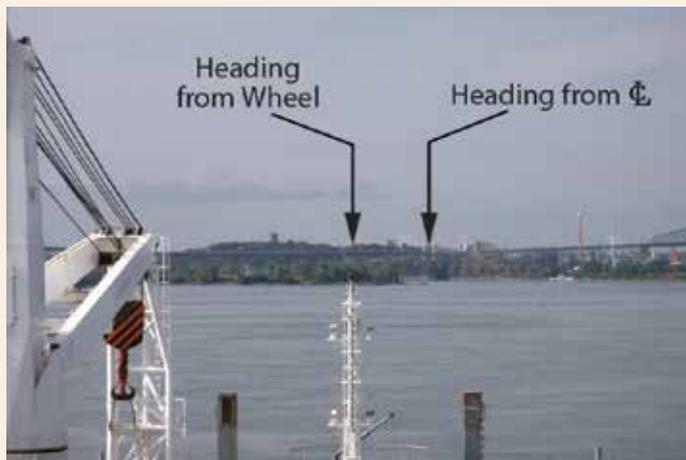
The vessel's pilot card showed a schematic of the navigating bridge that portrayed it as symmetrical either side of the centreline of the vessel. None of the documentation on the bridge indicated the important information pertaining to the conning and steering position, which was offset from the centreline. As it was, the steering stand was almost three metres to starboard of the centreline of the vessel. This resulted in a parallax error of approximately 1.6° to starboard if the line of sight is taken from the steering stand. The pilot was apparently aware that the steering stand was offset from the centreline, but had estimated the potential error to be about 0.5°.

Neither the offset steering stand from the centreline of the vessel nor specific and detailed information such as parallax error were provided to the pilot.

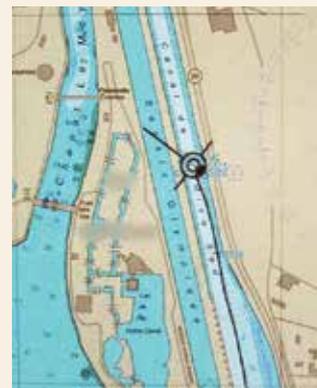
then reduced the pitch to 10% for the entry into the narrower part of the channel ahead. As the vessel entered the restricted part of the channel with a SOG of 6.8 knots and a heading of 350°G the helmsman had to apply starboard rudder to keep the vessel on the desired heading (an indication of bank suction astern). Shortly thereafter the vessel's course took a sudden sheer to port. Immediately, the pilot ordered the rudder hard to starboard and requested that the Master activate the bow thruster. The pilot used the CP propeller lever to produce an engine kick ahead, then set the CP propeller lever at full astern but the vessel continued crossing the channel at a 45° angle.

The vessel's bow subsequently grounded on the north bank of the channel some 0.75 nautical miles downstream from the lock they had just exited, the stern to the south side of the channel thereby blocking the waterway; vessel traffic was interrupted for approximately 10 hours until the vessel was successfully refloated.

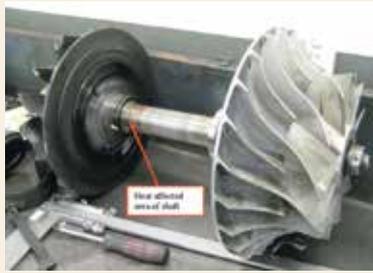
- 1 Turbine blades worn oval on half the wheel profile.
- 2 Turbine side shaft labyrinth deeply grooved and worn undersize and the shaft bent at the turbine end journal.

- 3 Turbine end journal bearing was subjected to extreme heat and had turned blue.
  - 4 Shaft bent at the compressor end journal.
  - 5 Compressor impellor worn oval on half the wheel profile.
- Given the above findings the rotor assembly was not repairable. The rotor assembly required replacement, along with a few other parts.

Damage to the turbocharger took place due to excessive wear of the turbine side bearing, thereby losing the centre line of rotation. On the whole, the components in the radial direction were found damaged.

- 1 Reduce main engine speed if surging occurs. If further reduction requires changing over engine to diesel oil, this should be carried out and the charterers and owners advised.
- 2 Ensure main engine lubricating oil purifier is working well.
- 3 Ensure bypass filters and turbocharger lubricating oil filters are clean.
- 4 Carry out routine marine grit cleaning on the turbine side.
