# Seaways

The International Journal of The Nautical Institute

# Mariners' Alerting and Reporting Scheme

MARS Report No. 257 March 2014

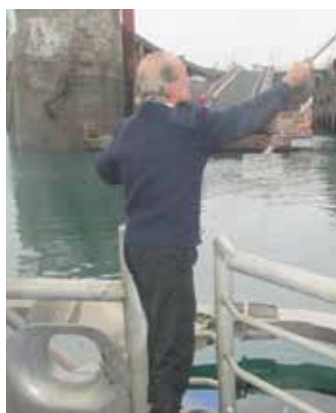
Suddenly, he over-balanced, falling over the two low rails (just below knee-level) and between the stag-horn and the adjacent railings, striking his head and coming to rest on the port jet thruster 'buckets' and guard. The port jet was immediately de-clutched (stopping movement of bucket) and quick action by deck and engine room crew on scene recovered the seafarer. While the engine room crew looked after the injured seafarer the vessel was secured and the victim then transported to medical attention. Having sustained an injury to the knee and a blow to the head, the seafarer was signed off work for a week.

Simulation showing position of the seafarer

- 1 Need for better guarding of the area concerned (and to eliminate the 'trip hazard' caused by the two low rails by the addition of a higher rail).
  - 2 Inadequate risk assessment for mooring operations on this class of vessel.
  - 3 Need for improved risk assessment procedures.
  - 4 The importance of mitigating the 'can-do' culture of seafarers to ensure that they always give priority to their own safety over other considerations.
- **Editor's note:** As the saying goes, always keep one hand for the vessel and one hand for yourself. Lesson number four is a good indication that the company management realises that often, employees just want to get the job done. It takes training and good leadership to change people's behaviour – and to ensure they always think about their own safety before and while undertaking a particular task.

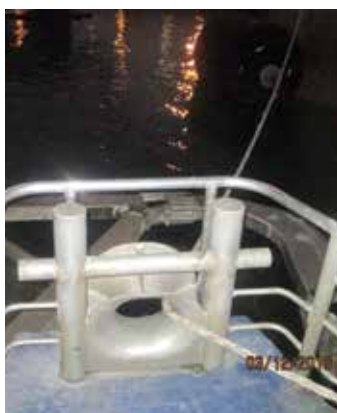
Modified guardrails

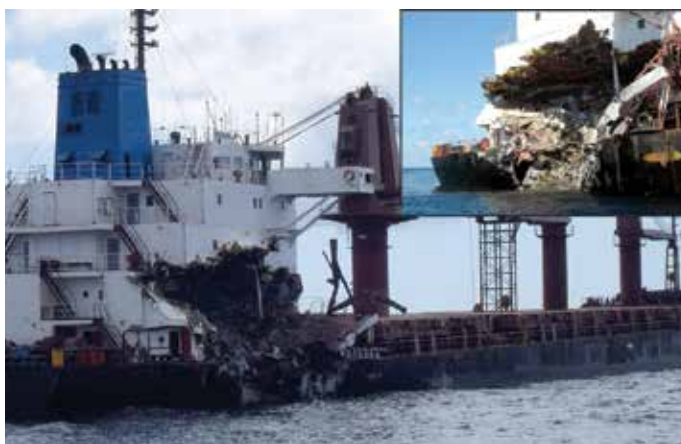
Vessel A

- Vessel A's OOW did not establish that vessel B was on a steady bearing, and that his was the give-way vessel. The inaction of vessel A's OOW showed a total disregard for the safety of his vessel and his shipmates. Despite his experience and knowledge of the Colregs, he made an unfounded assumption that vessel B would pass clear of his vessel.

- Vessel A's OOW did not assess the situation correctly initially, or reconsider his assessment when the situation did not develop as he expected. Even in the scenario that he had imagined, he was willing to accept a CPA that was much less than specified in the Master's night orders.

- The complacent attitude of vessel A's OOW, his misplaced belief in his ability to assess the risk of collision by eye, and his underestimation of the chance of encountering another vessel at close quarters combined to prevent him from taking the necessary actions to prevent the collision.

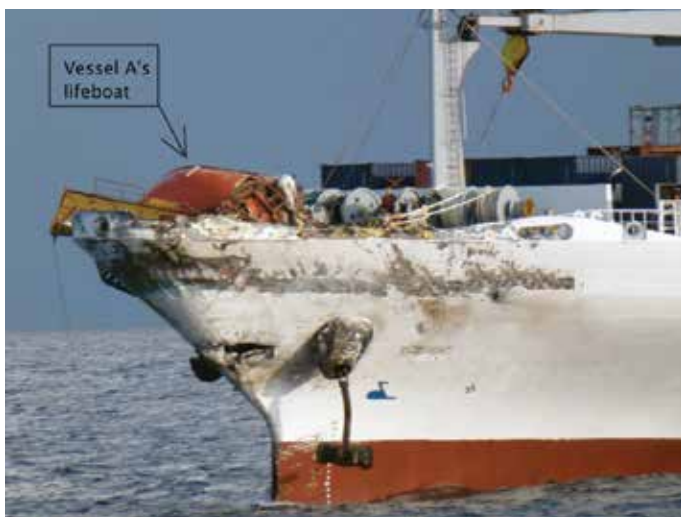
Vessel B

- Vessel B's watchkeeper did not post a lookout or set the watch alarm, and instead relied on his ability to maintain an effective lookout on his own.
- Vessel B's watchkeeper allowed himself to be distracted by tasks other than navigating and keeping a lookout, possibly by placing himself in a position where he could not see out of the bridge windows or look at his navigation aids.

- In choosing to take the watch alone and not setting the watch alarm, the watchkeeper on vessel B demonstrated extremely poor judgment, systematically overcoming each of the safeguards that should have been in place for keeping an effective navigational watch.

- The lack of regard of vessel B's watchkeeper for his primary roles as lookout and officer in charge of a navigational watch can only be assessed as complacent.

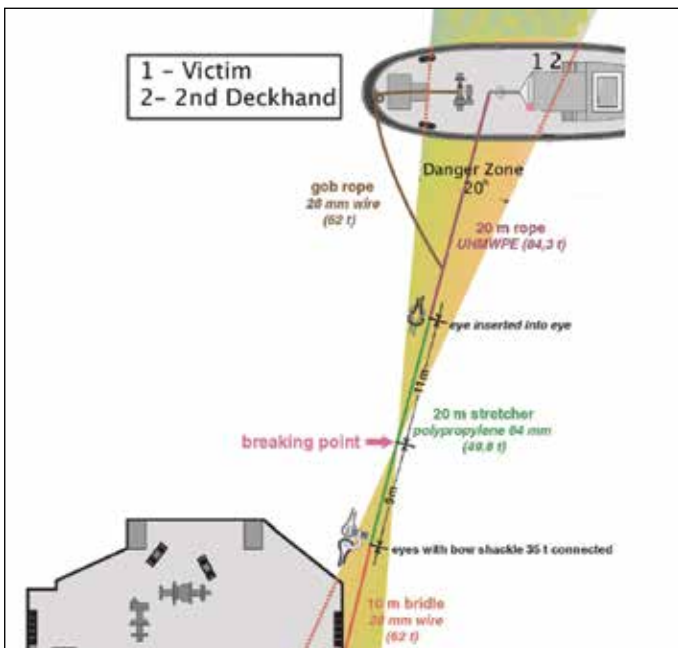
As can be seen in the diagram, the deckhands were within the snap back zone. A parted towsline snaps back faster than the speed of sound. This means that the break had already occurred before the bang was heard on the aft deck; the deckhands could not move to safety in time if they were still within the danger area. While the best protection is located in the superstructure, the Master and chief mate were already on station there leaving no room for the two deckhands. The procedures of the owner's quality management system do not define safety areas for the crew. Although the deckhand's safety area beside the companionway was apparently tried and tested at an earlier time, an analysis shows that the only possible safety area on the deck of an aft tug would be the forward edge of the bridge. Yet this is impractical on this tug as the trigger for the slip device cannot be accessed from that location.

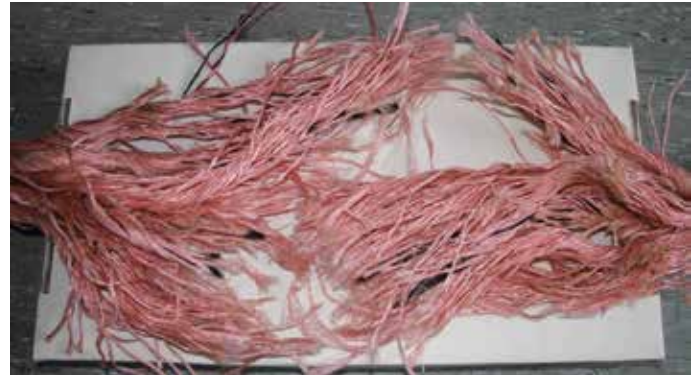
Failed stretcher, subsequently found to be undocumented and of unknown manufacture or SWL

- The material used for the fabrication of the stretcher was of low quality. Polypropylene split film of this type is normally used for mooring lines. The rope was manufactured and delivered without any of the 'tracer' threads that identify the company or the standard.

- The stretcher should never be the weakest component of the towing connection. Since a failure of the stretcher is virtually a worst case scenario, this element is normally oversized by 1.5 times the maximum tensile strength of the other connecting components, which themselves are usually set at two to three times the bollard pull of the tug.

- Best practice dictates that the length of the stretcher should be no less than 5m and no more than 10m for port towing connections. Also, only fairlead shackles should be used for connecting individual components of the towing gear. Both of these best practices were ignored in the present case.

- Prior to being used in this incident, 73 of the total of 456 fibres of the stretcher were already completely or partially frayed. The failure of the stretcher was primarily caused by this pre-existing damage.
