# Seaways

# Mariners' Alerting and Reporting Scheme

MARS Report No. 258 April 2014

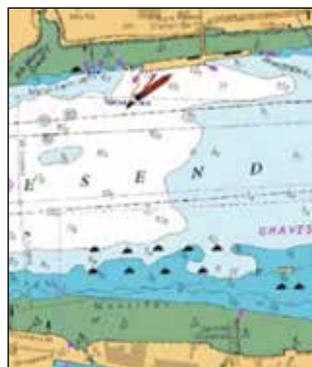
Figure 1

At departure the Master and pilot were on the port bridge wing. The OOW was operating both the helm and the engine telegraph, which was being responded to by the engine room crew. The duty helmsman was with the aft mooring party as the vessel left the berth. At 0551 (Figure 1) the Master and pilot entered the wheelhouse: the pilot ordered the engine to slow astern and the vessel's speed over the ground (SOG) increased to 2.1 knots on a course over the ground (COG) of 210°. Two minutes later, the vessel's engine was stopped and the pilot ordered 'dead-slow-ahead' and the helm hard-to-starboard: the SOG was 4.0 knots and COG 171° (Figure 2). The pilot requested the tug to pull on the port quarter at 25% power and 40 seconds later ordered the tug to increase to 50% power. Soon afterward, the pilot ordered the engine to slow-ahead and a few seconds later to half-ahead.

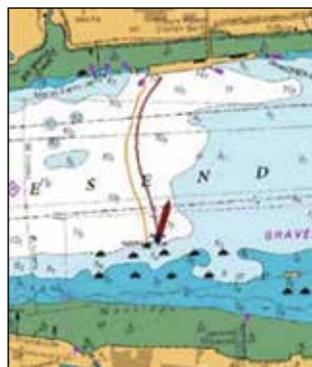
Figure 3

At 0555, VTS warned the vessel's pilot by VHF that the vessel was south of the fairway (Figure 3). The pilot then ordered the engine to full ahead and for the OOW to steer a heading of 073°. A minute later

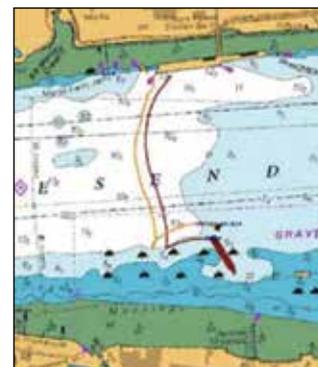
Figure 4

At 0558 (Figure 4) the vessel was continuing to swing to starboard at 3.5 knots SOG, the helm was hard-to-port and the engine was set to full-ahead, when the helmsman arrived on the bridge to replace the OOW at the helm. At about this time the Master informed the pilot that the vessel's engine was working normally and that he had instructed the engineers to increase power to full sea speed. By 0600 the vessel made contact with moored barges on the south side of the river before running aground.

- This accident was characterised by poor communications. These can be attributed to the initial failure at the briefing stage to assign appropriate roles and responsibilities within the bridge team to manage a port departure in restricted visibility. This in turn resulted in poor situational awareness and in team members acting in isolation, without fully communicating their actions to the other team members or the assisting tug.

- The use of the tug, in circumstances where [the pilot] had no visual references, resulted in a disproportionate effect being applied that turned the vessel some 90° more than intended so that the vessel drove out of the channel and grounded before he could assess and recover the situation.

- The need to check on roles and responsibilities [is paramount]. Had this been done, it is probable that an officer would have been allocated to maintain a radar watch during the vessel's departure.

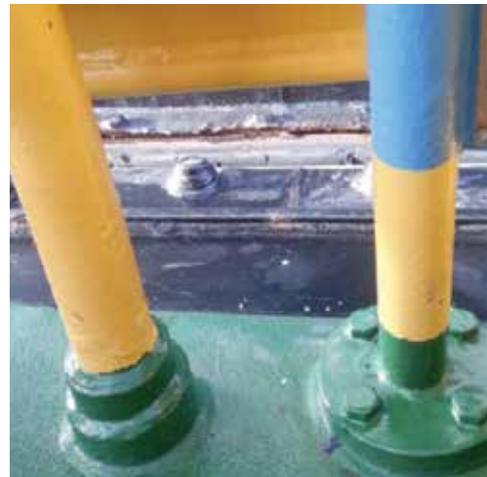
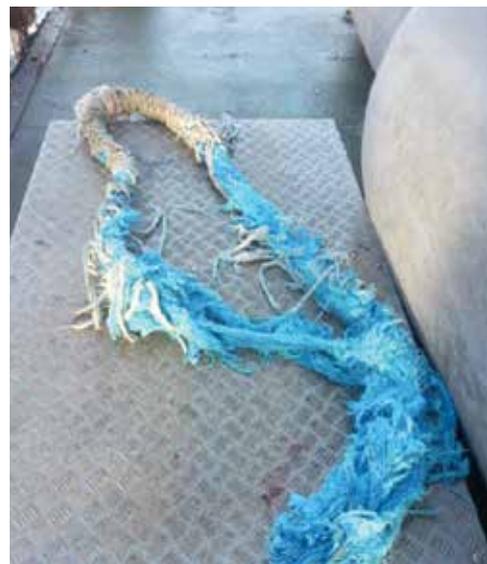
After tasking the standby tow line was fully recovered but with considerable damage found to the eye of the towline tail, minus the messenger line. A diving inspection was necessary to untangle the messenger line from the starboard pod; no damage to the pod was found.

It was found that the standby towline and specifically the messenger line had not been secured. It is believed that the seas taken over the bow while on passage outside the harbour caused the messenger and tail of the towline to be washed down the deck and then overboard via a freeing port. These then became entangled in the starboard pod unit.

underway earlier than anticipated, so that preparations had to be done while en route to the task. Ideally they would have been made alongside prior to getting underway. Passage time from berth to harbour entrance was only about five minutes, so there was an element of rush to get the tug and equipment secured.

- The Master should never assume, but always ask for verbal confirmation that all is secure and ready.
- Irrespective of location or weather, the same preparations should always be made to the same standard so that it becomes second nature.
- In poor weather the tug should be prepared for immediate tasking while alongside.

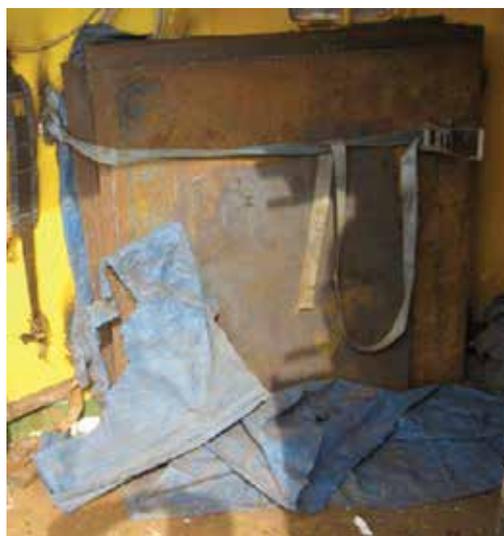
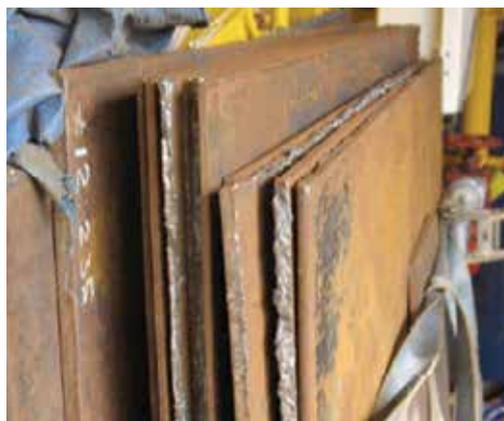
➔ Two deckhands were detailed to replace the torn tarpaulin covering some steel plates, which were stored upright on the poop deck. The 20 plates measured approximately 1.4m x 1.2m with a thickness of 5-10mm, and weighed about 1000kg in all. In order to undertake this task the deckhands released the single lashing strap that held the plates in place so as to free the tarpaulin. Upon release of the lashing strap several plates began to topple over, falling on top of one of the attending deckhands.

● Improper vertical storage and securing of steel plates, especially with only one securing strap and no wooden or other deck underlays to increase friction, unnecessarily increased risk.
