Seaways

The International Journal of The Nautical Institute

Mariners' Alerting and Reporting Scheme

MARS Report No. 259 May 2014

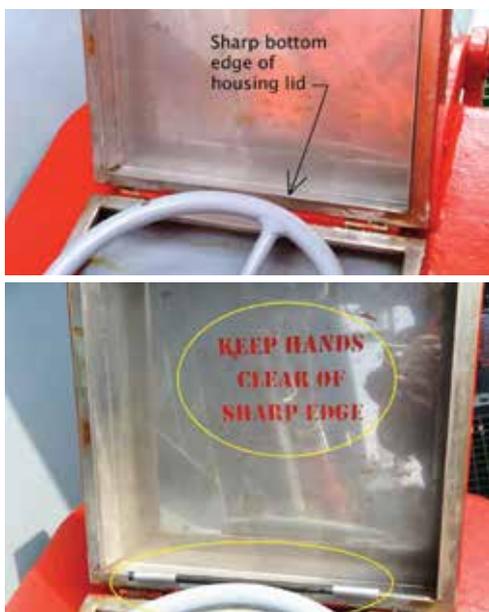
Emergency exit cuts like a knife

→ During an engine room fire drill, the crew practised an evacuation through the emergency escapes. After successfully exiting via the escape hatchway, the team leader instructed a rating to operate the external hand-wheel to ensure the free opening of the hatch lid for emergency entry purposes. The rating attempted to rotate the hand-wheel with all his strength in order to overcome the residual resistance of the securing dogs below. The dogs released with a jerk causing the wheel to turn freely. Due to the sudden absence of resistance, the rating's right hand shot past the sharp bottom edge of the housing lid, which inflicted a deep gash near the knuckle.

- The faulty design of the hand-wheel housing lid, with its sharp edges and wheel rim located very close to edge of housing cover.
- The hasty and vigorous operation of hand-wheel under the prevailing pressure of an ongoing emergency drill.
- The sudden release of securing dogs.
- The absence of gloves (normally not a requirement for emergencies or drills).

The incident was discussed at a special stand-down safety meeting held after the incident. An injury report was sent to management with a corrective action plan; a rubber strip was permanently glued to the sharp bottom edge of hand-wheel housing lid and a warning note was stencilled on the underside of lid.

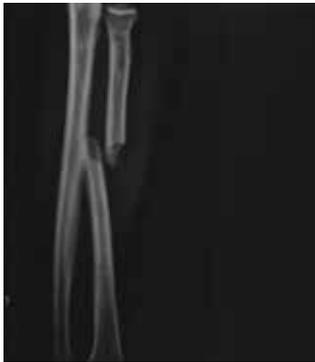
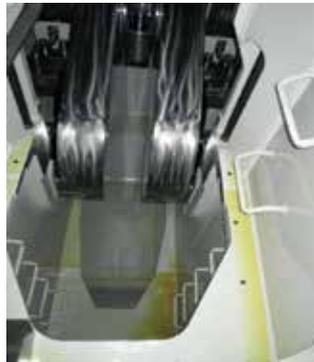
Once ready, and wearing a work suit, helmet and rubber boots, but not using gloves, the second engineer entered the crankcase. Inspection and measurements of units number one and two went without incident. However, while crossing from port to starboard on the horizontal crank web in unit number three, he lost his balance, tried gripping the hand rails/steps, and fell on to his left arm with all his weight. He was later diagnosed with a fracture.

- The second engineer was not wearing proper PPE. For example, he was not wearing correct safety shoes/boots nor an antiskid protective cover for the footwear. Nor was he wearing gloves such as dotted cotton gloves that enhances grip on slippery surfaces.

- Proper procedures were not followed during the inspection. Crew should not be crossing over from one side to the other through the crank web. Rather, the procedure calls for climbing down and passing underneath the crank web, then climbing up the other side to continue the inspection.

- Staff must be familiarised with procedures. The safety briefing conducted with senior officers prior to their joining the vessel has to be reviewed. This briefing should focus on raising standards of safety leadership on board. Senior officers shall be briefed on carrying out realistic risk assessments and the briefing shall include a video on risk assessments.

- Anti-skid covers for safety shoes are necessary PPE when working in slippery work spaces. The company shall provide all fleet vessels with antiskid covers for safety shoes. The PPE matrix will be amended in the appropriate manual.

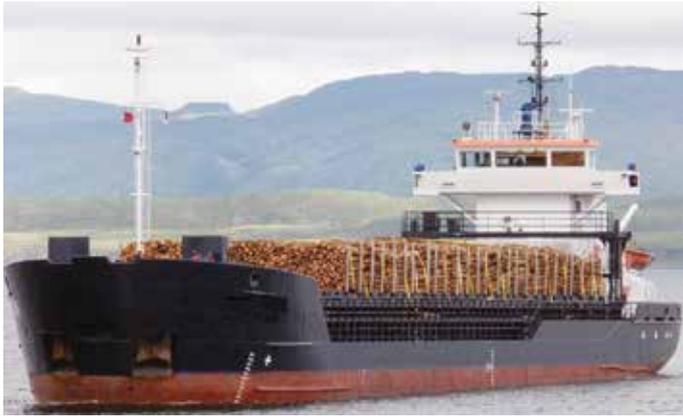
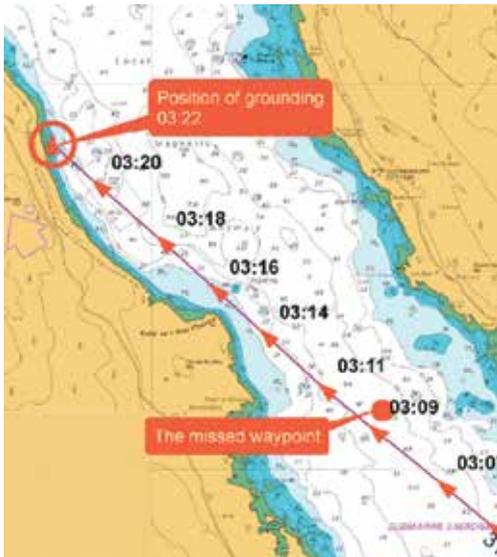
While ergonomically efficient, the bridge design encouraged the OOW to sit down, which increased the potential for him to fall asleep.

The OOW was possibly fatigued when he arrived on the bridge for his watch.

The bridge navigation watchkeeping alarm system (BNWAS) was probably not switched on during the period leading up to the grounding, and the ECS and GPS audible alarms were insufficiently loud to wake the sleeping second officer.

Editor's note: If you are tired, or even you are not, at such early hours anyone can fall asleep if in a comfortable position. The best remedy is to occupy oneself with watch keeping duties of position fixing, radio watch, and lookout, including effective use of radar by regularly changing scales. If you feel yourself very tired, get some help. Also, never work alone at night; have an effective lookout posted at all times in darkness and in reduced visibility.

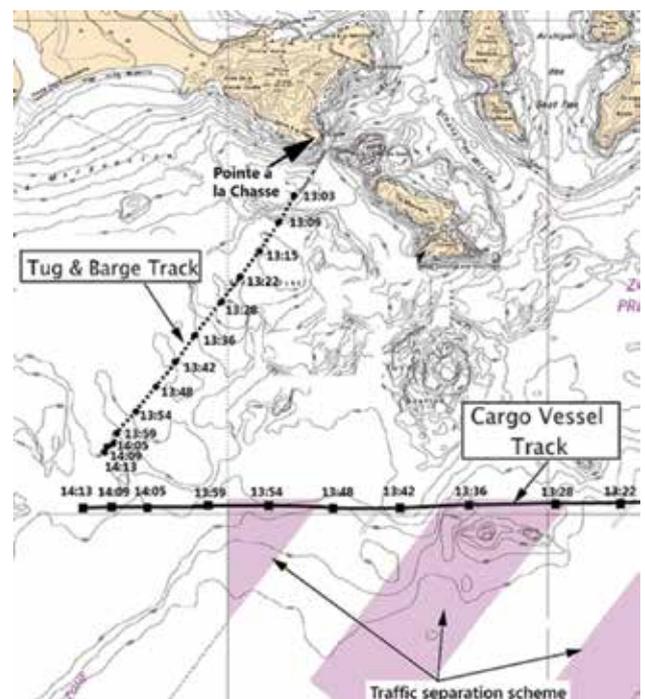
The cargo vessel maintained course to pass across the bow of the tug without taking action to avoid the close quarters situation, resulting in a risk of collision.

Following VHF radiotelephone communications, the tug remained unclear as to the cargo vessel's intentions and did not sound the appropriate whistle signals to indicate their doubts. The tug maintained course and speed until it became apparent that the cargo vessel was not taking action.

Upon arriving on the bridge, the Master on the cargo vessel reduced the vessel's speed prior to assessing the situation, further reducing the CPA.
